Occurrences in Quebec and Nunavut on runways undergoing construction that are reduced in width

Air transportation safety
issue investigation report

A18Q0140

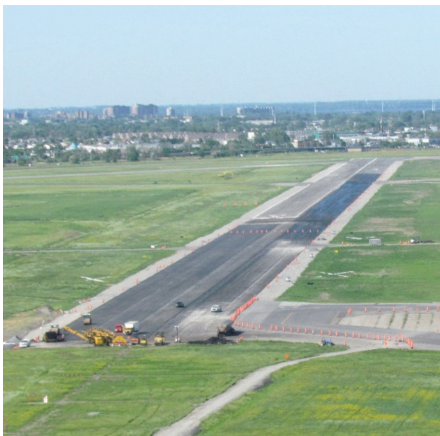
Aerial photo of the runway markings used for Runway 24R at the Montréal/St-Hubert Airport during the 1st phase of construction

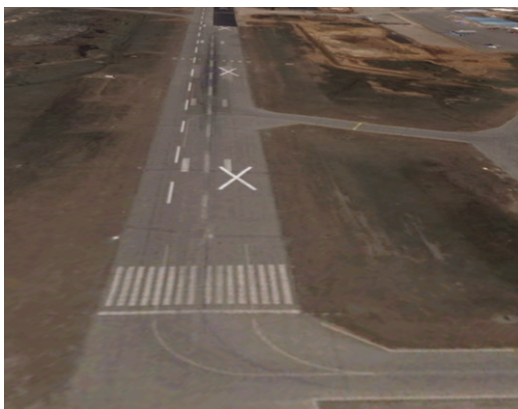
Aerial view of the runway markings used at the Iqaluit Airport during construction

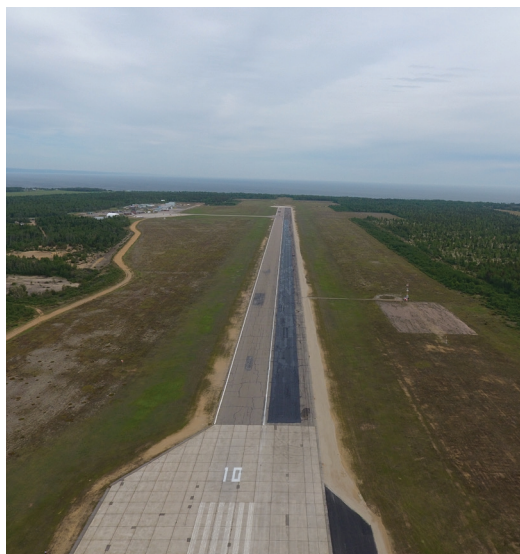
Aerial photo of Runway 10 at the Baie-Comeau Airport during the rehabilitation work on the south side of the runway in June 2018
