## **RAIL TRANSPORTATION SAFETY INVESTIGATION REPORT R18T0058**

### **TRESPASSING ACCIDENT**

Canadian Pacific Railway  
Freight train 141-17  
Mile 16.82, Galt Subdivision  
Mississauga, Ontario  
18 March 2018

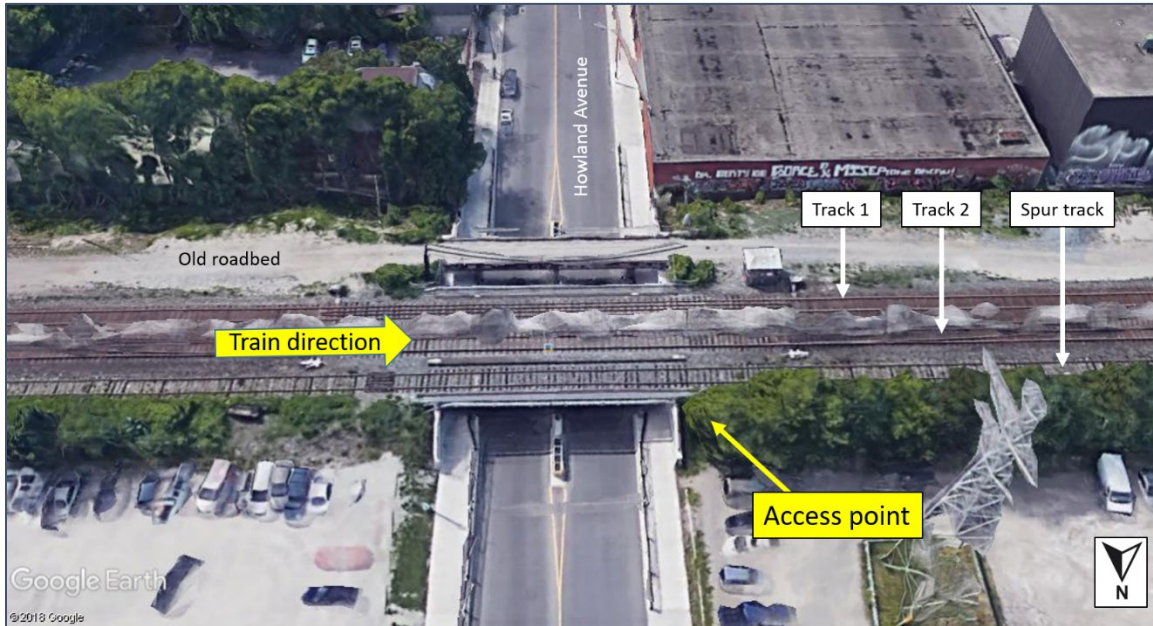
Figure 1. Howland Avenue grade-separated crossing where the teenagers accessed the right-of-way, looking south down Howland Avenue (Source: Google Earth, with TSB annotations)

Shortly after 0115, 2 teenage girls, who lived in the area, were walking south on Howland Avenue and observed train 651 slowly moving westward. They climbed the embankment immediately northwest of the Howland Avenue overpass and entered onto the railway right-of-way (Figure 1) without authority, through a gap between the fencing and the overpass barrier. The teenagers, who were intoxicated, climbed onto the train intending to travel to the nearby Christie Street grade-separated crossing, located some 2600 feet west of the Howland Avenue grade-separated crossing, on their way to Christie Pits Park.

During site observations following the occurrence, it was noted that a worn pathway extended from the parking lot northwest of Howland Avenue up the embankment and through a gap between the fencing and the overpass barrier where the teenagers had accessed the right-of-way (Figure 4). Several access points were present on the south side of the right-of-way through broken fencing and up the embankment.

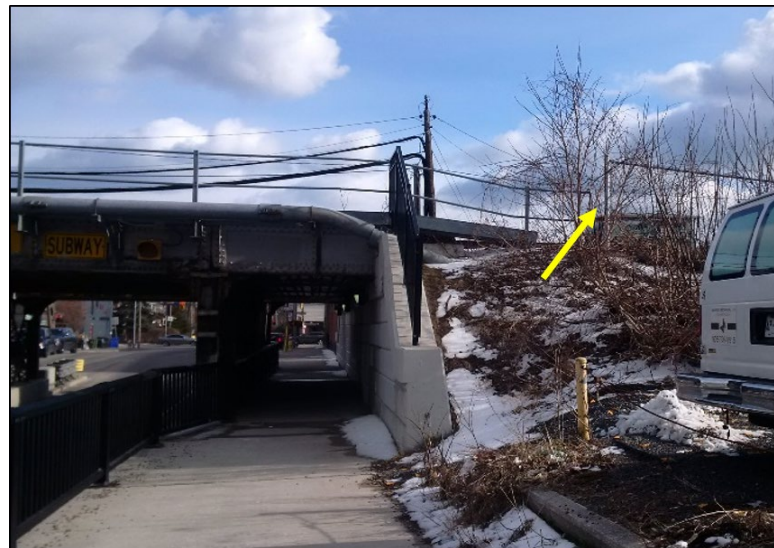
Figure 4. Gap in the fencing at the Howland Avenue grade-separated crossing, where the teenagers accessed the right-of-way (Source: TSB)

In the vicinity of the Howland Avenue grade-separated crossing, there were a number of physical indicators that trespassing was common. These included a well-worn pathway at the gap between the fencing and the overpass barrier, an old roadbed running parallel to the track, and graffiti on the side of the signal bungalow. The occurrence teenagers lived in the area and had regularly observed other people trespassing on the railway property without any negative safety consequences.

Effective engineering strategies provide one of the best measures to inhibit trespassing by way of effective physical barriers that prevent access to railway rights-of-way where possible. At the Howland Avenue grade-separated crossing, the railway tracks were easily accessed from either side. On the north side, there was a gap between the fencing and the overpass barrier. The gap was wide enough to accommodate a person without significant effort, and there was no indication of any pre-existing barriers. On the south side, there were several access points through broken fencing.

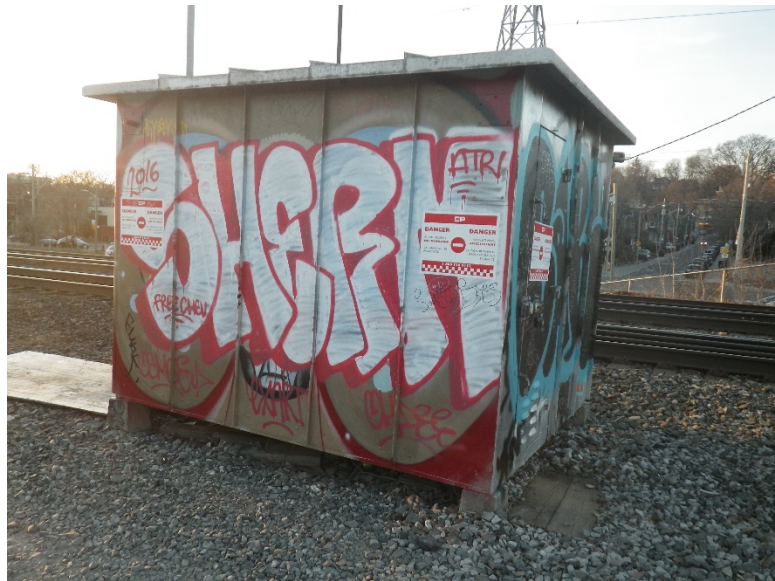
Figure 5. Red and white “No Trespassing” signs installed on the signal bungalow over red and white graffiti (Source: TSB)

The limited visual contrast between the “No Trespassing” signs and the graffiti reduced the conspicuity of the signs, making it less likely that people would see and read them. The level

“No Trespassing” signs were posted on the signal bungalow located immediately south of track 1. Graffiti was present on the signal bungalow, but did not cover the signage.

The conspicuity of a warning sign refers to how well it can capture the attention of an observer who does not necessarily expect it to be present.<sup>13</sup> In this occurrence, the only “No Trespassing” signs were those affixed to the signal bungalow immediately south of track 1. These warning signs were red and white, which were also the colours of some of the graffiti on the signal bungalow (Figure 5).

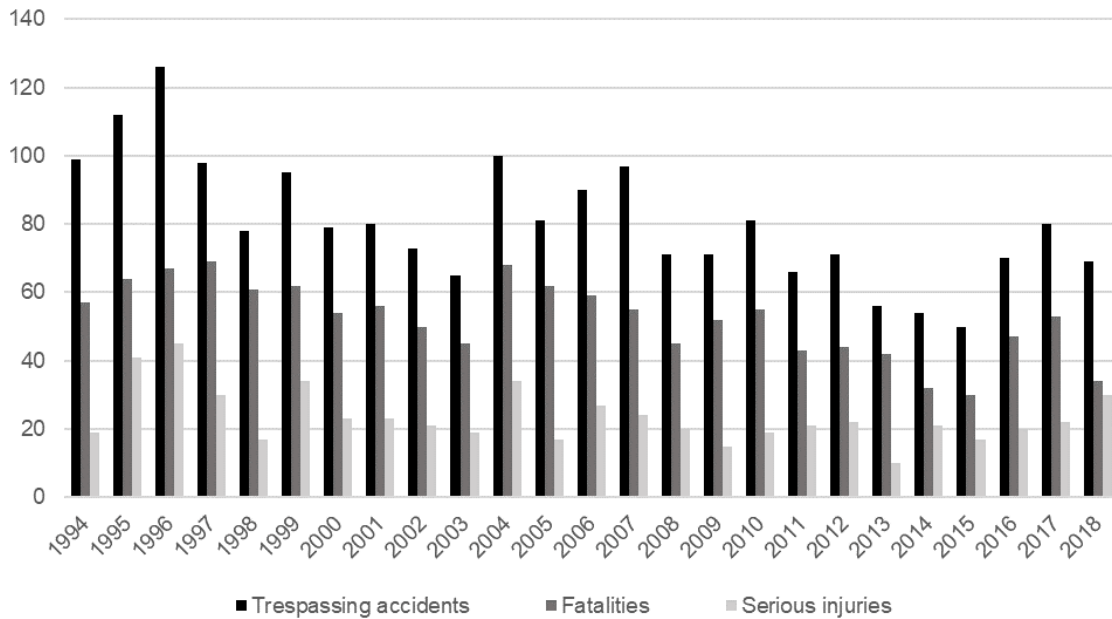
Figure 6. Number of trespassing accidents, fatalities, and serious injuries, 1994 to 2018 (Source: TSB Rail Occurrence Data System)

While there was a substantial decrease in trespassing accidents from 1994 to 2008, there has been little change in the data over the most recent 10-year period (from 2009 to 2018).

Figure 6 presents a summary of RODS data on trespassing accidents for the past 25 years (1994–2018), as well as the number of fatalities and serious injuries resulting from these accidents.<sup>32</sup>

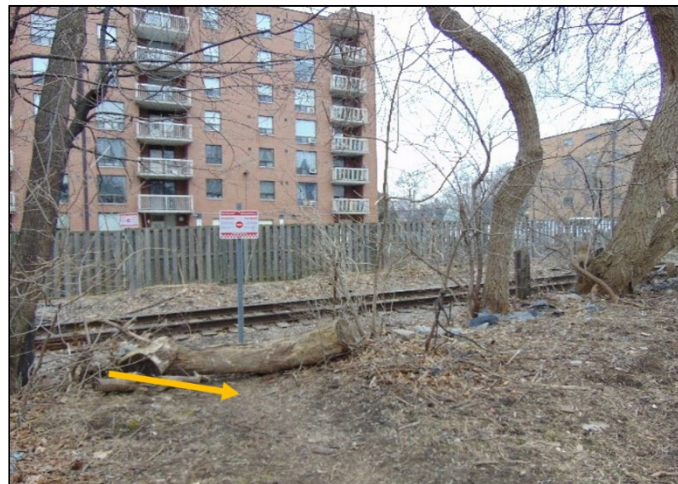
Figure 7. Worn footpath leading to the railway tracks near Mile 0.5 of the Hamilton Belt Line Spur, indicated by the arrow (Source: TSB)

On 05 April 2018, at about 1800, a CP yard assignment was proceeding at approximately 5 mph in Hamilton, Ontario, with a cut of cars destined for CP's Hamilton Yard. Near Mile 0.5 of the Hamilton Belt Line Spur, a group of young children were playing unsupervised near the railway right-of-way. In the vicinity, a well-worn footpath led to the railway tracks (Figure 7). As the train passed through this location, one of the children accessed the footpath, approached the train, fell, and was run over by the train, sustaining serious injuries. The railway tracks pass through a residential area with apartment buildings and homes backing onto the tracks. Access to the tracks is protected partially by fencing in some areas. However, in other areas, such as where the children were playing, the public can easily access the railway tracks.

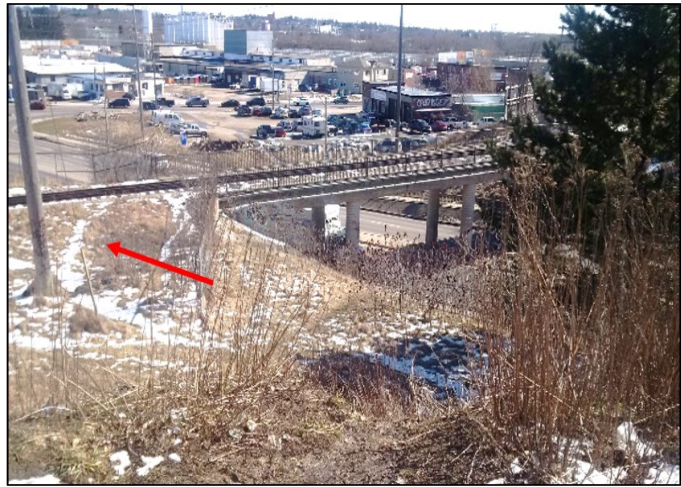
Figure 8. Worn pathway at Victoria Road North in Guelph, indicated by the arrow (Source: TSB)

On 12 April 2018, at about 1455, a Goderich-Exeter Railway (GEXR) train was proceeding westward at about 35 mph when it struck and fatally injured an individual at Mile 47.9 of the GO Transit Guelph Subdivision, in Guelph, Ontario. The individual was walking westward on the railway tracks, wearing headphones, and facing away from the train. Although it is not known exactly where he had accessed the tracks, several well-worn pathways were present, extending from the east side of the road (Victoria Road North) to the right-of-way (Figure 8).
