OPERATIONAL SERVICES BRANCH  
**ENGINEERING LABORATORY REPORT**

LP168/2013

Metallurgical Analysis of Tank Car Coupons  
Montreal, Maine & Atlantic Railway Train, MMA 2  
Date of Occurrence: 06-Jul-2013

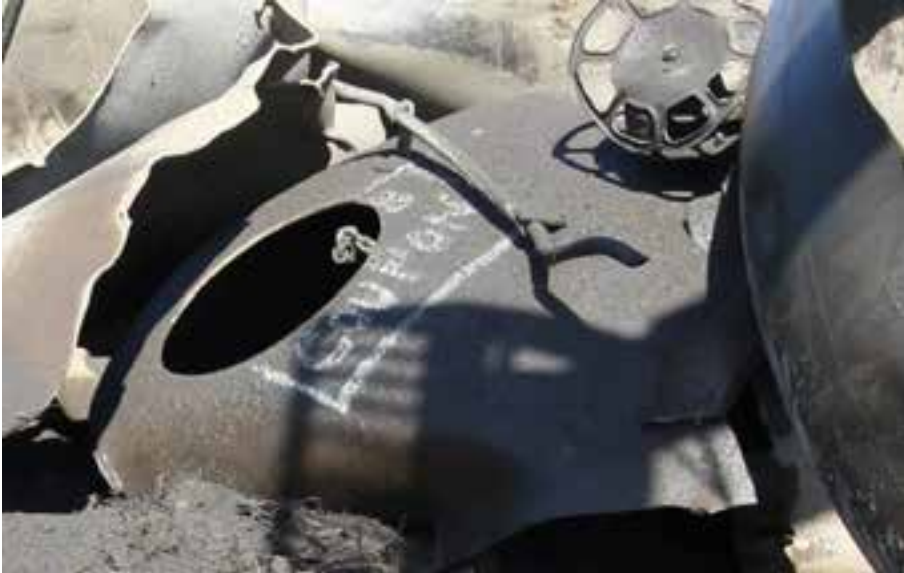
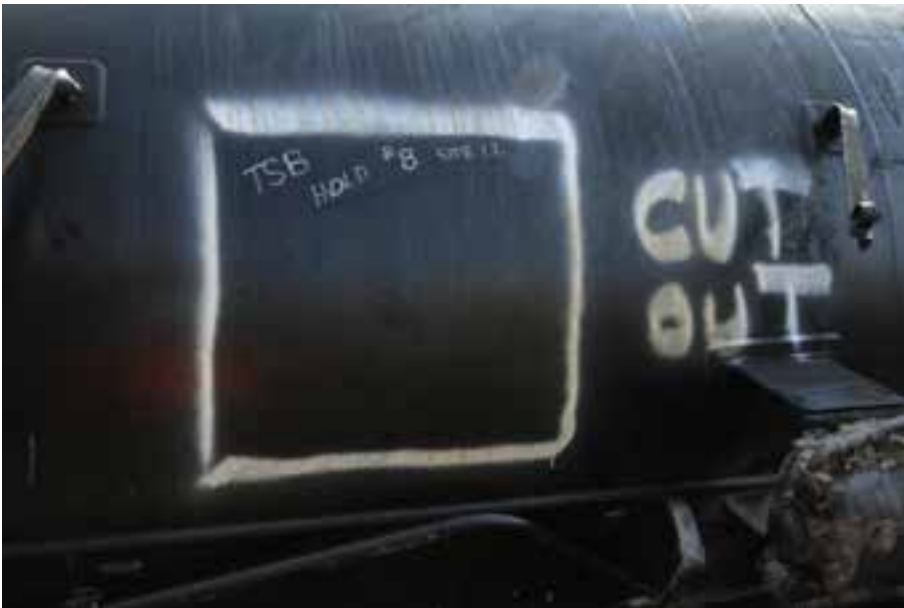
Figure 1: Photographs showing coupons marked on tank car WFIX 130682.

(a) Sheared-off head with a round hole where the coupon has been cut out using water-jet equipment.

(b) Coupon marked on the shell.

1.3.2 Figures 1 through 9 are photographs that show the coupons as marked on the cars. Coupons were taken from locations with as little impact and fire damage as possible, except for car WFIX 130571 from which a coupon was purposely taken from an area with extensive fire damage that contained a burn-through<sup>4</sup> (Figure 6). The marked sections of cars were cut out using hydraulic shears before the cars were scrapped. Since hot work was not permitted on the occurrence site due to the fire hazard, an external company was contracted to cut circular coupons from the sheared-off sections of tank car using water-jet equipment. Figure 1a is a representative example of a sheared-off section of tank car after the circular

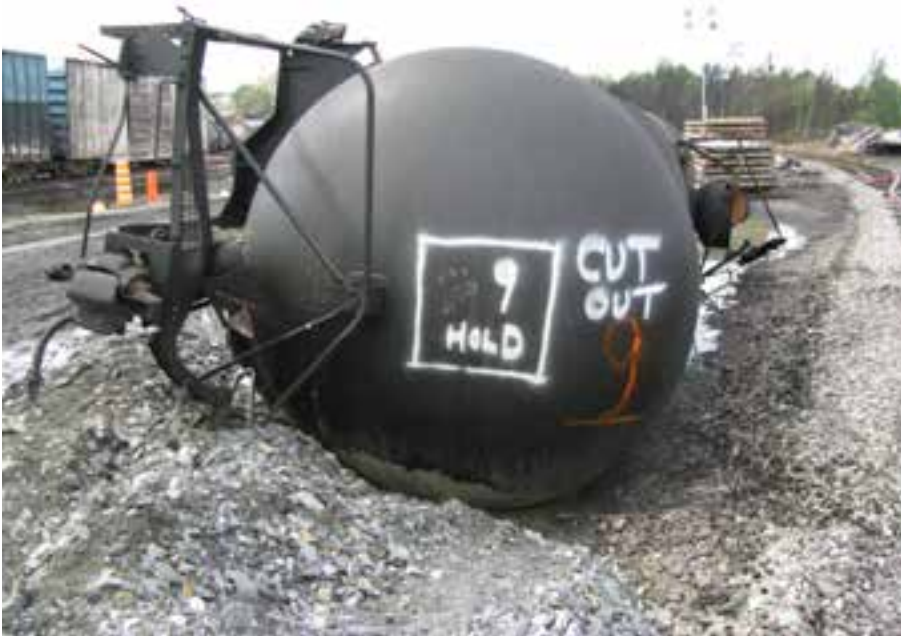
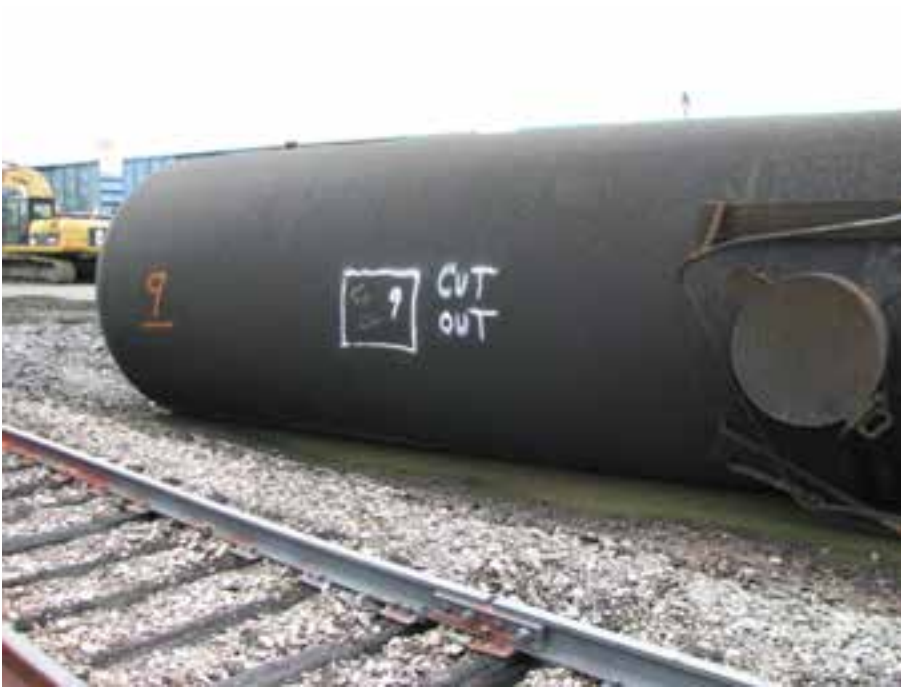
Figure 2: Photographs showing coupons marked on tank car TILX 316641.

(a) Coupon marked on the head.

(b) Coupon marked on the shell.

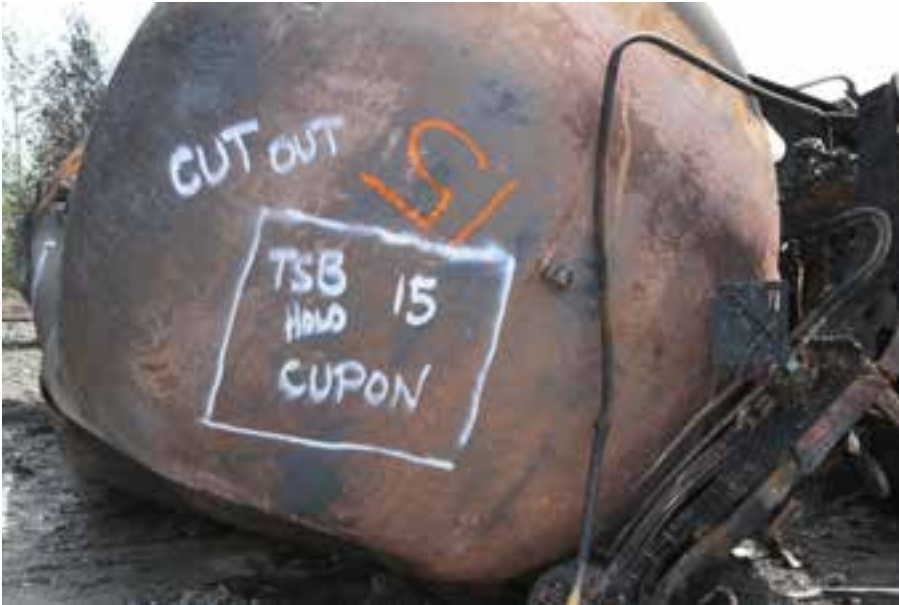
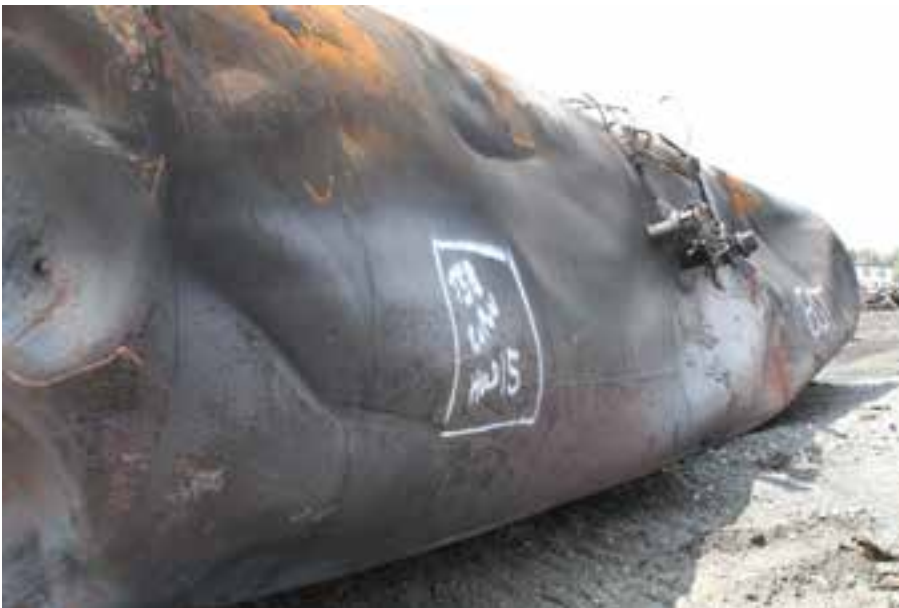
Figure 3: Photographs showing coupons marked on tank car ACFX 79709.

(a) Coupon marked on the head.

(b) Coupon marked on the shell.

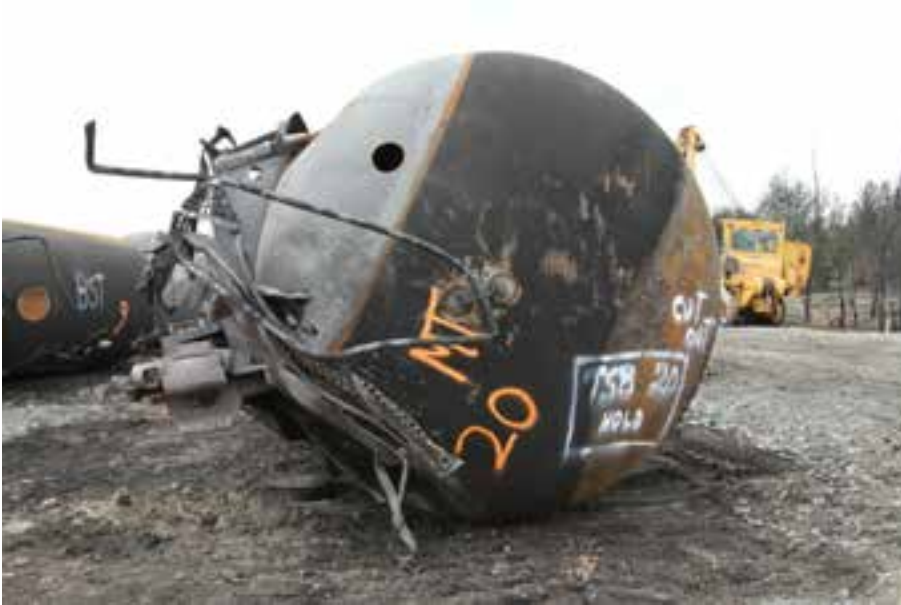
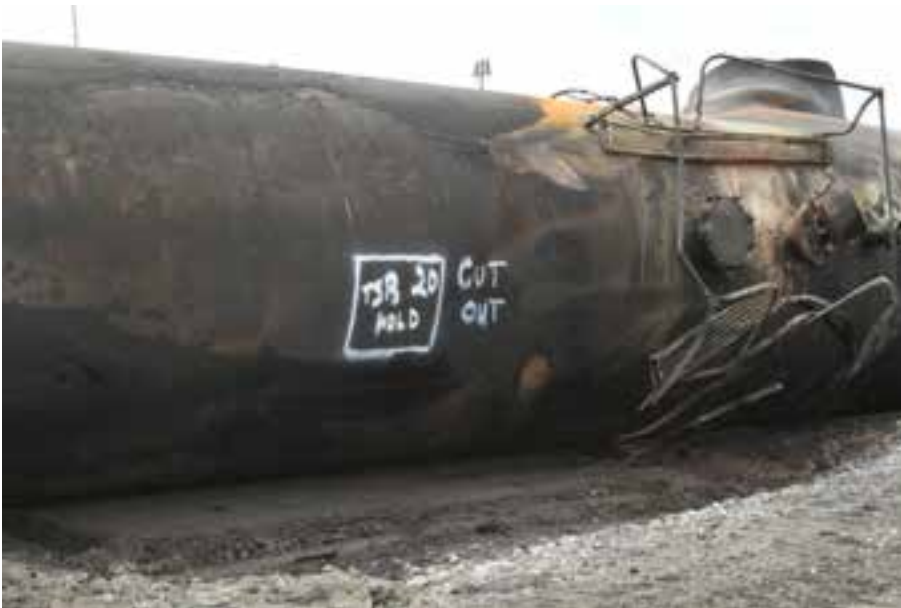
Figure 4: Photographs showing coupons marked on tank car PROX 44293.

(a) Coupon marked on the head.

(b) Coupon marked on the shell.

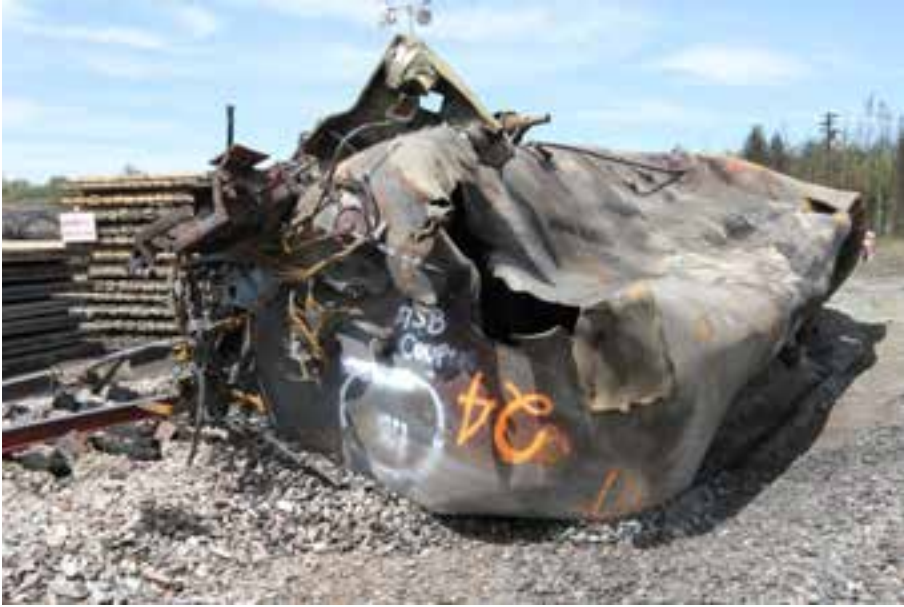
Figure 5: Photograph showing coupon marked on the head of tank car ACFX 76605.

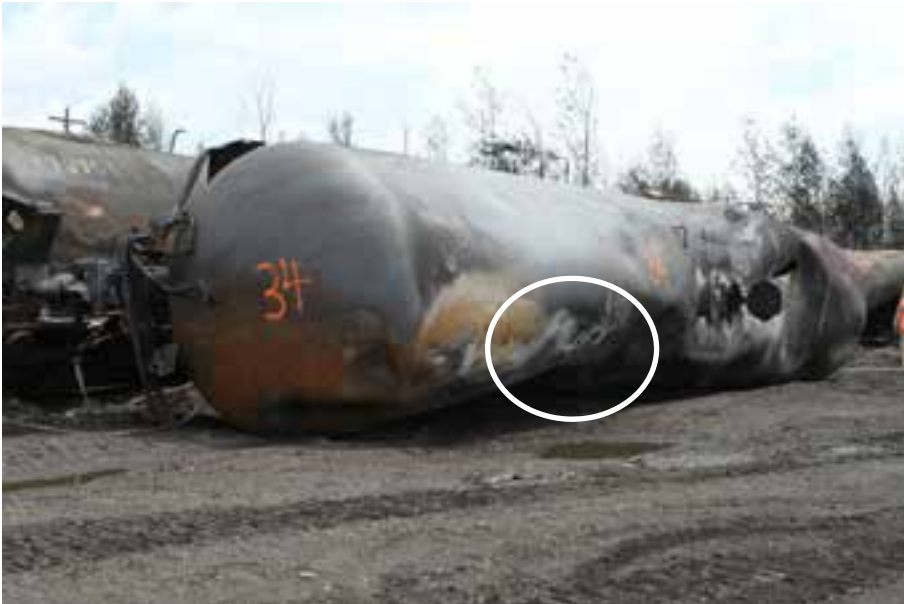
Figure 6: Photograph showing the location (circled) from which a coupon was taken from tank car WFIX 130571.

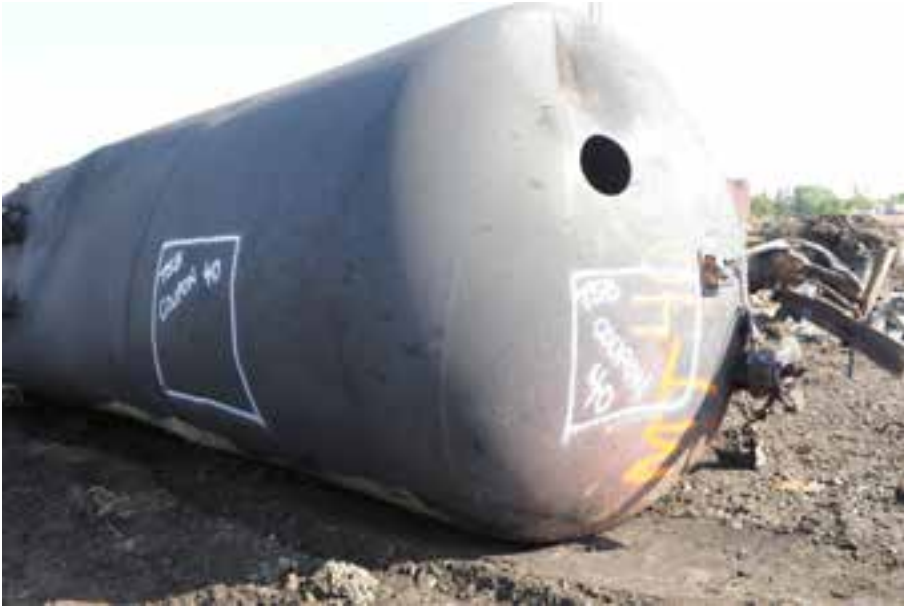
Figure 7: Photograph showing coupons marked the head and shell of tank car CTCX 735572.

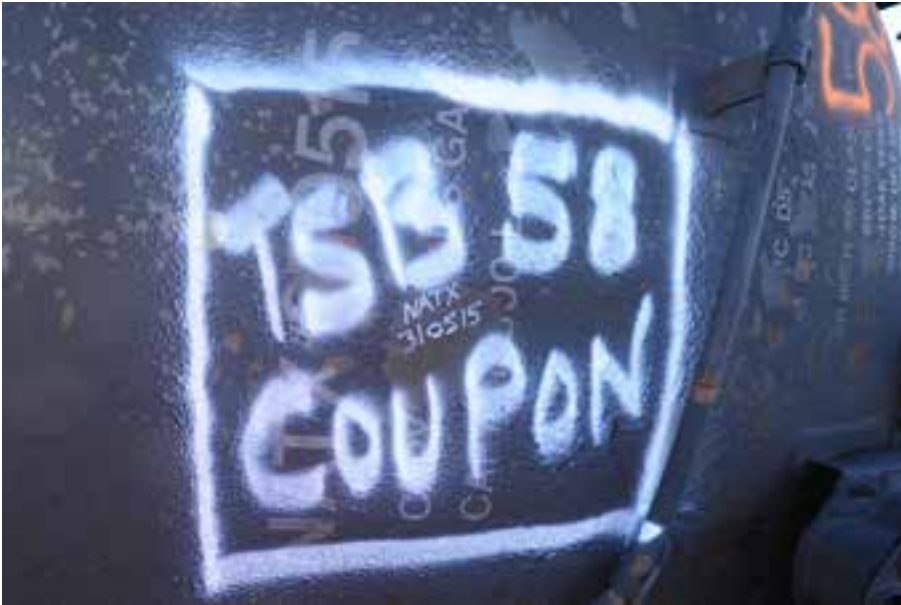
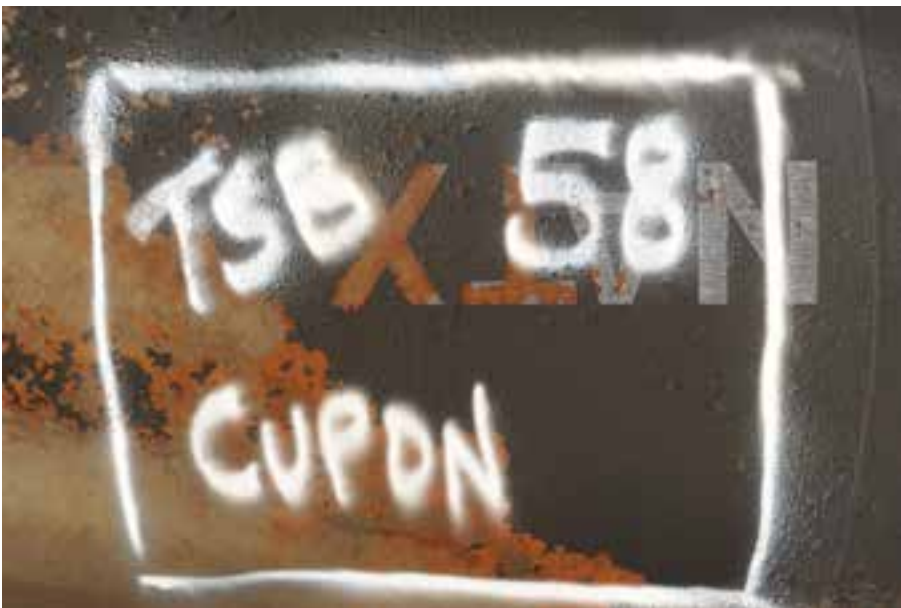
Figure 8: Photographs showing coupons marked on tank car NATX 310515.

(a) Coupon marked on the head.

(b) Coupon marked on the shell.

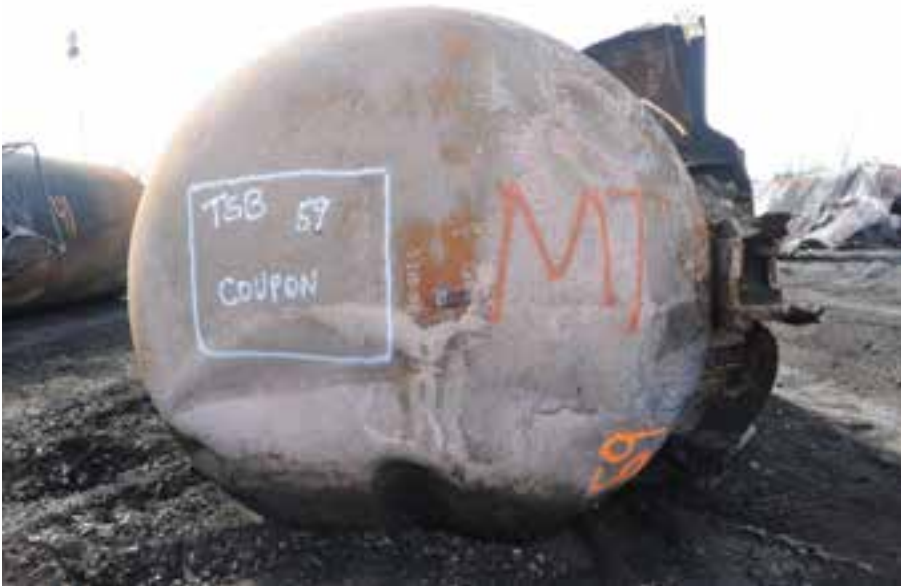
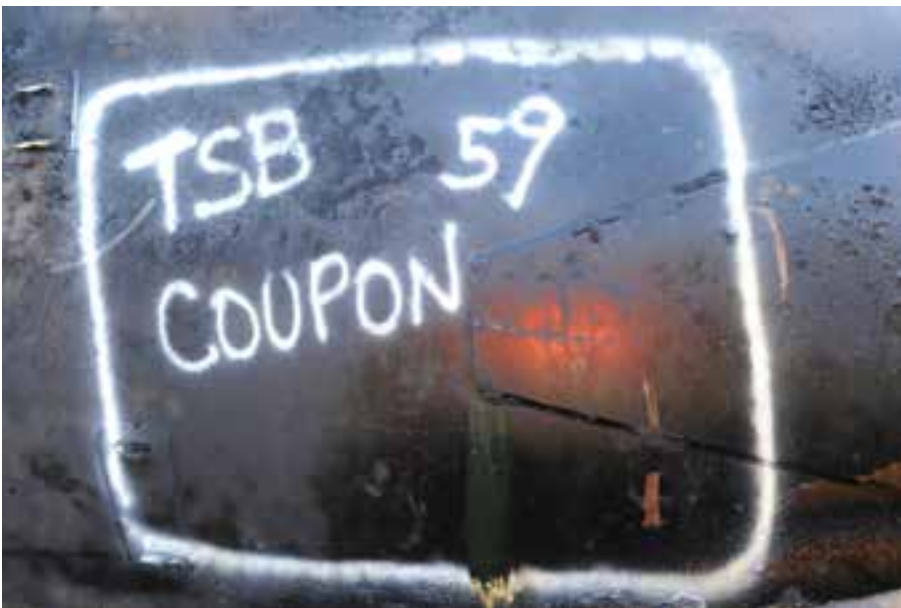
Figure 9: Photographs showing the coupons marked on tank car ACFX 79383.

(a) Coupon marked on the head.

(b) Coupon marked on the shell.

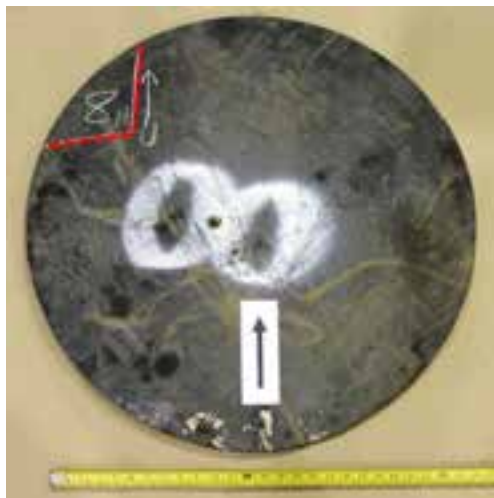
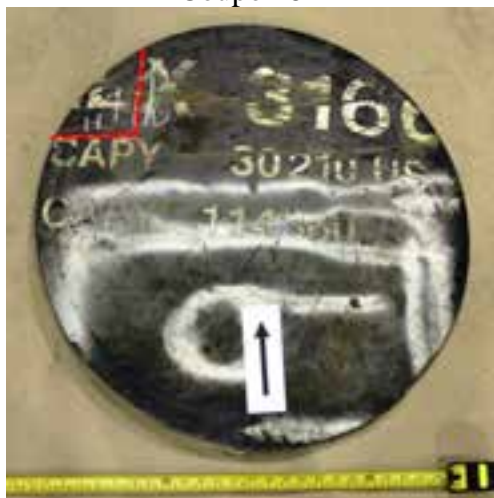
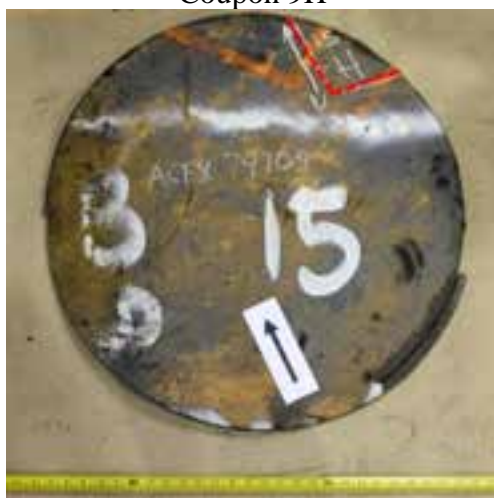
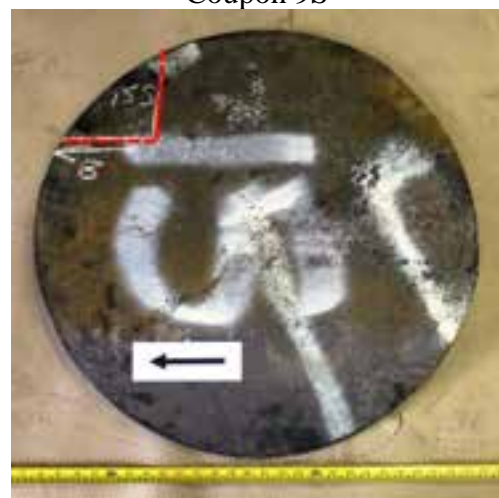
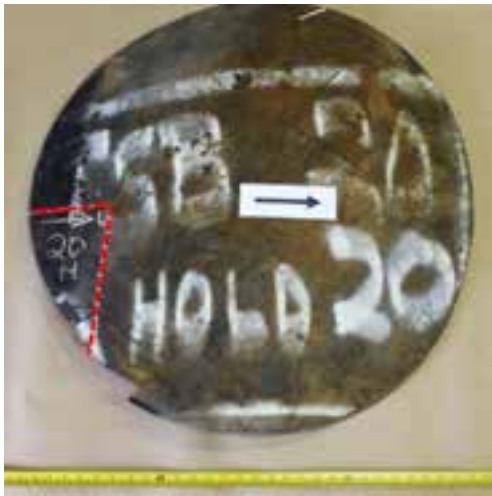
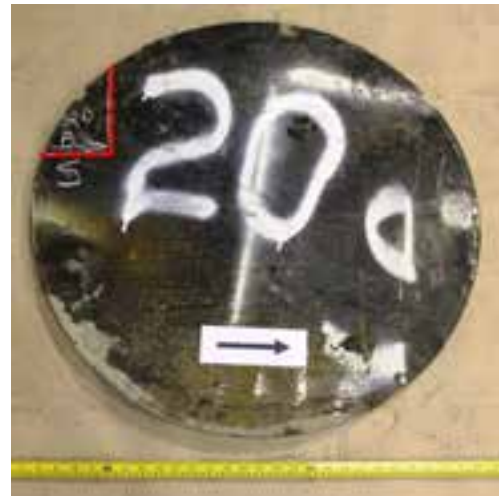
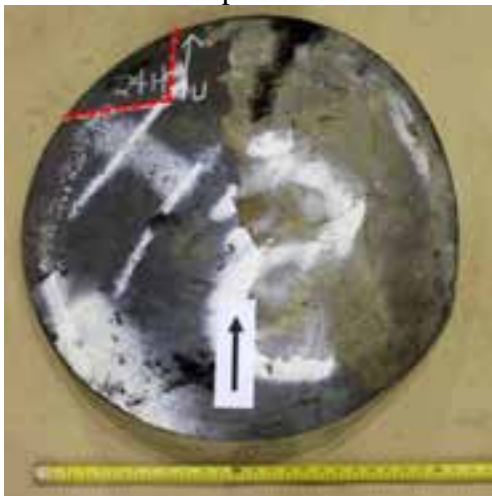
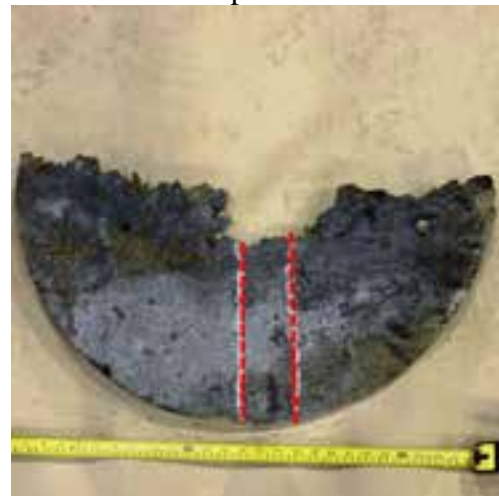
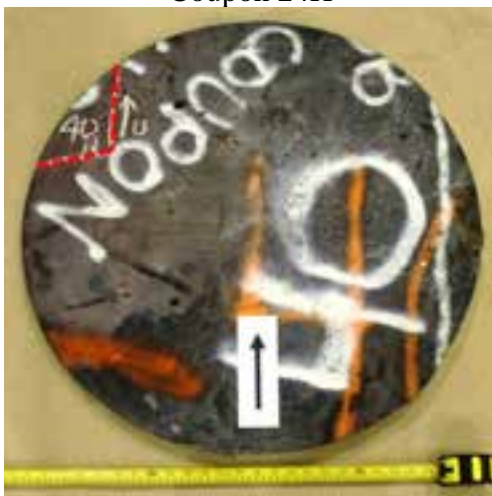
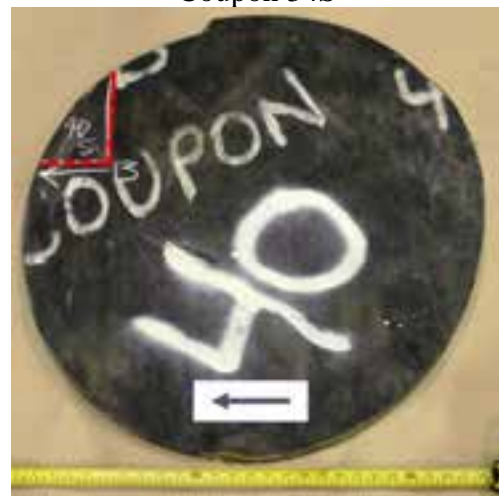
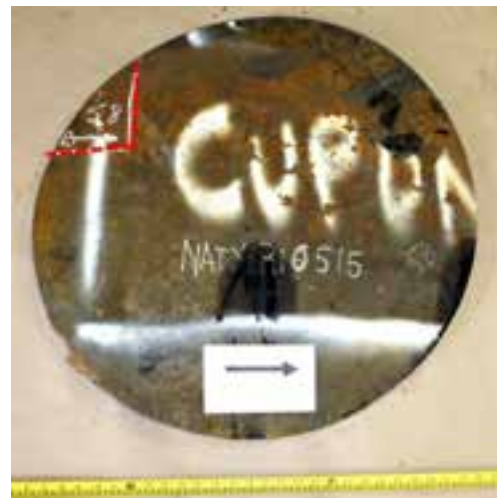
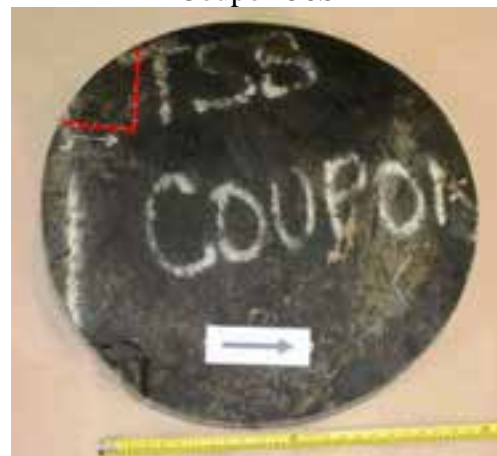
Figure 10: Photographs showing the coupons as received.

coupon was cut out. Table 2 summarizes the identification and origin of each coupon. Figure 10 shows the water jet-cut coupons as received at the TSB Engineering Laboratory.

Arrows indicate the “up” direction (head coupons) or the car’s longitudinal axis (shell coupons). Dashed red lines indicate the portion used for chemical analysis, metallurgical examination and hardness testing.

#### 2.1.1 Samples approximately 1 by 2 inches in size were cut from each tank car coupon at the locations indicated by the dashed red lines in Figure 10. The cut-out

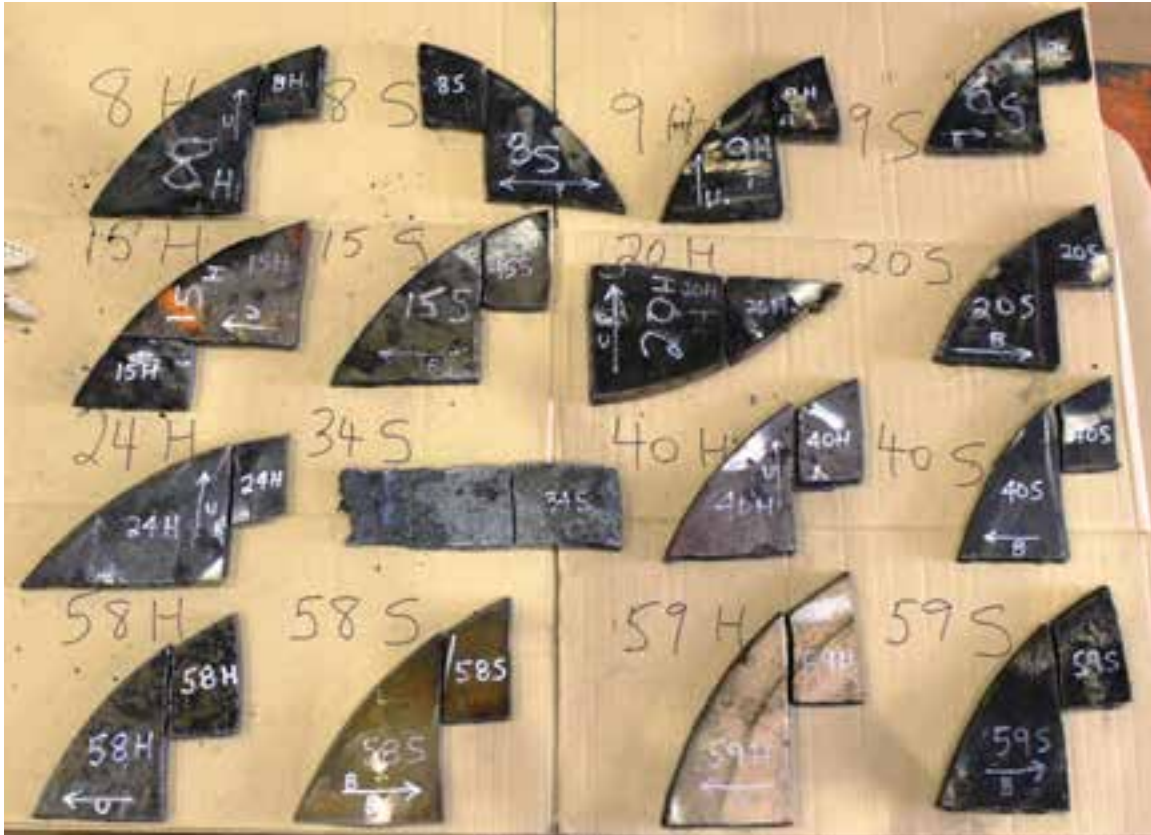
Figure 11: Photograph showing the samples cut out of each coupon.

samples are shown in Figure 11. The samples were sent to an external laboratory<sup>14</sup> for chemical analysis in accordance with ASTM E415-08<sup>15</sup> and ASTM E1019-11.<sup>16</sup> The detailed chemical analysis results are presented in Appendix A (see Tables A-1 through A-9).

The smaller piece was used for chemical analysis; the larger piece for metallurgical examination and hardness testing. Arrows marked on the larger pieces indicate the vertical direction (head coupons) or the tank car's longitudinal axis (shell coupons).

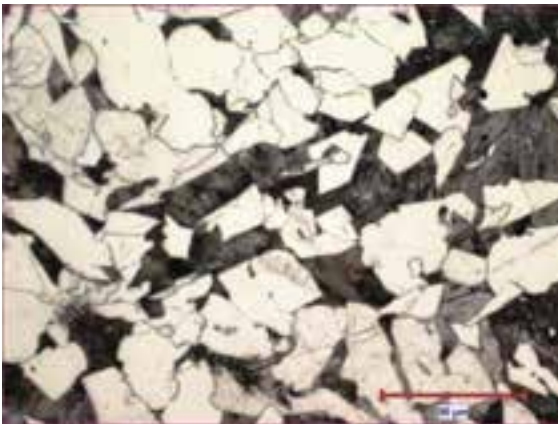
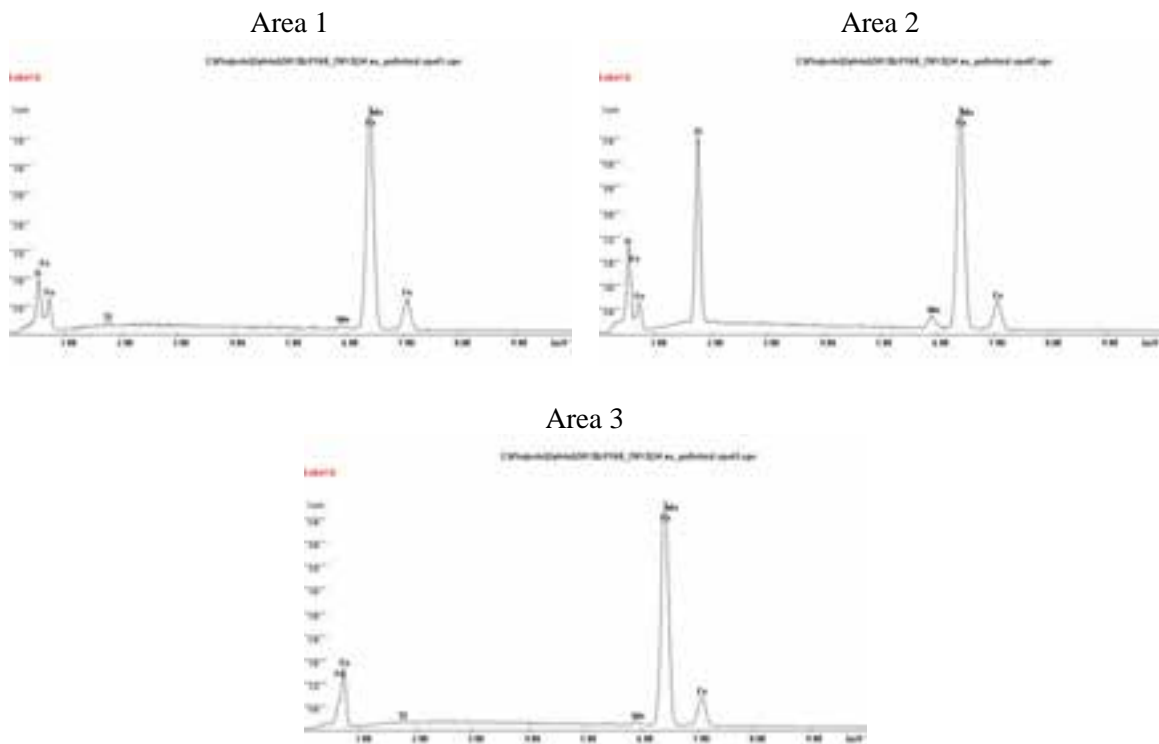
Figure 17: Metallurgical cross-section of the WFIX 130571 shell coupon taken near the burn-through.

- 2.3.4 Figures 17 and 18 show the microstructure of coupon 34S (WFIX 130571 shell). Two cross-sections were prepared from this coupon: the first through the edge of the burn-through (Figure 17) and the second a few centimeters away from the burn-through (Figure 18). Both cross-sections revealed significant microstructure variations across the thickness of the plate (Figures 17a and 18a). There was a visible reduction of the amount of pearlite (dark constituent) near the outer surface whereas the material adjacent to the inner surface was almost fully pearlitic. Such variations were not observed on the other tank car coupons.

- 2.3.5 On the first cross-section (through the edge of the burn-through), the material adjacent to the inner surface had a lamellar pearlite microstructure with blocky ferrite grains decorating the boundaries of the large prior austenite grains (Figures 17b and 17c). On the second cross-section (away from the burn-through), the material adjacent to the inner surface also exhibited a fully pearlitic microstructure but the prior austenite grain boundaries were decorated with a continuous film of carbide phase (most probably cementite) - see Figures 18b, 18c, 18d and 18e. These observations suggest that the region adjacent to the inner surface was significantly enriched with carbon. The carbon content corresponding to a fully pearlitic microstructure is about 0.8 wt.%,<sup>21</sup> as compared with the initial carbon concentration of 0.11 wt.% (Table A-6). It is considered most probable that this carbon enrichment occurred when the steel was exposed to a carbon-rich environment at elevated temperatures during the post-derailment fire. The crude oil in the tank car likely acted as a supply of carbon for absorption and diffusion into the steel.

- 2.3.6 The middle portions of the coupon 34S cross-sections exhibited amounts of ferrite and pearlite phases similar to those observed in other cross-sections of as-rolled TC128 Grade B steel (for example coupon 8S). However, the coupon 34S cross-sections had visibly larger grain size, as demonstrated by comparing the grain size on Figures 12b and 12f (coupon 8S) with Figures 17d, 17e, 18f and 18g (coupon 34S). This is consistent with the steel having been overheated during the exposure to the post-derailment fire.

- 2.3.7 The microstructure at the outer surface of coupon 34S was composed mainly of ferrite, with only a small amount of pearlite. The outer surface was covered with an irregular layer of oxide. Figure 17f shows a representative cross-section through this oxide. Energy dispersive x-ray spectroscopy (EDS) indicated it was composed of iron oxide (see area 1 on Figures 17f and 17g) and iron-silicon oxide (see area 2 on Figures 17f and 17g). The above observations indicate that the outer surface of coupon 34S was both decarburized and oxidized. When steel is exposed to an environment containing oxygen and water vapour at high temperature (as would have been present during the response to the post-derailment fire), the carbon atoms near the surface react with the oxygen and water vapour, causing a reduction of the surface carbon content and consequently, an increase of ferrite content. The iron atoms in the steel also react with the oxygen and water vapour to form iron oxide at the surface.

(a) Montage of optical micrographs showing the microstructural variation across the plate thickness (left-outer surface, right –inner surface, Nital etch, original magnification 25X).

(b) Optical micrograph taken near the inner surface (Nital etch, original magnification 200X).

(c) SEM micrograph taken near the inner surface (Nital etch, original magnification 2000X).

(d) Optical micrograph taken in the middle of the cross-section (Nital etch, original magnification 200X).

(e) SEM micrograph taken in the middle of the cross-section (Nital etch, original magnification 2000X).

(f) SEM micrograph showing the oxide layer on the outer surface (back scattered electron mode, as-polished, original magnification 150X).

(g) EDS spectra obtained from the areas highlighted on Figure 17f (O - oxygen, Si - silicon, Mn - manganese, Fe - iron).

- 3.7 The examination of a coupon taken from a tank car with extensive fire damage revealed a carbon-enriched region at the tank's inner surface. The crude oil in the tank car likely acted as a supply of carbon for absorption and diffusion into the steel during the exposure to the post-derailment fire. High-temperature carburization attack can produce embrittlement, pitting and rapid loss of material (so-called metal dusting).<sup>26</sup> The outer surface of the steel was decarburized and oxidized, consistent with exposure to oxygen and/or water vapour at elevated temperature. No sign of melting was observed on the coupon cross-sections indicating that melting was not the cause of the burn-through. It is concluded that chemical reaction of the steel with the crude oil and the external environment was likely responsible for the plate erosion and loss of material causing the burn-through.

- 3.8 The cross-sections of the fire-damaged coupon had large grains suggesting that the steel was exposed to high temperatures in the austenite range (well above 800°C), causing significant coarsening of the austenite. This is consistent with the range of temperatures within pool fires reported in available literature (900 to 1100°C).<sup>27</sup>

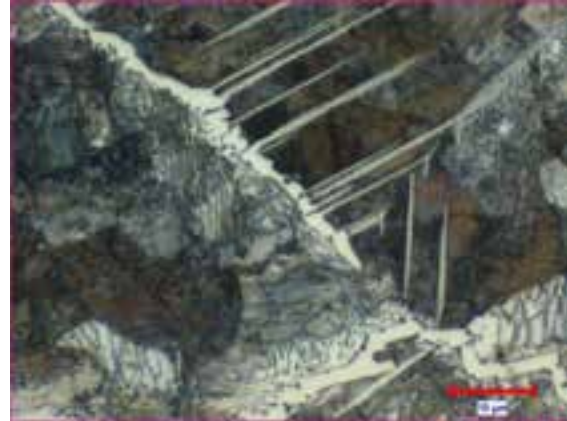
Figure 18: Metallurgical cross-section of the WFIX 130571 shell coupon taken away from the burn-through.

(a) Montage of optical micrographs showing the microstructural variation across the plate thickness (left- outer surface, right –inner surface, Nital etch, original magnification 25X).

(b) Optical micrograph taken near the inner surface (Nital etch, original magnification 200X).

(c) Optical micrograph taken near the inner surface (Nital etch, original magnification 1000X).

(d) SEM micrograph taken near the inner surface showing carbide phase decorating the prior austenite grain boundary (Nital etch, original magnification 2000X).

(e) SEM micrograph taken near the inner surface showing pearlitic microstructure (Nital etch, original magnification 2000X).

(f) Optical micrograph taken in the middle of the cross-section (Nital etch, original magnification 200X).

(g) SEM micrograph taken in the middle of the cross-section (Nital etch, original magnification 2000X).
