ENGINEERING LABORATORY REPORT

LP187/2013

Brake Force Analysis

Montreal, Maine & Atlantic Railway, Train MMA-002

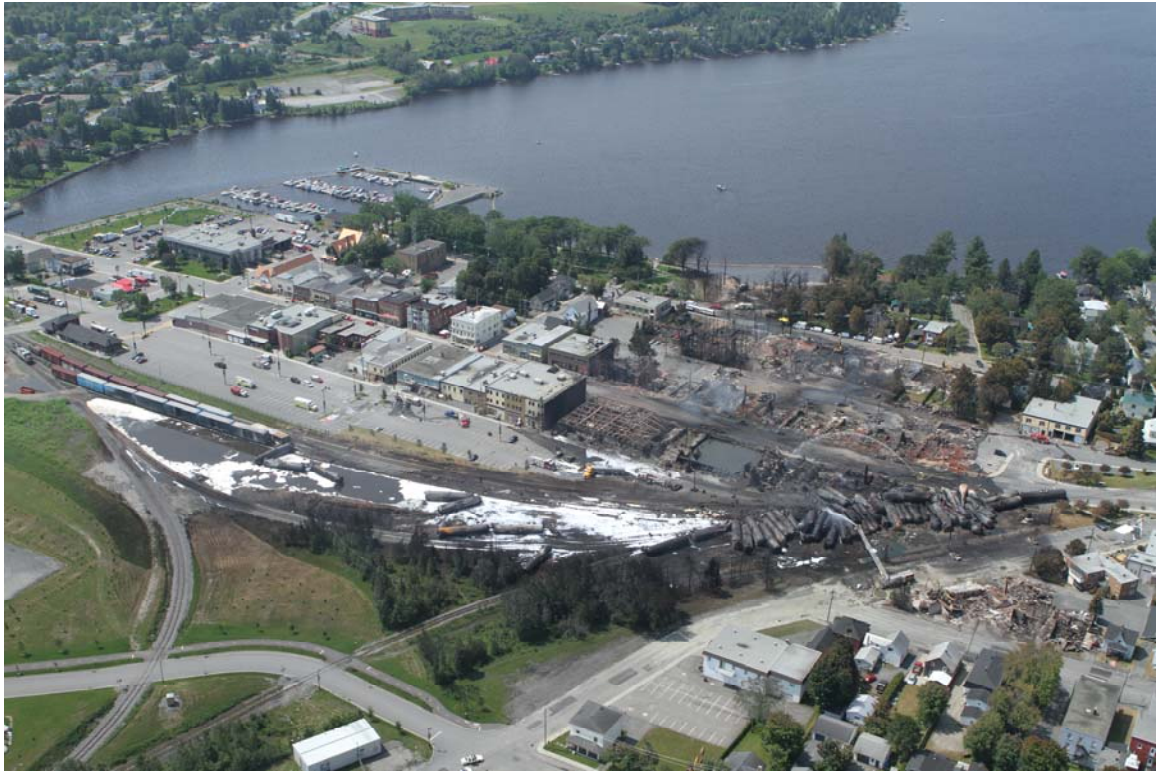
Figure 1: Aerial View of Derailment Site

- 1.1.3 The derailed buffer box car struck a stationary cut of cars on the siding track. The following 8 tank cars were scattered in separated jackknifed positions. The next 2 tank cars lay in the direction of the turnout siding, ahead of the main jackknifed pile-up of the rest of the derailed tank cars among which the fire and explosions occurred. The last 9 tank cars in the train did not derail. They were disconnected and removed back and away from the derailment and fire by the locomotive engineer and emergency responders. An aerial-view photograph of the accident site is shown in Figure 1.

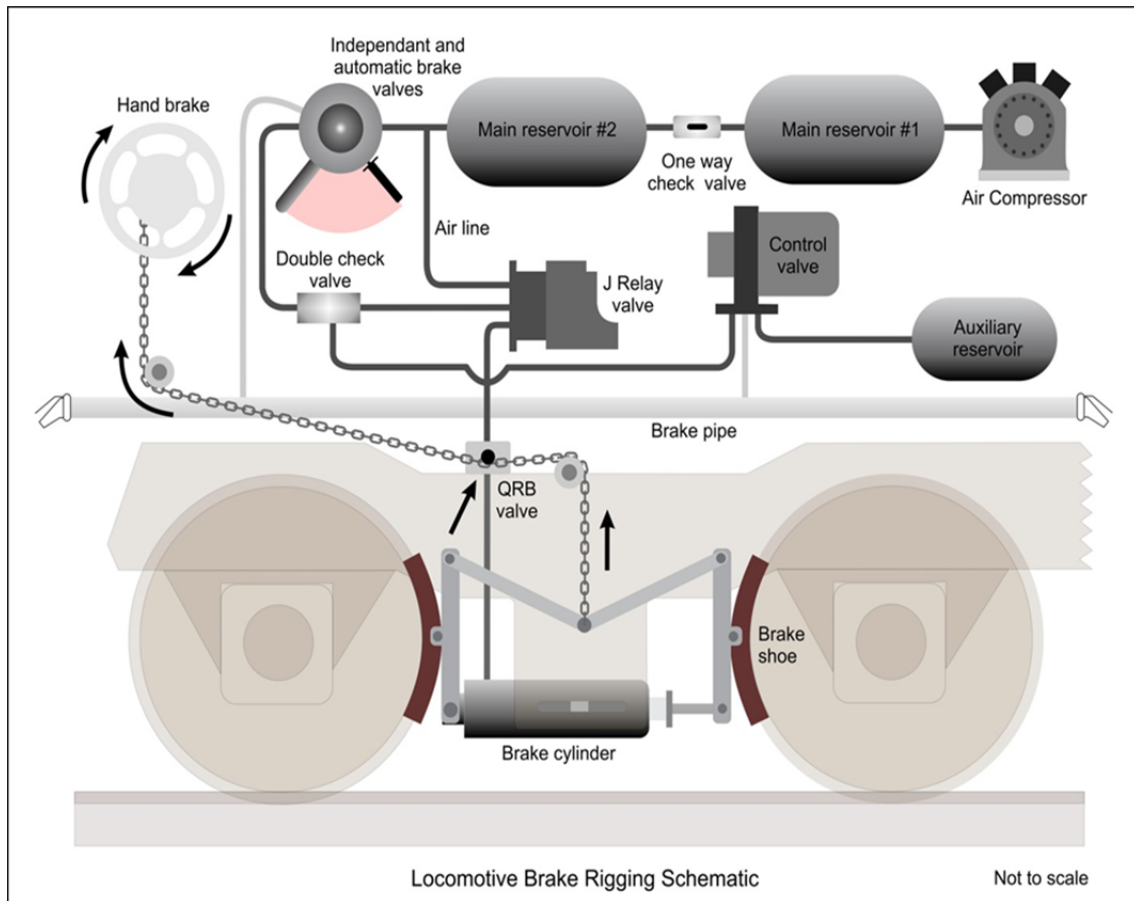
Figure 4: Locomotive Brake Rigging Schematic

- 2.1.3 Each locomotive is also equipped with independent brakes in addition to the air brake system on cars as shown in Figure 4. These brakes, which are also supplied with air from the main reservoir, only apply on the locomotives. The independent brakes are controlled by the independent brake handle located on the control stand. The independent brakes are not normally used during train operations, but are primarily used as a parking brake. When the independent brakes are applied, they inject up to approximately 75 psi of air pressure into the brake cylinder, which then applies the brake shoes to the locomotive wheels.

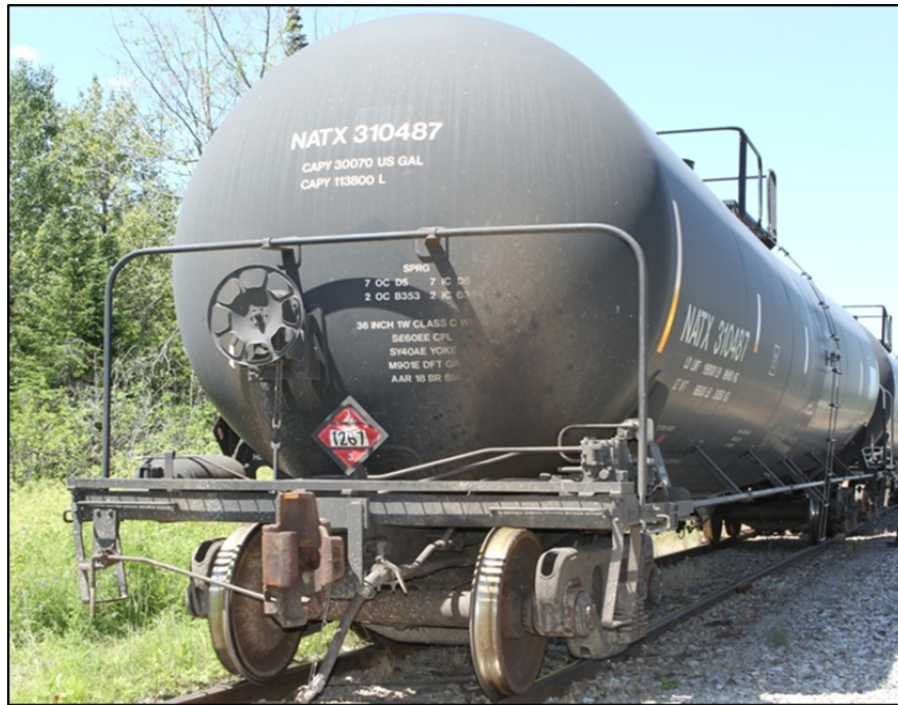
Figure 5: Tank Car Hand Brake

2.2.1 All locomotives and rail cars are equipped with a hand brake, a mechanical device allowing the brake shoes to be applied against the wheel treads to prevent the wheels from moving or to retard their motion (see Figure 5). Hand brake components include a chain linked to the brake rigging that, when tightened, applies the brakes on the equipment.

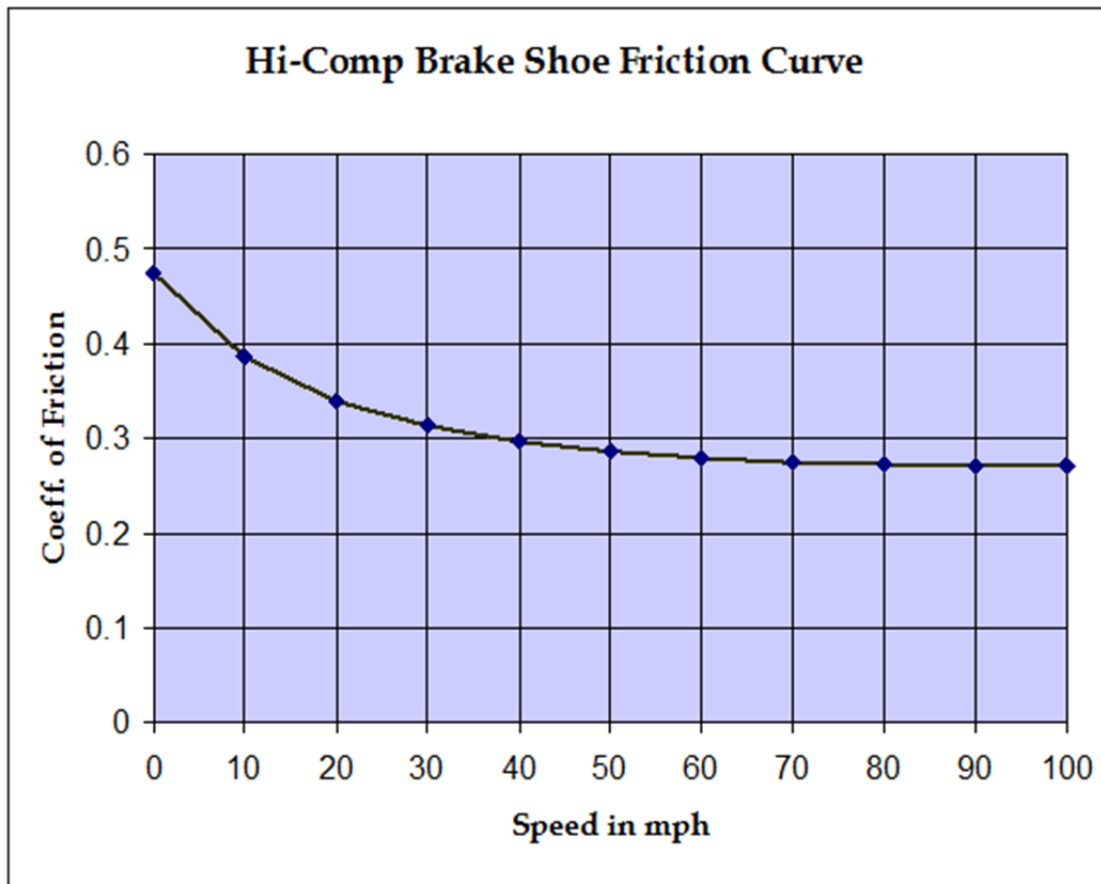
Figure 6: Coefficient of Friction for New Clean Brake Shoes

3.1.5 The coefficient of friction between wheel tread and composite brake shoes is related to the condition of the contact surface and the speed. An experimental curve of the friction and the speed is shown in Figure 6. Under normal condition, the average coefficient of friction is approximately 0.315 for speed range 0-100 mph. According to the Wabtec test experience, the average coefficient of friction of 0.38 is normally used in evaluation of stationary retarding brake force from the tested brake shoe force.

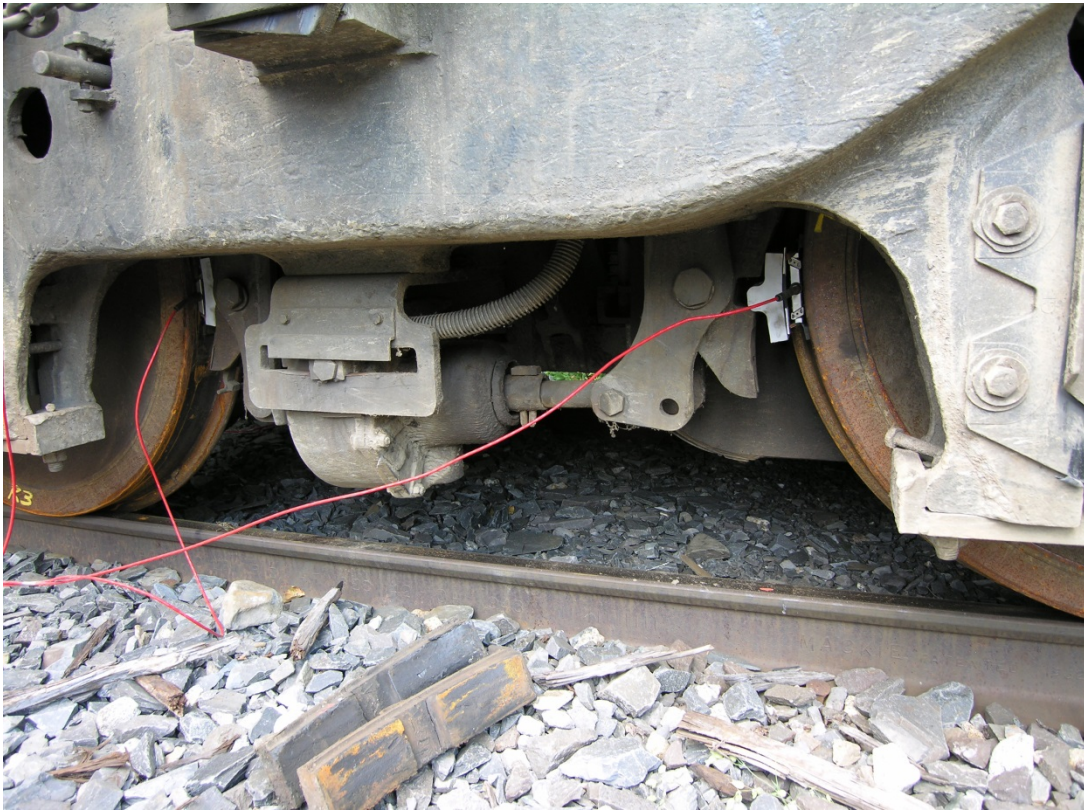
Figure 7: Smart Shoe Sensors

3.1.7 A Smart shoe testing kit includes 4 or 8 sensors that replace the brake shoes and measure the pressure force (brake shoe force) on the wheel tread applied by the air cylinder pistol or hand brake chain. The sensors are connected to an integrated amplifier and monitor (Figure 9) to read the brake shoe forces from each of the wheels. The readings are summed to calculate the total brake shoe force and the brake ratio of the tested vehicle.

3.1.6 The brake shoe forces are measured by using specially designed and manufactured measurement kits. Golden shoe testing, Jim shoe testing and Smart shoe testing are the commonly used testing systems on market. In the tests that TSB conducted for this investigation, the Smart shoe testing system, as shown in Figure 7 was the main tool. A Jim shoe testing kit was used in testing of the VB car, but its measurement range was insufficient for testing of the locomotives and tank cars. The Golden shoe and Jim shoe systems use compressor sensors (Figure 8), while the Smart shoe uses adjustable bending strain gauge sensors to improve the accuracy. The Smart shoe system can save the readings into electronic text files.

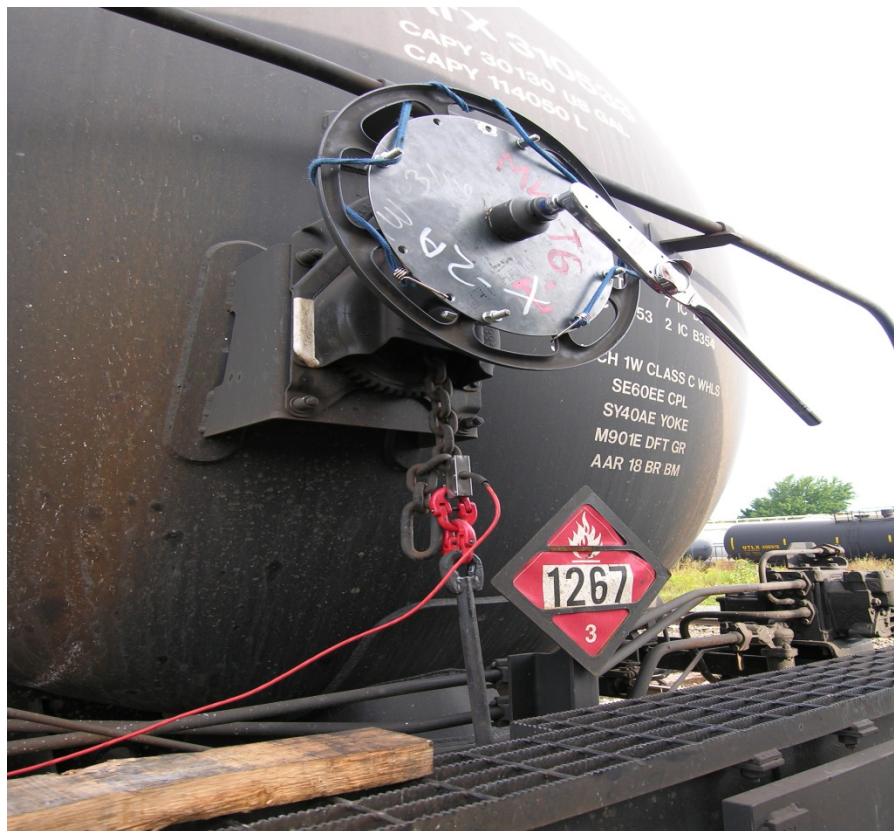
Figure 10: Inserted Chain Force Sensor and Torque Ranger

3.1.8 A sensor is inserted to measure the chain force that is a base index for the hand brake test. Simultaneously the torque on the handbrake wheel is also measure by a ranger with torque scale, as shown in Figure 10.

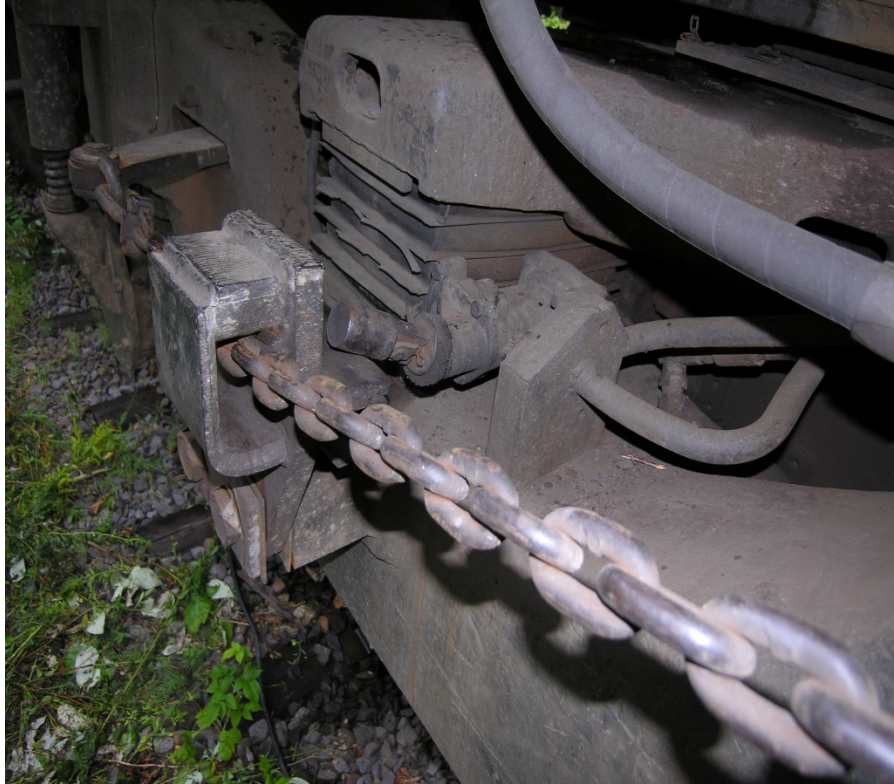
Figure 11: QR Valve on MMA5026

- 3.3.7 The hand brake ratio of VB-1 was much higher than those of the locomotives, but its air brake ratio was lower than those of the locomotives.
- 3.3.8 Three locomotives in the consist were equipped with the QRB as shown in Figure 11. The QRB on the second locomotive (MMA 5026) was determined to be defective, while the other two worked properly. When the hand brake was applied, the QRB at MMA 5026 did not release the cylinder air. In this situation, there would not have been any hand brake force if the QRB was not manually tripped.

BC +Torque	F _c	R2	R3	Sum	BR	Comments
INDBC72+T0	0	11649	10450	22099	5.7%	IND only, F _{bs} on two wheels
IND+T195	3580	12264	12047	24311	6.2%	BC not released by QRB
BC50+T195	2591	9285	8448	17733	4.5%	Reduce BC by LE
BC27+T195	1430	5278	4701	9979	2.6%	
BC0+T195	37	33	69	102	0.0%	HB totally lost
Reapp IND	2591	13415	11745	25160	6.5%	
Note: F _c is the chain force, BR is brake ratio						
Conclusion: QRB was not functional, HB would loss when BC bled off

2.6.2 On GE C30-7 locomotives, the brake cylinder on the axle where the hand brakes are applied is equipped with a quick release brake (QRB) valve. The QRB is tripped during the application of the hand brakes by the brake chain. When tripped, the QRB valve removes air from the brake cylinder and applies the brakes on the 2 wheels on which the hand brake is being applied. To ensure that the hand brake remains operational on these locomotives, MMA issued Summary Operating Bulletin 2-276 which stated in part:

- 7.3 The QRB on the second locomotive MMA 5026 was determined to be defective, which result in no hand brake application on MMA 5026 in the occurrence.

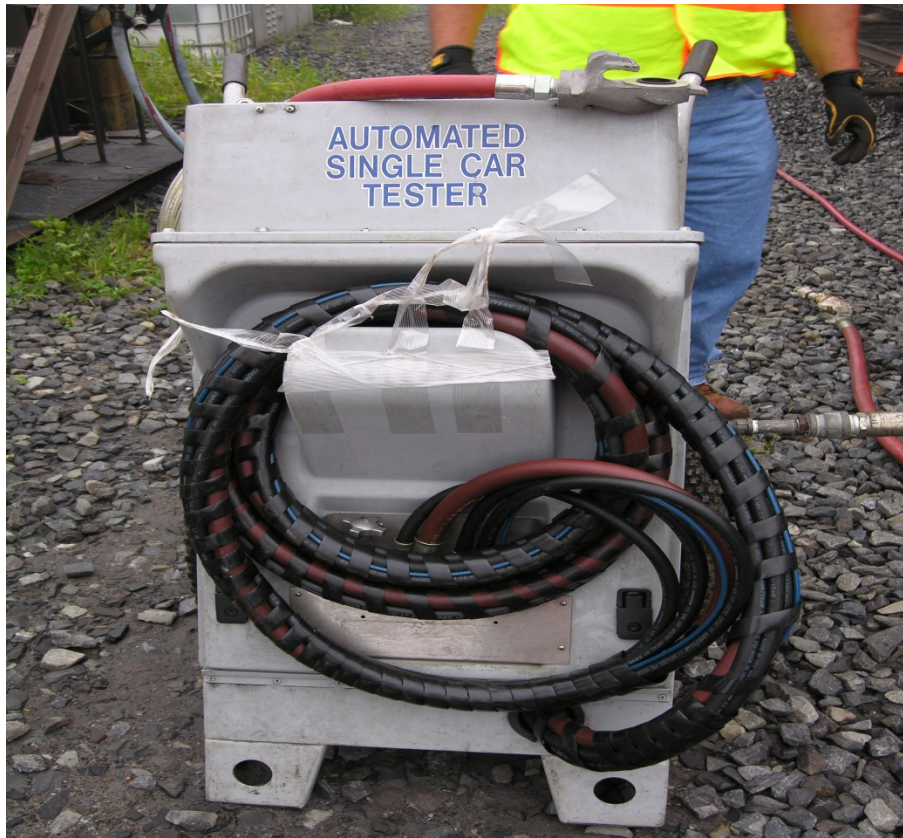
Figure 12: Single Car Test Kit

4.1.2 Similar to the testing on the locomotive consist, Smart shoe kits but no Jim shoe kit were used in the air and hand brake testing to measure the brake shoe forces. The air brake test was conducted by using a single car air brake test kit as shown in Figure 12. The air brake tests were conducted at minimum application (6-7 psi BP reduction) and full service application. Two test loops were applied on each car and the brake shoe forces were measured at Service Equalization and Wrapped condition respectively. The brake ratios were calculated and averaged.
