AVIATION INVESTIGATION REPORT

A04O0092

RISK OF COLLISION

NAV CANADA

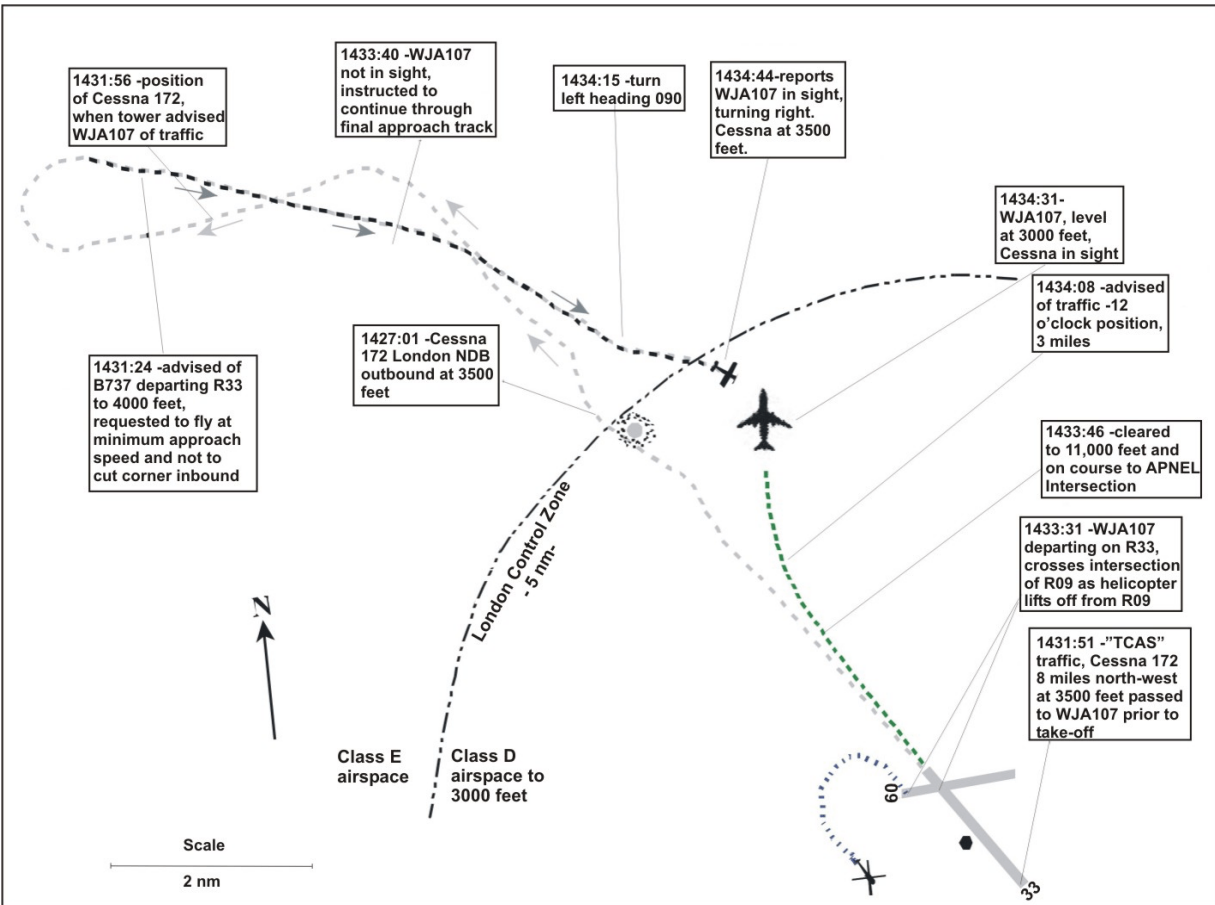
Appendix A – Sequence of Events

At 1431:24, the tower controller advised the Cessna that a Boeing 737 would be departing Runway 33 shortly. The tower controller requested that the Cessna pilot maintain the minimum approach speed and avoid cutting the corner on the turn inbound to the airport. This would delay the turn inbound in an effort to increase spacing with WJA107 (see Appendix A).
