AVIATION INVESTIGATION REPORT

A04Q0003

LOSS OF SEPARATION

NAV CANADA
MONTRÉAL AREA CONTROL CENTRE –
LA GRANDE SECTOR
LA GRANDE, QUEBEC 160 nm SSW
13 JANUARY 2004

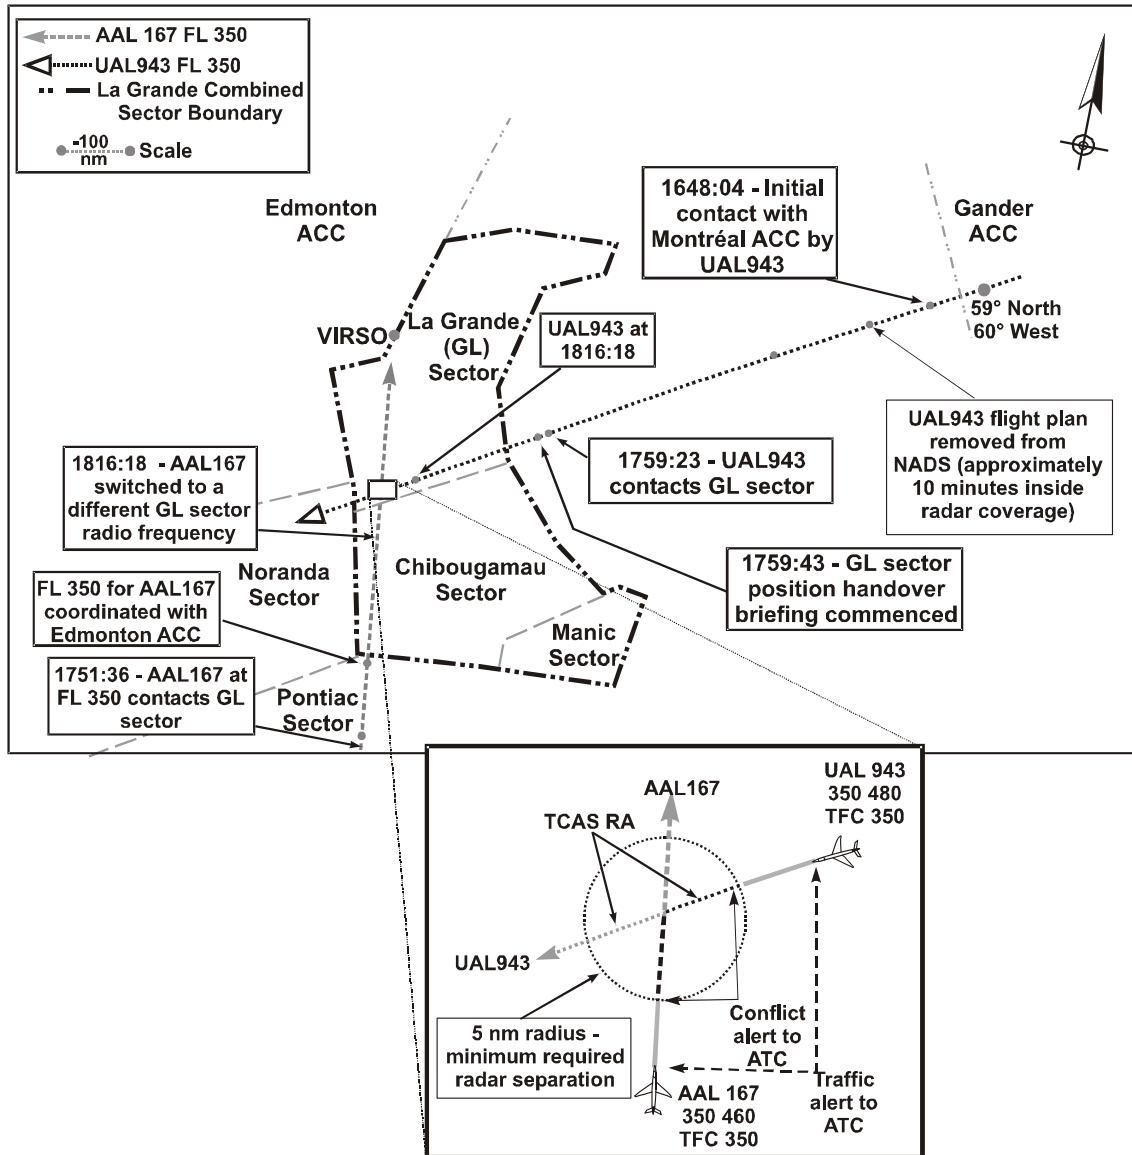
Appendix A – Aircraft Flight Paths

NOTE: All times in this diagram are Coordinated Universal Time (eastern standard time plus five hours).

There were three main traffic flows through the GL combined sector in the time leading up to the incident: a stream of traffic in the southern part of the MT sector heading southwest into the Pontiac sector; a southwest bound stream (including UAL943) in the southern part of the GL sector heading to the Noranda sector; and a northbound stream (including AAL167) through the western part of the MT and GL sectors heading toward Edmonton, Alberta, ACC controlled airspace (see Appendix A). The aircraft within each individual stream were properly separated.
