MARINE INVESTIGATION REPORT

M04L0050

GROUNDING

PASSENGER AND VEHICLE FERRY

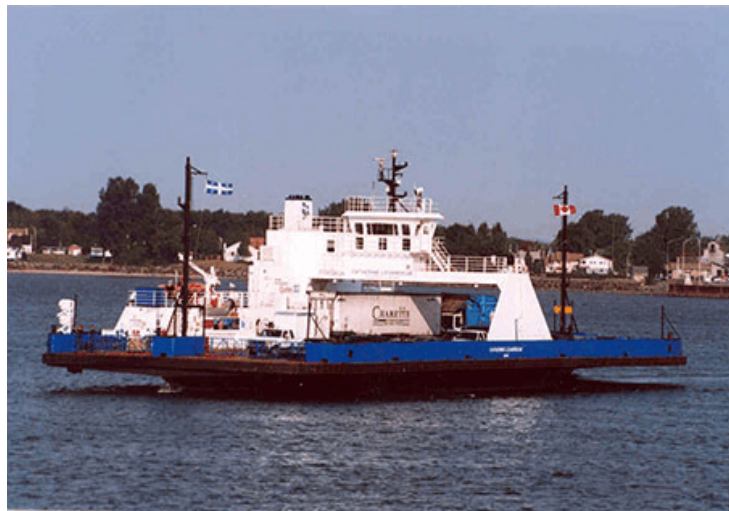
Photo 1. Passenger and vehicle ferry *Catherine-Legardeur*

The *Catherine-Legardeur* is a double-ended ferry that carries passengers and vehicles across the St. Lawrence River between Sorel, Quebec, and Saint-Ignace-de-Loyola, Quebec. Both ends of the vessel are identical, each having a centreline rudder and propeller and a boarding ramp that provides vehicles with direct roll-on, roll-off convenience (see Photo 1). Dual engine and rudder controls are positioned at a central conning position in the wheelhouse, such that they can be readily activated by a single operator (see Photo 2).
