**AVIATION INVESTIGATION REPORT
A10A0032**

RUNWAY EXCURSION

**CARGOJET AIRWAYS LTD.
BOEING 727-225, C-GCJZ
MONCTON, NEW BRUNSWICK
24 MARCH 2010**

Report Number A10A0032

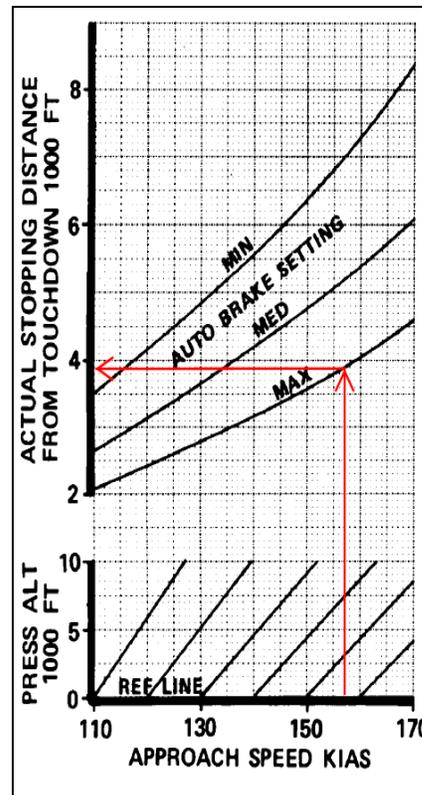
Figure 2. Boeing Actual Stopping Distance Chart

The Boeing 727-200 Operations Manual also contains an actual stopping distance chart, based on dry runway performance. This chart, which assumes no reverse thrust credit, is used on aircraft equipped with auto brakes, as a guideline to determine what auto brake setting is most appropriate for landing. As airspeed decreases during the landing roll, reverse thrusts become less effective.²² With a touchdown speed of 157 KIAS on a dry runway and no reverse thrust credit, maximum auto braking is required when the available stopping distance is between 3920 feet and 5210 feet (see Figure 2). At a speed of 157 KIAS, an actual stopping distance of less than 3920 feet on a dry runway would be beyond the capabilities of the auto brake system, assuming no reverse thrust credit.
