MARINE INVESTIGATION REPORT

M01W0116

NEAR SINKING

CATAMARAN PASSENGER VESSEL *WASCA II*
WASCANA LAKE, REGINA, SASKATCHEWAN

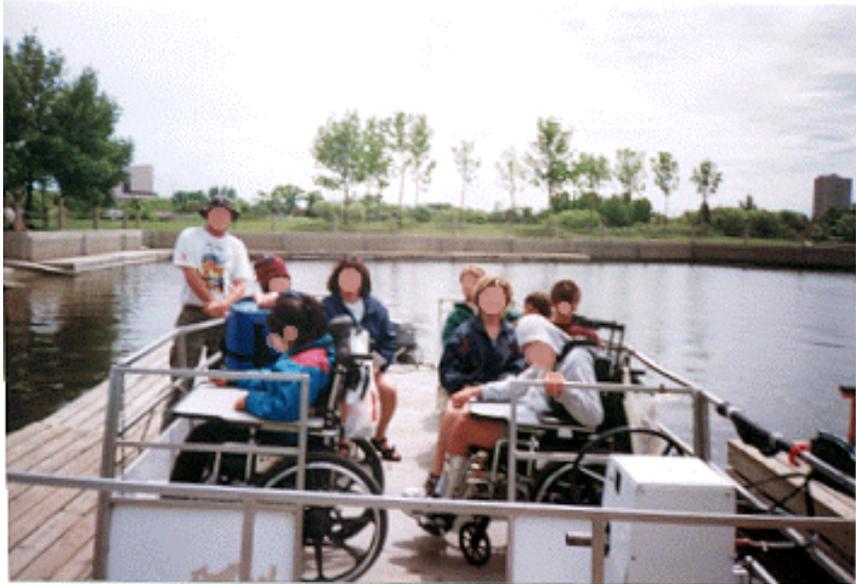
The basic layout of the *Wasca II* vessel is shown in Figure 1.

The *Wasca II*, a “Starlighter” catamaran-type small passenger vessel, consists of two cylindrical aluminum pontoons 450 mm in diameter, 8.8 m long, spanned by a wooden deck over welded frames and cross beams. Aluminum railings surround the perimeter of the passenger deck. Three rows of twin plastic seats, attached to aluminum footings on either side of the centre line, provide seating for 12 passengers. The steering position and the control console are located at the port side forward, and the outboard motor is mounted at the stern.
