MARINE INVESTIGATION REPORT

M03L0124

DOWNFLOODING AND GROUNDING

FISHING VESSEL *EVAN RICHARD*
OFF ANTICOSTI ISLAND, QUEBEC
29 SEPTEMBER 2003

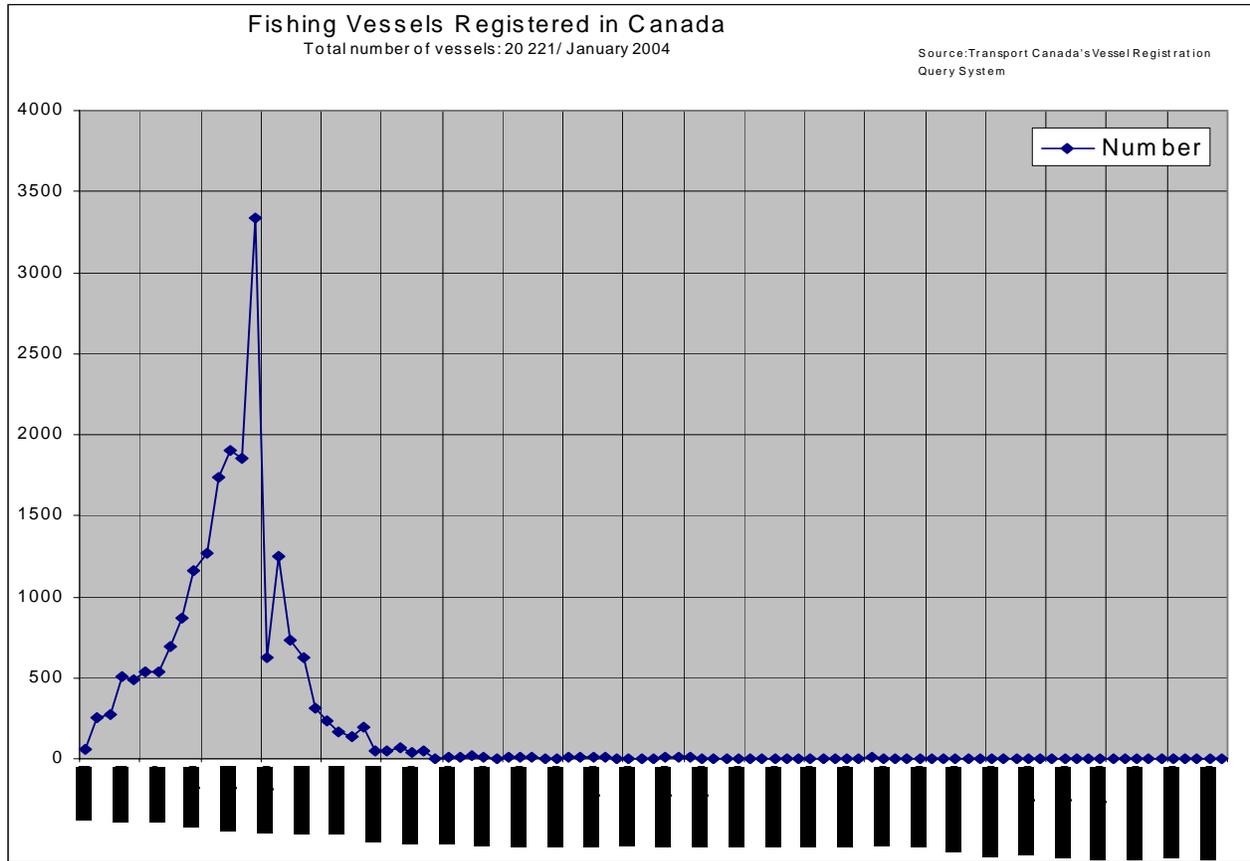
Appendix B – Fishing Vessels Registered in Canada⁶

1. 15 469 fishing vessels have a gross tonnage of 15 or less, which represents 76 per cent of the Canadian fleet.
2. 19 020 fishing vessels have a gross tonnage of 60 or less, which represents 94 per cent of the Canadian fleet.
3. 3336 fishing vessels have a gross tonnage greater than 14 but not over 15; this group represents 15 per cent of the Canadian fleet.
