MARINE INVESTIGATION REPORT

M09W0141

TUG GIRDING AND CAPSIZING

TUG *NORTH ARM VENTURE* WHILE TOWING THE BARGE

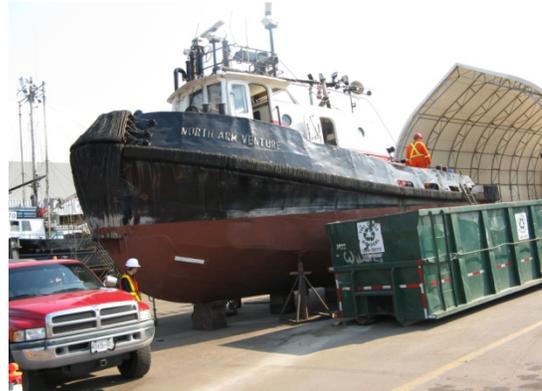
Photo 1. *North Arm Venture*

The *North Arm Venture* is a conventional coastal tug of steel construction (see Photo 1 and Appendix B). The navigation bridge is located on the fore part of the main deck. There is a conning position in the wheelhouse with steering and engine controls, another on the wheelhouse top with similar controls – allowing an unobstructed view in all directions – and a third steering position alongside the towing winch. All three positions are equipped with an abort switch for the tow line.

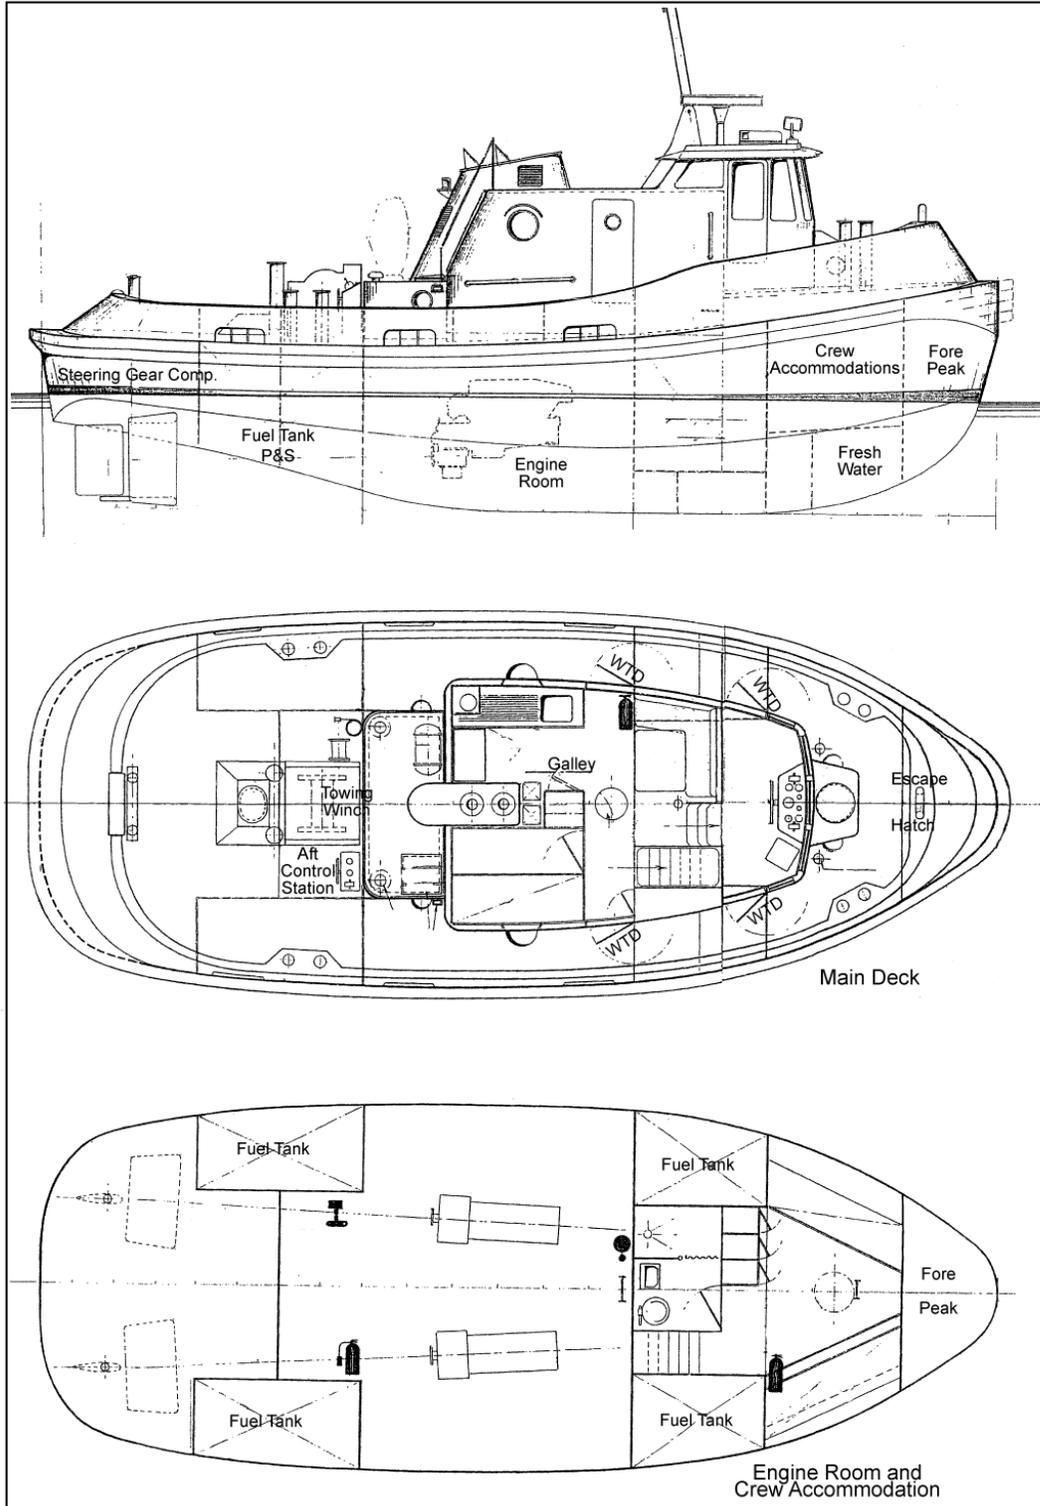
Appendix B – General Arrangement

The tug has two propellers in Kort nozzles² and two rudders. On the main deck is a galley, a mess area and a cabin for the master. The deckhouse is fitted with watertight doors port and starboard. One deck below and forward in the forecabin is a cabin for the mate and two deckhands. An escape hatch is located on the deckhead of the forecabin; this exits just forward of the navigational bridge.
