**MARINE INVESTIGATION REPORT**  
**M13L0055**

**ACCIDENTAL DEATH**

**BULK CARRIER *FEDERAL YOSHINO***  
**BAIE-COMEAU, QUEBEC**  
**08 MAY 2013**

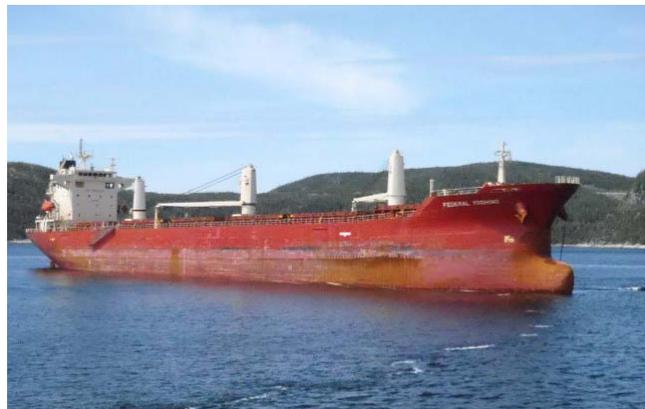
Photo 1. *Federal Yoshino*

The *Federal Yoshino* is a dry bulk cargo vessel built of steel with machinery spaces and accommodations located aft (Photo 1). The 6 cargo holds and hatches are serviced by three 30-tonne electric-hydraulic cranes mounted on the centreline of the vessel. The vessel has 1 overhead travelling crane located in the engine room and 2 electric motor-driven provision cranes situated on either side of D deck, aft of the accommodations (Appendix A). The port provision crane has a 3 tonne capacity and a radius that ranges between 2.75 m and 8 m. The starboard provision crane has a 0.9 tonne capacity and a fixed boom. The starboard crane was not in service at the time of the occurrence. The bridge is equipped with all the required navigational equipment.

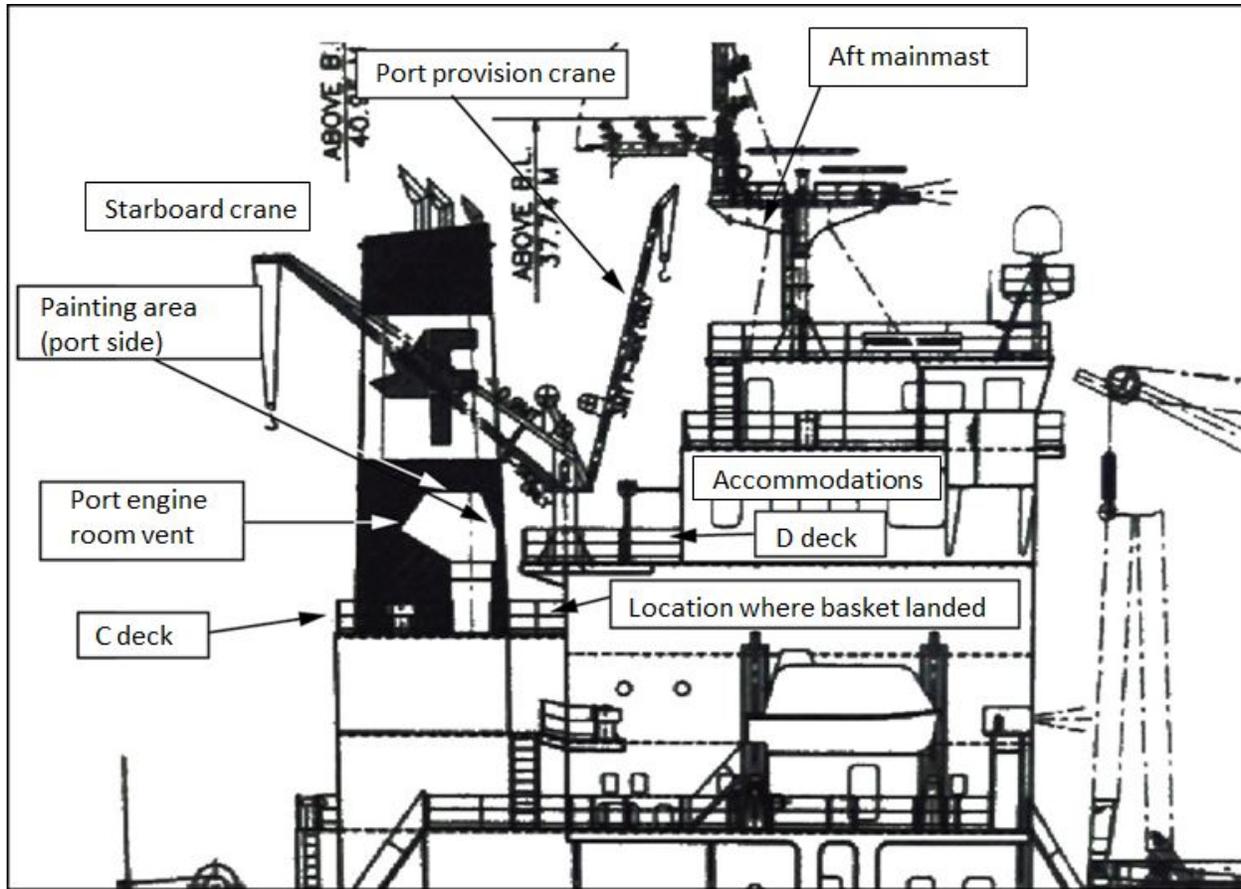
### Appendix A – Partial view of Federal Yoshino's starboard side

Note: The port provision and starboard cranes are located on opposite sides of the vessel but are transversely aligned in this view.
