RAILWAY INVESTIGATION REPORT

R16D0076

Crossing collision

Canadian National Railway Company

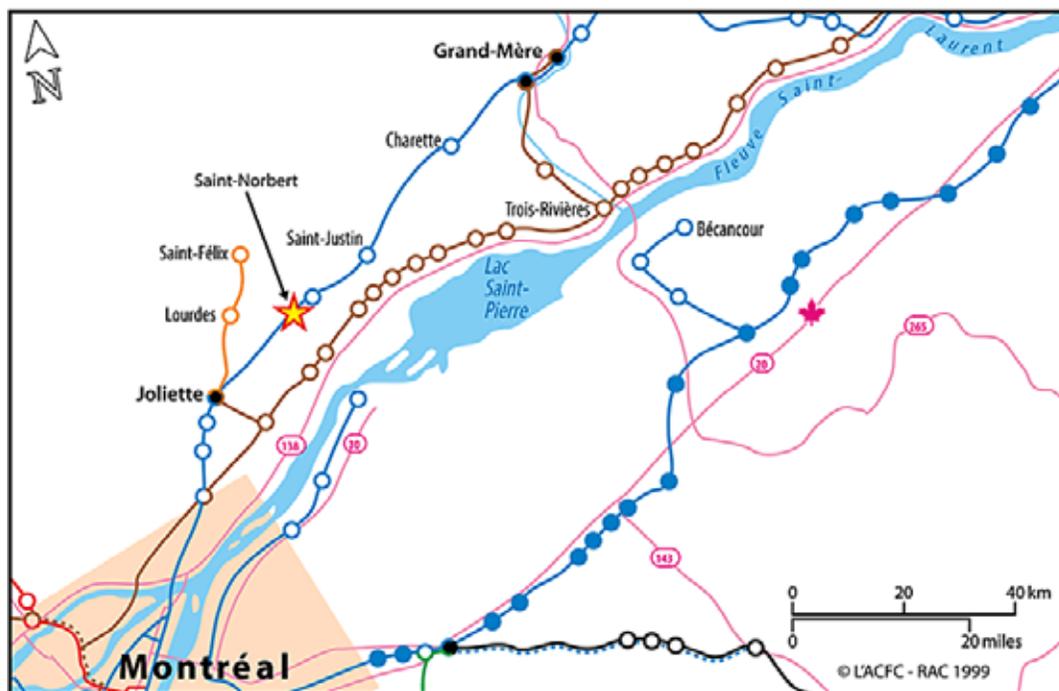
At approximately 0330, the multi-crane was travelling at approximately 16 mph (26 km/h) as it approached the Highway 347 public grade crossing, at Mile 90.61, near the municipality of Saint-Norbert, Quebec (Figure 1). The crossing warning device was not activated. The multi-crane operator saw that a CN flag-person was positioned east of the crossing. The flag-person signalled to the multi-crane operator to proceed, then walked through the crossing and stood on the road.

Figure 1. Collision site (Source: Railway Association of Canada, *Canadian Railway Atlas*, with TSB annotations)

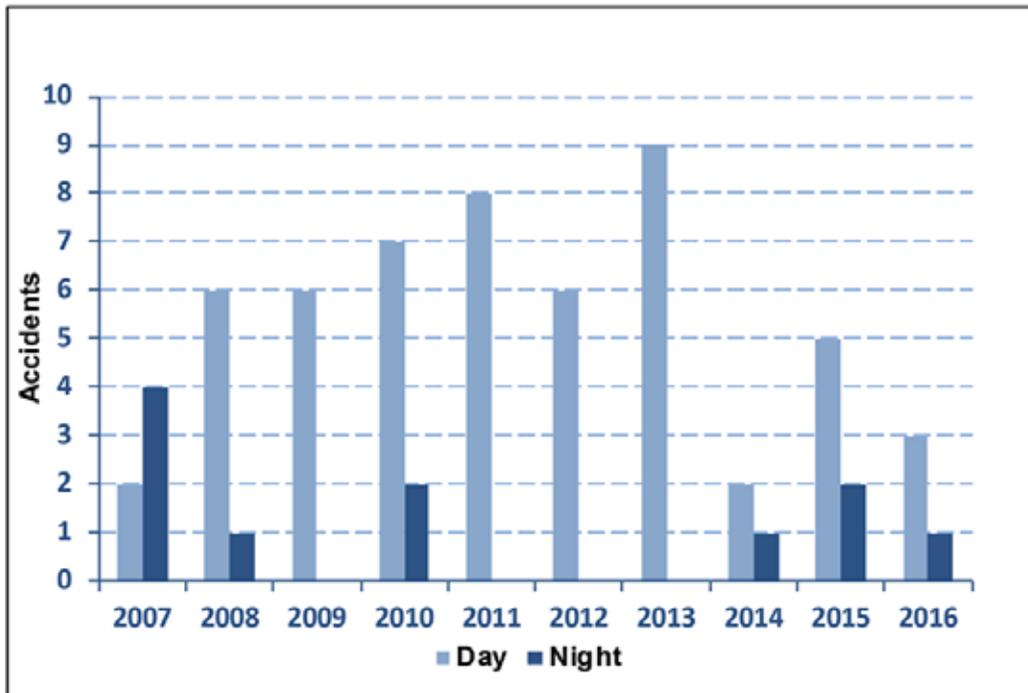
According to the TSB's railway occurrence database, from 2007 to 2016, there were 65 occurrences involving a TU at a grade crossing. Of those, 39 happened at grade crossings with warning devices and 28 involved insulated TUs that could not activate grade crossing warning devices. During that same period, 11 accidents occurred at night (Figure 7). As well, 2 accidents occurred while a flag-person was protecting the crossing and the warning device was not activated.

Figure 7. Crossing accidents involving track units, during the day and at night, from 2007 to 2016
