# Air Transportation Safety Investigation Report A18P0115

## LOSS OF CONTROL ON INITIAL CLIMB AND IMPACT WITH THE RUNWAY

Historic Flight Foundation  
de Havilland DH-89A MKIV Dragon Rapide (biplane), N683DH  
Abbotsford Airport, British Columbia  
11 August 2018

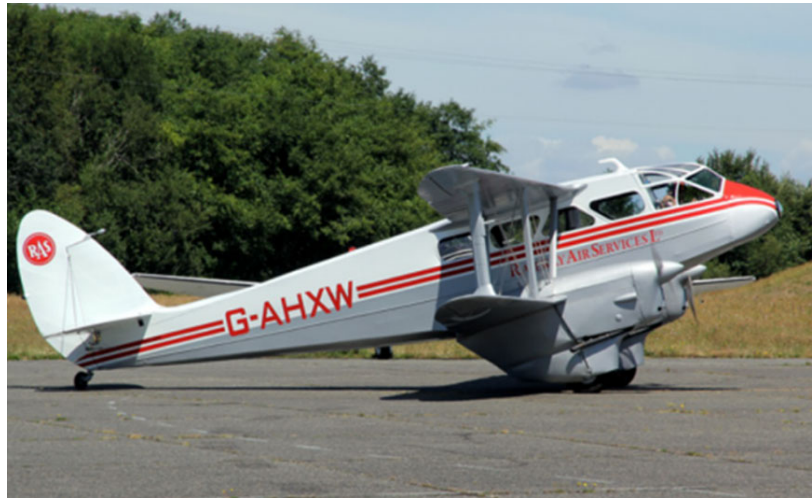
Figure 3. Occurrence aircraft (Source: David Lednicer)

The occurrence aircraft, a de Havilland DH-89A MKIV Dragon Rapide (Figure 3), was manufactured in Britain in 1944. The aircraft is a biplane equipped with a free-castering tail wheel and is constructed primarily of fabric-covered wood. The pilot's seat is located in the nose, on the aircraft's centreline, and 8 passenger seats are located aft, with 4 seats on each side. The
