## **AIR TRANSPORTATION SAFETY INVESTIGATION REPORT A18A0085**

### **RUNWAY OVERRUN**

Sky Lease Cargo

Boeing 747-412F, N908AR

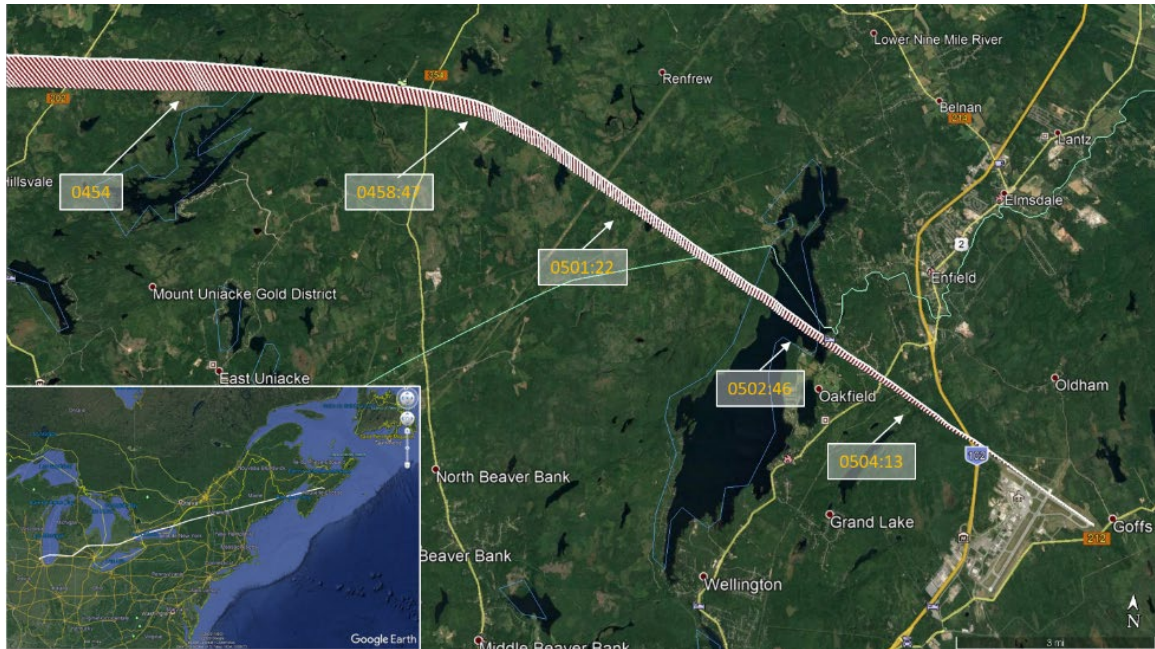
Figure 1. Flight profile (Source: Google Earth, with TSB annotations)

At 0454, the CYHZ tower controller informed the Moncton area control centre (ACC) controller that the arrival runway was being changed from Runway 14 to Runway 23, due to wind direction change, and that the approach into the airport was now the Runway 23 area navigation (RNAV) approach. When this exchange of information took place, the occurrence aircraft was descending through 13 000 feet ASL and approximately 52 NM from the airport (Figure 1). The runway change information was not communicated to the crew.

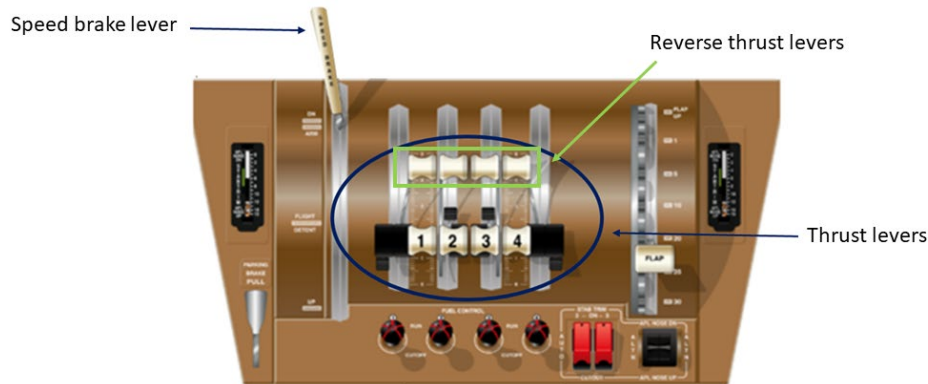
Figure 3. Boeing 747-400 centre pedestal (Source: Copyright © Boeing. Reprinted with permission of The Boeing Company, with TSB annotations)

When the speed brakes are extended automatically, the auto speed brake system moves the speed brake lever aft to the UP position (Figure 3), which, in turn, raises the spoiler panels on the wings. This significantly reduces the lift generated by the wings and transitions the weight of the aircraft onto the wheels. If the auto speed brakes are not deployed properly, the landing distance required on a dry runway may be increased by as much as 870 feet. The FCTM contains 2 specific sentences about the importance of deploying auto speed brakes:

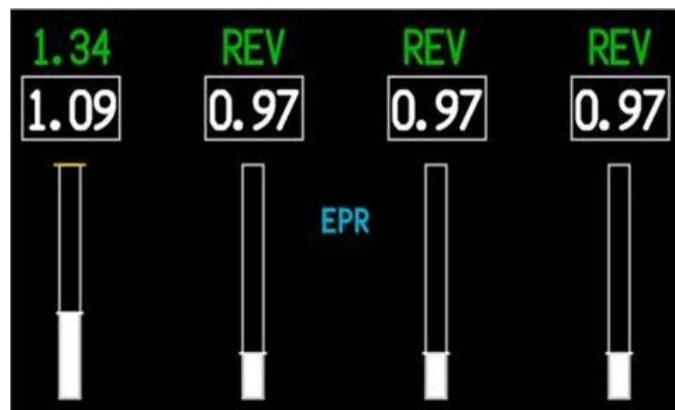
Figure 4. Boeing 747 engine indicating and crew alerting system reverse thrust indication (Source: Boeing proprietary information. © Boeing. Reprinted with permission of The Boeing Company)

The reverse thrust indication is displayed on the primary EICAS display (Figure 4). A thrust reverser status annunciator is positioned above each digital exhaust pressure ratio indicator. The reverse (REV) annunciator appears amber when the related reverser is unlocked or moving. The annunciator changes to green when the reverser is fully deployed. When the reverser is stowed and locked, the annunciator is no longer visible.

During the occurrence landing, 1 second after touchdown, the No. 1 thrust lever was advanced past flight idle, which inhibited the reverse thrust lever from deploying reverse thrust on that engine. The thrust reversers on engines No. 2, No. 3, and No. 4 operated as designed, with no anomalies.
