AIR TRANSPORTATION SAFETY INVESTIGATION REPORT A19P0142

MAIN ROTOR BLADE FAILURE AND COLLISION WITH TERRAIN

E & B Helicopters Ltd.
Bell 206B (helicopter), C-GEBY
Campbell River, British Columbia
24 September 2019

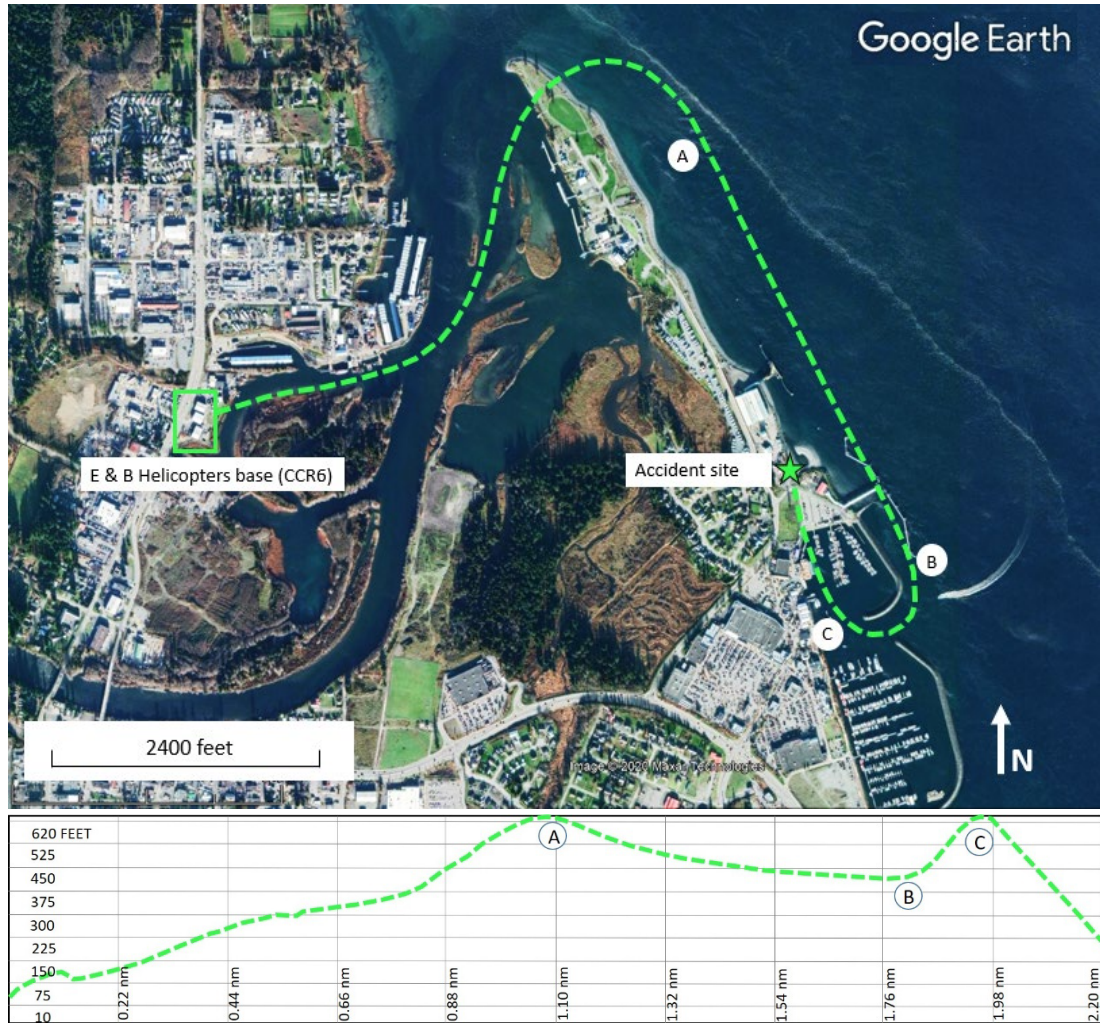
Figure 1. Helicopter flight path and vertical profile (Source: Google Earth, with TSB annotations)

The helicopter climbed to the east and, once beyond the coastline, headed southeast. At 1102:50, the helicopter levelled off briefly at 615 feet above sea level (ASL) and then began to descend at a rate of approximately 400 fpm, at 87 knots ground speed (Figure 1, point A), accelerating to 92 knots ground speed. At 1103:17, when the helicopter was at 417 feet ASL, it entered a right-hand turn (Figure 1, point B). During the turn, the helicopter's ground speed decreased and its altitude increased to a peak of 620 feet ASL. At that peak altitude, the helicopter was rolling out of the turn, and it began to descend at a rate of approximately 1950 fpm, with a ground speed of 63 knots (Figure 1, point C). This descent was maintained for 4 seconds on a north-northwest track. Over the next 5 seconds, the helicopter's ground speed decreased to 54 knots. When the helicopter was at 200 feet ASL, at 1103:40, the helicopter departed controlled flight and the main rotor blade contacted the tail boom.

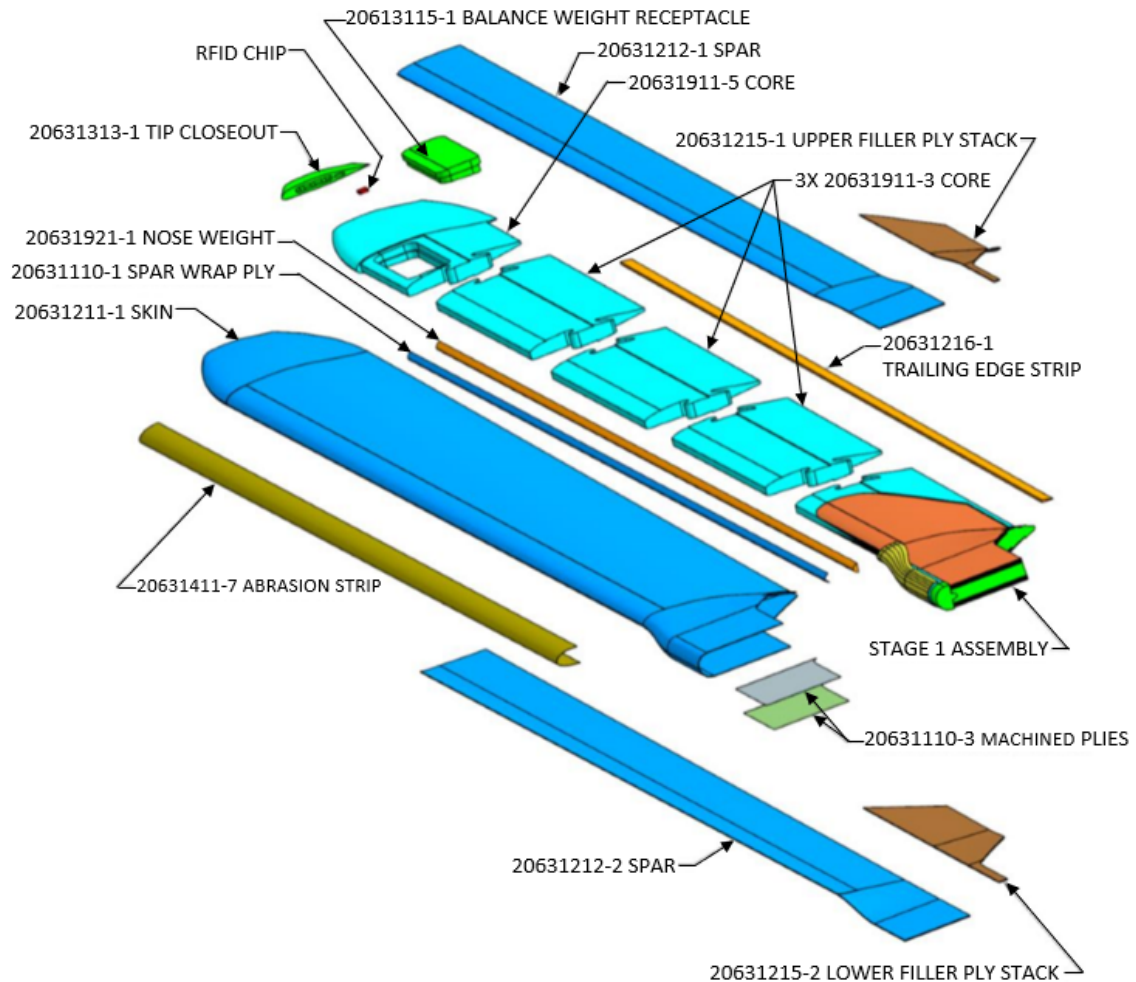
Figure 3. Sub-assemblies of the Van Horn Aviation, LLC composite main rotor blade, part number 20631000-101 (Source: Van Horn Aviation, LLC, with TSB annotations)

carbon/epoxy material (laminate stacks) on the upper and lower skins (Figure 3). Flight characteristics of the blades are similar enough that no changes to the performance section of the Bell 206B rotorcraft flight manual were required.

In the summer of 2020, a newer version¹⁷ of the main rotor blade was approved by the FAA¹⁸ and replaced the original part number. The main difference between the 2 versions is that the newer blade has a different carbon fibre ply count and orientation. According to Van Horn, the “[p]ly adjustment along with changes to the mass distribution provides a softer ride [...]”¹⁹ In total, 152 blades (or 76 sets) of the original main rotor blade had been sold before the newer main rotor blades were approved. The last original blades were manufactured in April 2018. It is not known how many original blade sets are in operation in Canada; however, it is estimated that there are 6.
