AIR TRANSPORTATION SAFETY INVESTIGATION REPORT A20Q0015

CONTROLLED FLIGHT INTO TERRAIN

Service aérien gouvernemental of Quebec
Bell 206L-4 (helicopter), C-GSQA
Lac Saint-Jean, Quebec
22 January 2020

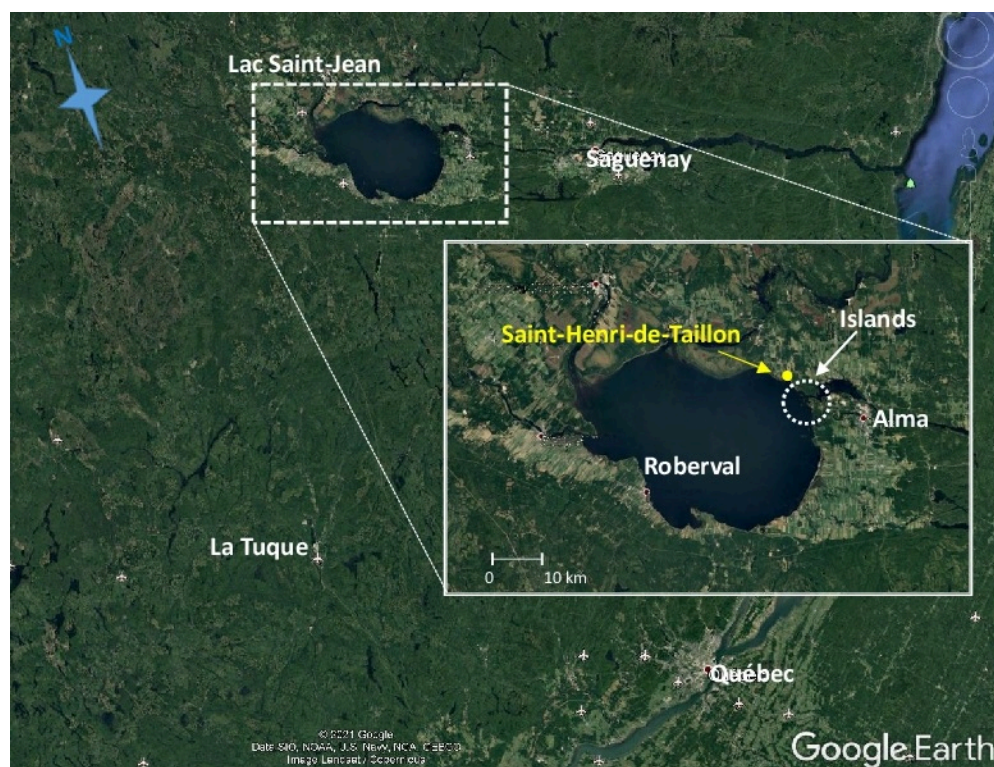
From 1130 until 1219, the occurrence pilot conducted searches at very low altitude, less than 100 feet above the frozen surface of Lac Saint-Jean, in the vicinity of the islands near La Grande Décharge Lake (Figure 1).

Figure 1. Map of the general area of the occurrence, with magnification in box (Source: Google Earth, with TSB annotations)

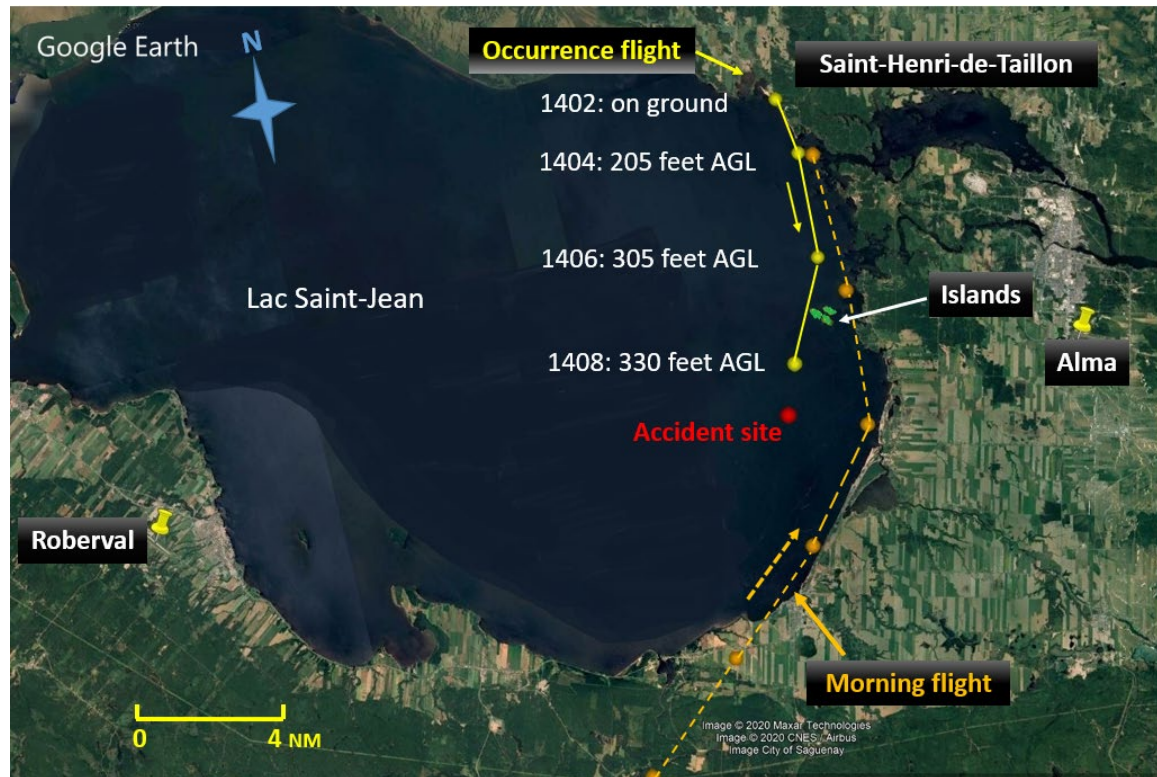
However, the aircraft was equipped with a satellite flight tracking system, and data were retrieved from the SAG's aircraft tracking and management website. This system recorded the aircraft's GPS position, altitude, and ground speed every 2 minutes (Figure 5).

Figure 5. Representation of the morning flight (dashed line) and occurrence flight (solid line)
(Source: Google Earth, with TSB annotations based on data from the flight tracking system)

For the return flight in the afternoon, the occurrence pilot had planned to fly at a low altitude (approximately 500 feet AGL) because there was a headwind. The aircraft took off from Saint-Henri-de-Taillon at 1402 and flew a track that was almost parallel to the eastern shore of the lake. At 1406, at an altitude of 305 feet AGL and 1 NM laterally from the shore, the aircraft was approaching a group of islands 1.3 NM ahead. The pilot veered right, flying west of the islands. At 1408, the aircraft was 2.4 NM laterally from the shore at an altitude of 330 feet AGL. The aircraft struck the surface of the lake about 1 minute later, approximately 1.34 NM further. The angle between the height of the last recorded position at 1408 and the point of impact was approximately 2.3°.
