Marine Occurrence Report

Grounding

Sight-seeing Boat "TAN 1"
Grande Batture, East of the Wharf at
Les Escoumins, Quebec
11 August 1993

Report Number M93L0003

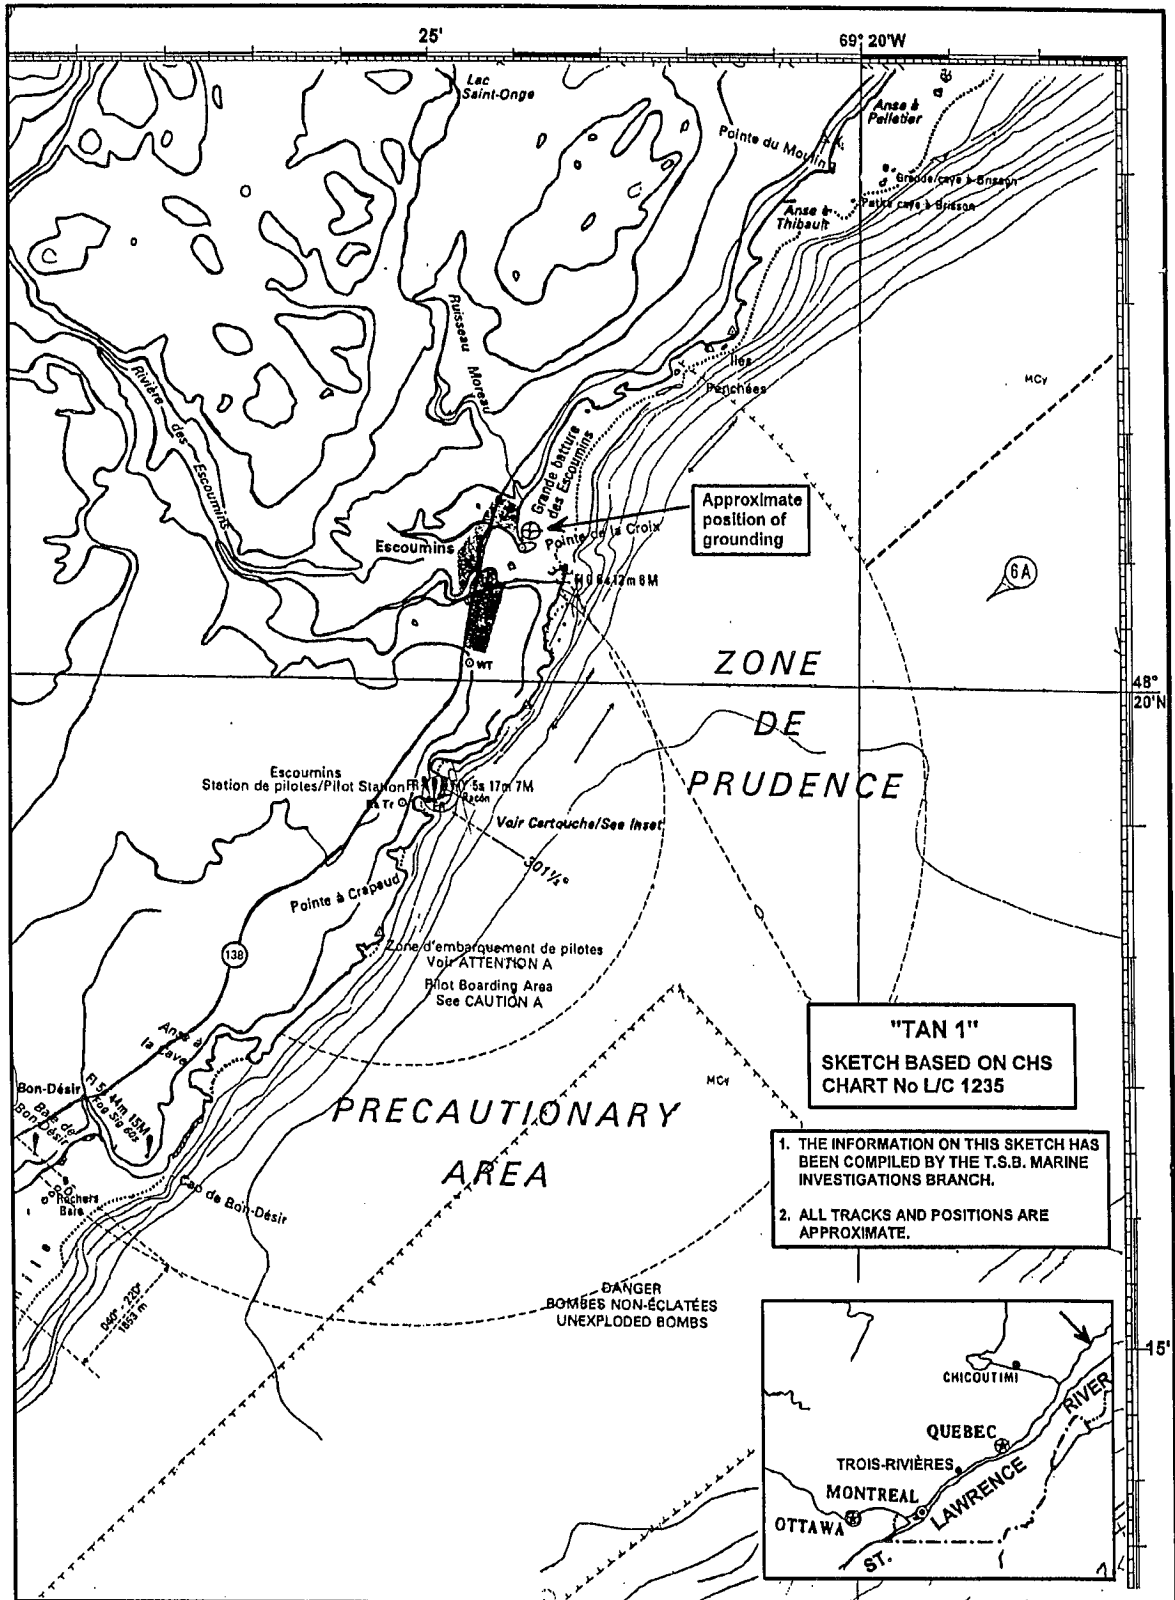
Appendix A - Sketch of the Area of the Occurrence

The "TAN 1" departed the pontoons of the pilot station at Les Escoumins, Quebec, at approximately 1715 on 11 August 1993 on a whale-watching cruise in fog and restricted visibility with the owner/operator and 12 passengers on board. Shortly thereafter, the operator became disoriented, and the boat ran aground on a large rock of the Grande Batture near Les Escoumins.

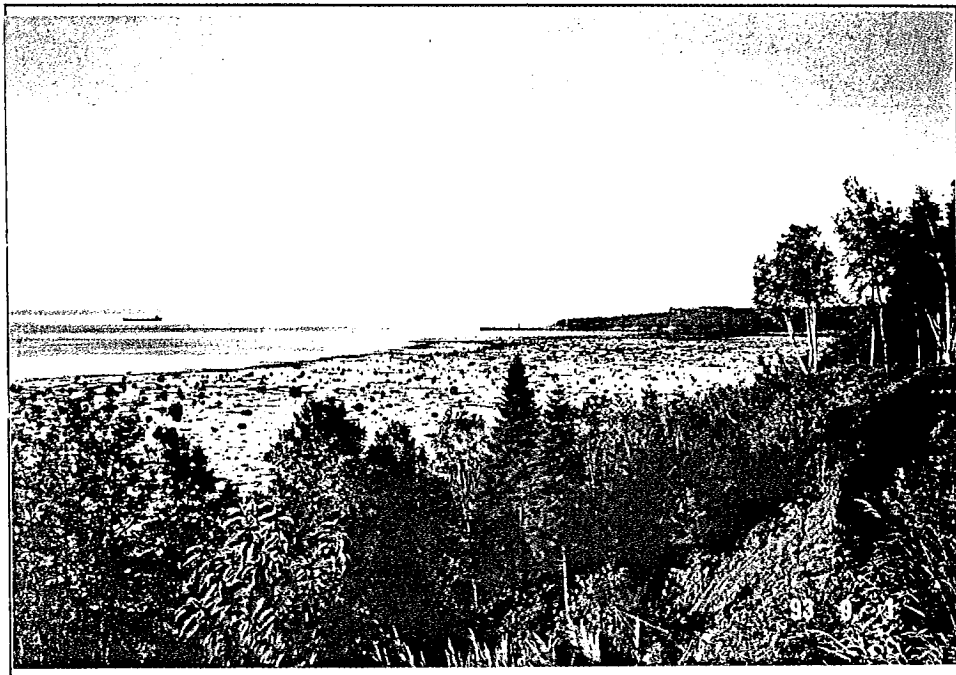
The Grande Batture near Les Escoumins completely dried off at low tide.
