MARINE INVESTIGATION REPORT

M01C0054

STRIKING AND SUBSEQUENT FIRE ON BOARD

BRIDGE 11, WELLAND CANAL

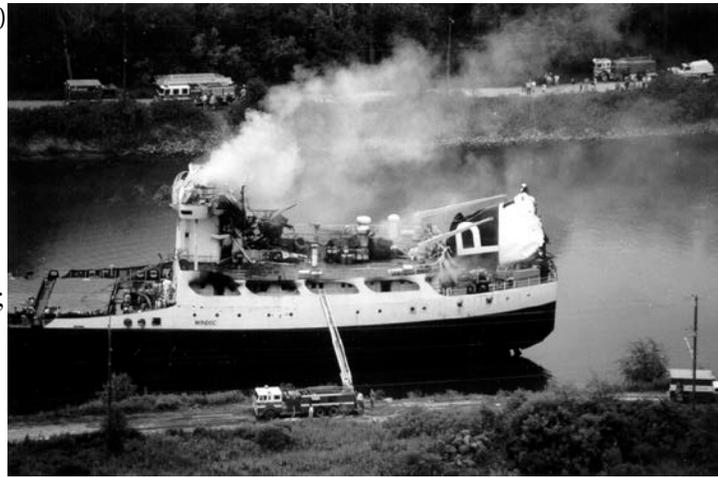
Since the *Windoc's* stern was approximately 20 m away from the canal bank and there was only the vessel's liferaft available for boarding, the fire department would not board the vessel initially. They started fighting the fire using portable pumps and hoses from aerial trucks (see Photo 3). The Thorold Fire Department did not have suitable boats to access the vessel; however, rigid bottom inflatable boats were provided later in the evening by the St. Catharines Fire Department. Neither TCC nor local fire departments were aware of boat launch ramps convenient to the occurrence site, thus delaying the arrival of the boats while a suitable launch site was located.
