MARINE INVESTIGATION REPORT

M11W0063

FIRE AND SINKING
SMALL FISHING VESSEL *NEPTUNE II*
BROKEN ISLANDS, JOHNSTONE STRAIT,
BRITISH COLUMBIA
09 MAY 2011

Report Number M11W0063

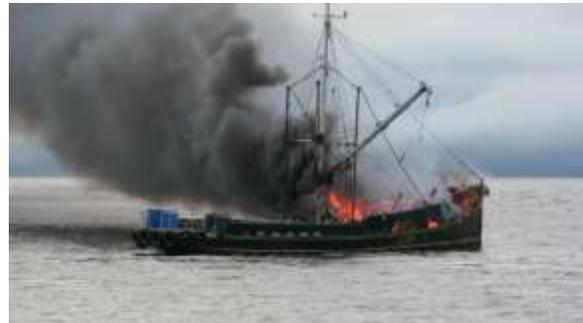
Photo 1. The *Neptune II*

While the crew was fighting the fire, the vessel was under power, making way, and turning slowly to starboard. As a result, the vessel was repeatedly enveloped by smoke from its continuously changing direction, forcing the crew to circle the deck to stay out of the smoke (Photos 1 and 2).
