MARINE INVESTIGATION REPORT

M11W0091

STRIKING OF A BRIDGE

TUG *F.W. WRIGHT* AND BARGE *EMPIRE 40*
FRASER RIVER
QUEENSBOROUGH RAILWAY BRIDGE, BRITISH
COLUMBIA
28 JUNE 2011

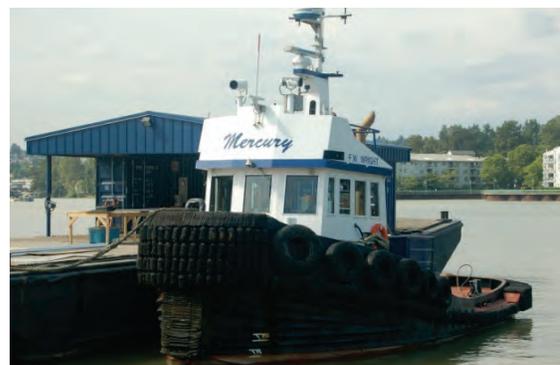
Photo 1. *F.W. Wright*

The *F.W. Wright* is a tug of steel construction (Photo 1). The navigation bridge is located on the fore part of the main deck. There is a conning position with steering and engine controls inside the wheelhouse, another on the top of the wheelhouse with similar controls, and a third immediately on the starboard side of the winch on the after deck.
