**MARINE INVESTIGATION REPORT
M13L0185**

LOSS OF TOW AND SUBSEQUENT GROUNDING

**TUG *ANDRE H.* TOWING THE BARGE *I.V. NO. 8* AND THE
VESSELS *I.V. NO. 9* AND *I.V. NO. 10*
GROS-MORNE, QUEBEC
15 DECEMBER 2013**

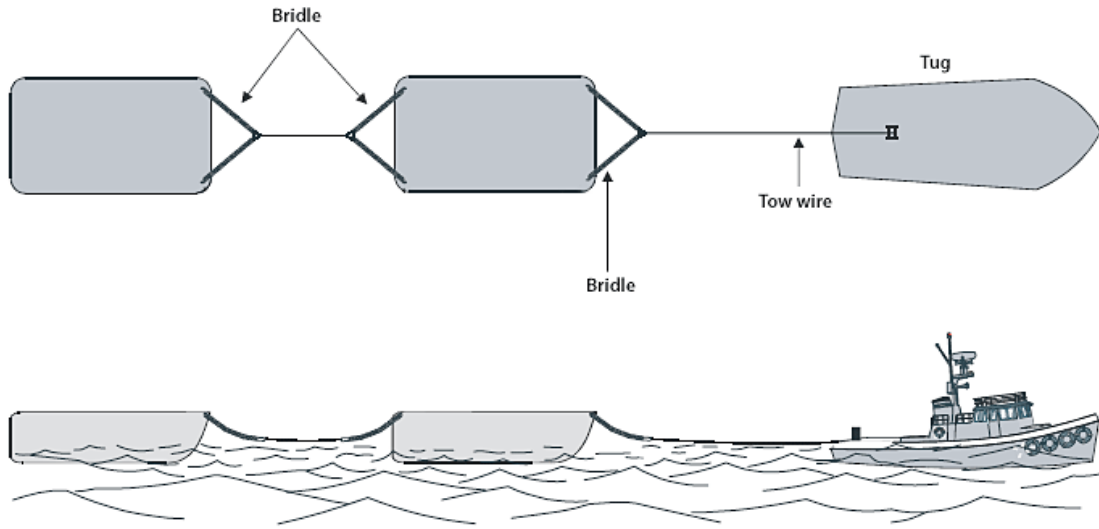
Figure 2. Tandem towing arrangement with single tow line¹²

According to these standards, in exposed waters, a long all-wire towing arrangement is preferred. The accepted way to connect multiple tows is for intermediate tow lines to connect the following tow to the stern of the one forward with bridles. Moreover, in order to minimize the surging action between the towed vessels, the tow lines must be of an appropriate length to allow for an adequate catenary effect (Figure 2). Multiple tow lines from the tug may also be used to achieve the same effect (Figure 3).
