MARINE TRANSPORTATION SAFETY INVESTIGATION REPORT M18C0240

Crew member seriously injured

Passenger vessel *Amadea*

09 September 2018

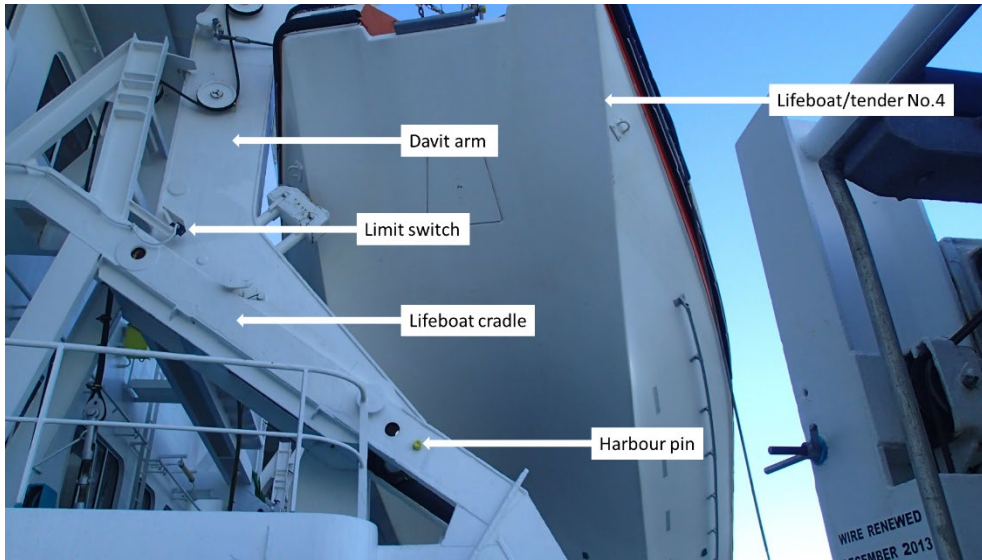
No. 3 and 4 davits are fitted with twin-arms that are paired with a single winch. Each davit arm has an adjustable lever-operated electromechanical limit switch that interrupts the winch motor's power supply once each davit arm approaches its uppermost position, immediately before contacting its stop, during lifeboat stowage (Figure 2 and Appendix C).

While at sea, gripes ensure that the lifeboats remain in their stowed positions. In addition to the gripes, 2 harbour pins can be inserted in holes that are aligned on each davit arm and the davit frame, to lock the lifeboats in their stowed position while the vessel is in port or during maintenance (Figure 2).

Figure 2. Lifeboat/tender No. 4 shown in its stowed position with harbour pin installed
(Source: TSB)

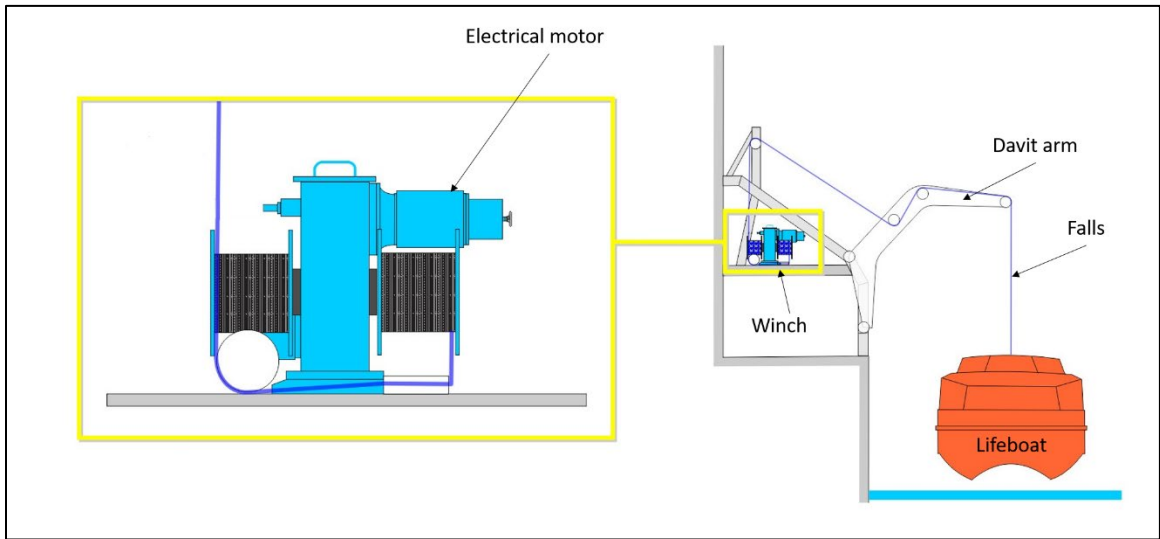
Figure 4. Diagram showing how lifeboat No. 4 hangs over the water, secured on its wire falls with davit arms fully deployed, and close-up view of the winch and its electrical motor (Source: TSB)

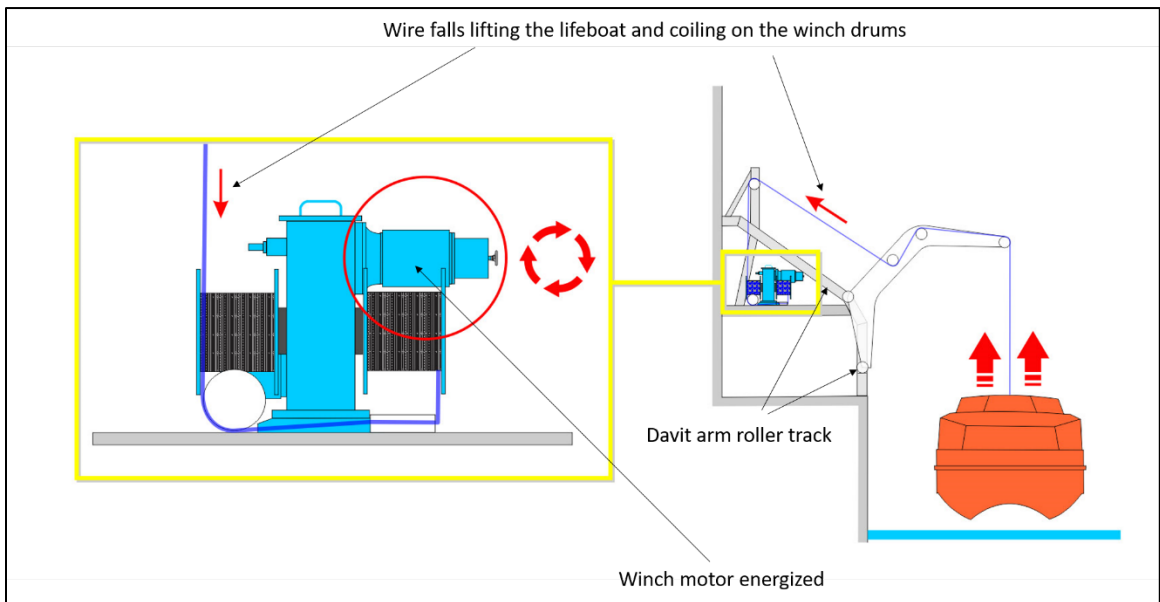
Figure 5. Diagram illustrating the lifting of the lifeboat: the winch motor is energized, the drums turn, and the wire falls coil onto the drums (Source: TSB)

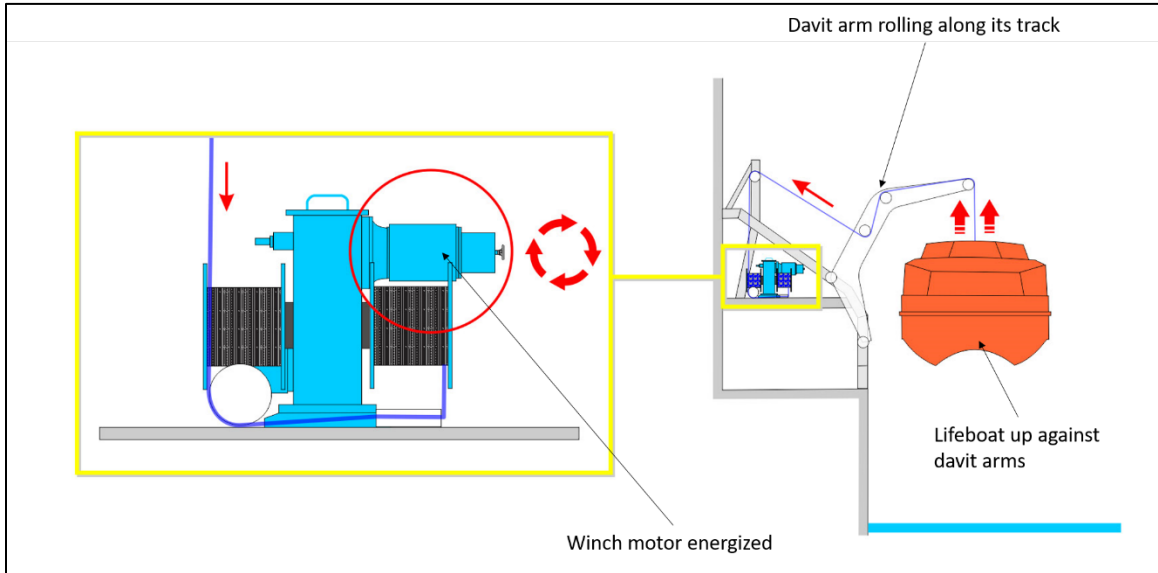
Figure 6. Diagram illustrating the lifting of the lifeboat: the davit arms roll along the roller track and are pulled inboard (Source: TSB)

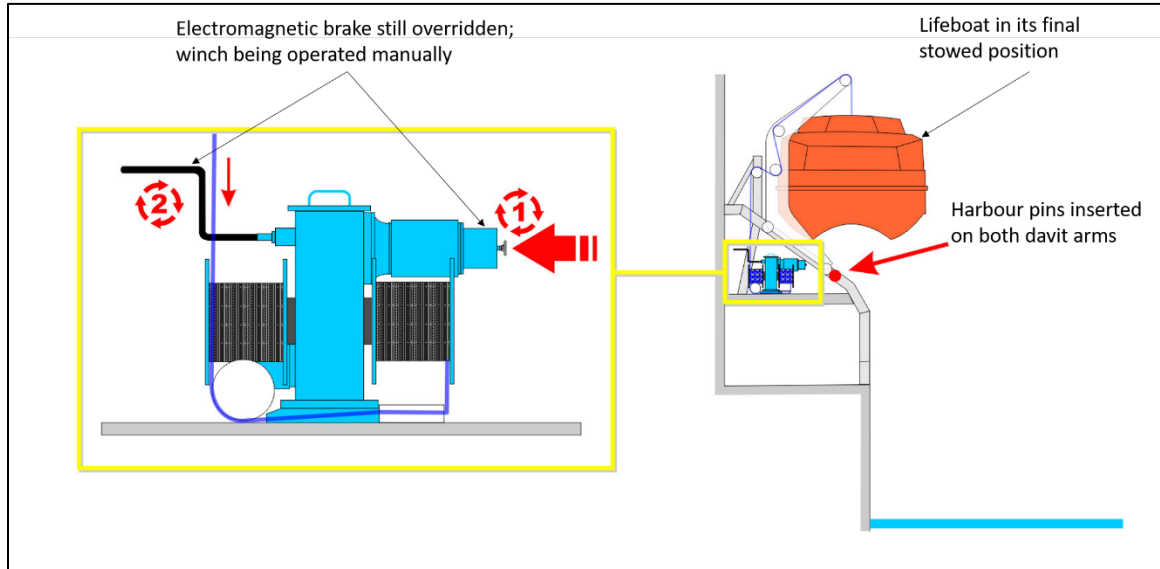
Once operators winch the lifeboat to its final stowed position, they secure the lifeboat with gripes. At this point, the holes in the davit arms and davit framed are aligned and the harbour pins can be inserted while the vessel is in port or during maintenance, to further secure the arrangement (Figure 9). The electromagnetic brake is still overridden in this situation, because the winch is being operated manually.

Figure 9. Diagram illustrating the lifeboat in its final stowed position, with the harbour pins inserted in the davit arms (Source: TSB)

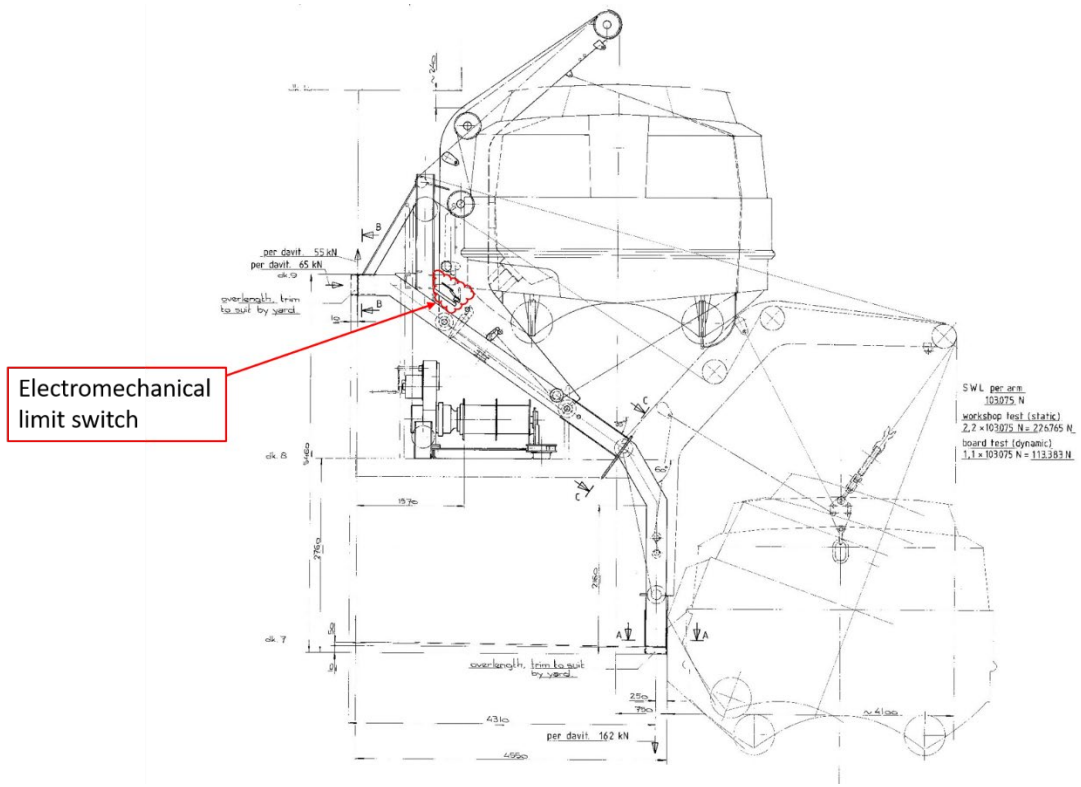
Appendix C – Technical drawing of Lifeboat No. 4 showing electromechanical limit switch

The fixed end of the wire falls of the *Amadea's* lifeboat davits is fitted with a turnbuckle so that adjustments can be made to ensure that the davit arms remain aligned while they are moving (Appendix D). Overloading of the wire falls and damage to the mechanical components of the davit (Figure 2, Figure 7, and Appendix C) is prevented by means of an electromechanical limit switch to each davit arm.

Both electromechanical limit switches are adjustable, and their levers can be repositioned to vary the point at which the winch motor de-energizes before the davit arms reach their stops. At the time of the occurrence, the switches were adjusted so that the winch motor would de-energize 20 cm before the davit arm reached its stop.
