# MARINE TRANSPORTATION SAFETY INVESTIGATION REPORT M22C0335

## CREW MEMBER INJURY

Self-propelled barge *Rivière Saint-Augustin*  
Chevery, Quebec  
13 October 2022

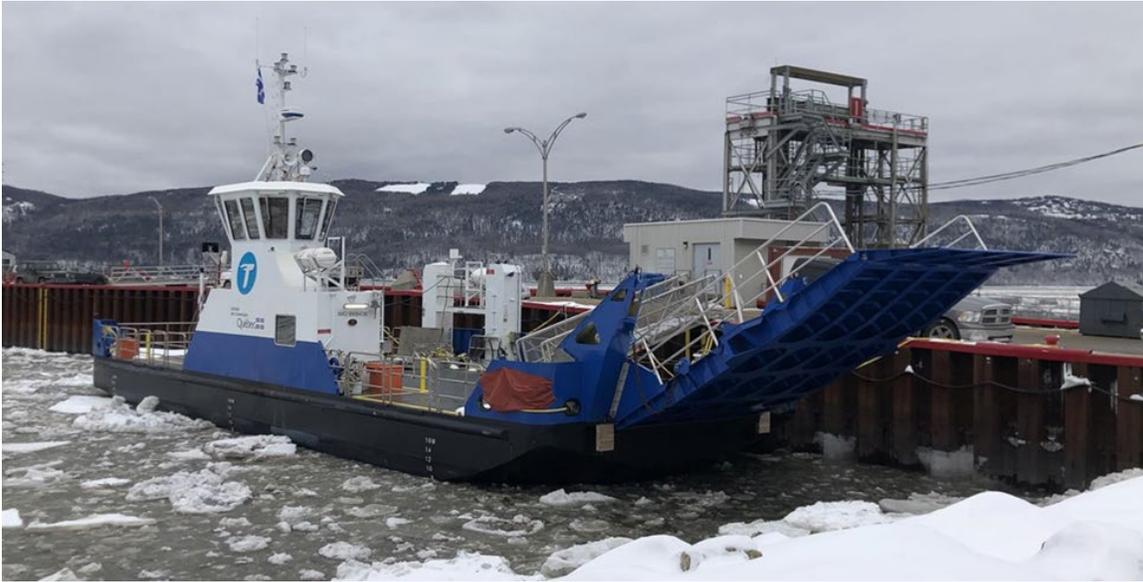
Figure 1. The Rivière Saint-Augustin (Source: Third party, with permission)

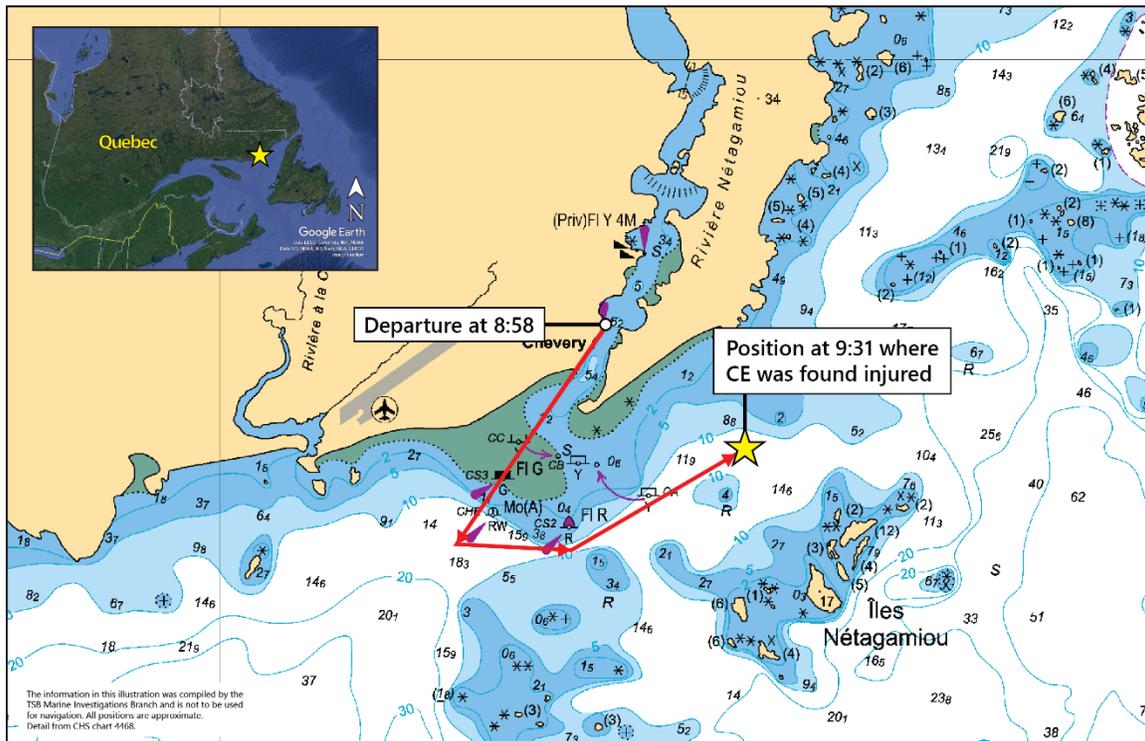
On 13 October at 0858,<sup>2</sup> the vessel left the public dock at Chevery (Figure 3). The vessel was under the command of the chief officer, the master was on deck with the 2 deckhands, and the chief engineer was in the machinery space.

Figure 3. Chart of the occurrence voyage (Source of main image: Canadian Hydrographic Service chart 4468, with TSB annotations. Source of inset image: Google Earth, with TSB annotations)
