**RAILWAY INVESTIGATION REPORT  
R11D0075**

**MAIN-TRACK DERAILMENT**

**CANADIAN NATIONAL RAILWAY  
FREIGHT TRAIN M310-31-23  
MILE 2.03, MONTREAL SUBDIVISION  
NEAR POINTE-SAINT-CHARLES, QUEBEC  
24 SEPTEMBER 2011**

Report Number R11D0075

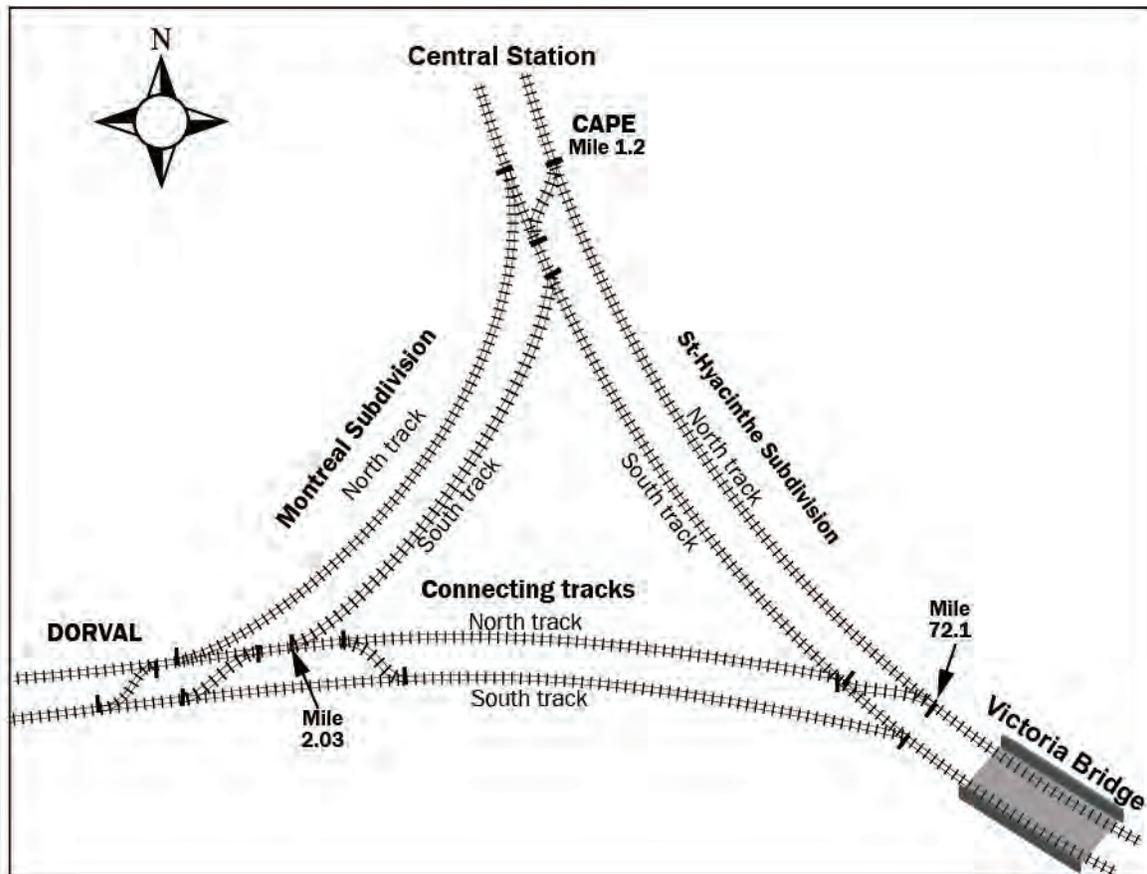
Figure 3. Diagram of connection tracks (diagram not to scale)

The Montreal Subdivision consists of double main track that runs from Cape (junction with the St-Hyacinthe Subdivision) at Mile 1.2 near Central Station in Montréal, Quebec, to Dorval, Quebec, at Mile 11.6. The north and south connecting tracks allow trains to travel from the Montreal Subdivision to the St-Hyacinthe Subdivision while avoiding the junction at Cape. They cover a distance of 1.18 miles, from Mile 2.03 of the Montreal Subdivision to Mile 72.12 of the St-Hyacinthe Subdivision (Figure 3).
