## **RAILWAY INVESTIGATION REPORT R13W0257**

### **MAIN-TRACK DERAILMENT**

**CANADIAN NATIONAL  
FREIGHT TRAIN G84042-09  
MILE 73.6, FORT FRANCES SUBDIVISION  
NICKEL LAKE, ONTARIO  
10 NOVEMBER 2013**

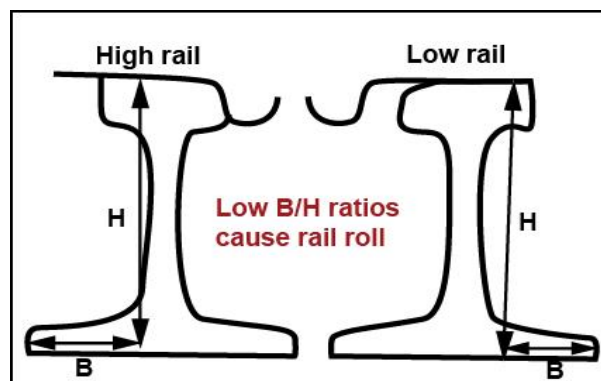
Figure 3. Rail base/rail height ratio (Source: Transportation Technology Center, Inc. / Norfolk Southern report TD-11-052)

A Transportation Technology Center, Inc./Norfolk Southern report (TD-11-052, *Root Cause of Rail Roll/Reverse Rail Cant*) determined that certain track maintenance tasks (e.g., gauging, rail cant restoration and tie renewal) can result in track conditions that are susceptible to high lateral forces, reducing the track structure's ability to resist gauge-widening forces. In curves, these track maintenance activities tend to move the contact position of the wheel towards the field side of the high rail and towards the gauge side of the low rail. The high rail will tend to have strong 2-point contact, resulting in poor curving performance. Vertical load applied to the field side of rail, due to poor wheel/rail profile contact, results in low rail base/rail height (B/H) ratios<sup>13</sup> (Figure 3) and a high risk of rail rollover<sup>14</sup> unless the rail profile is corrected by rail grinding.

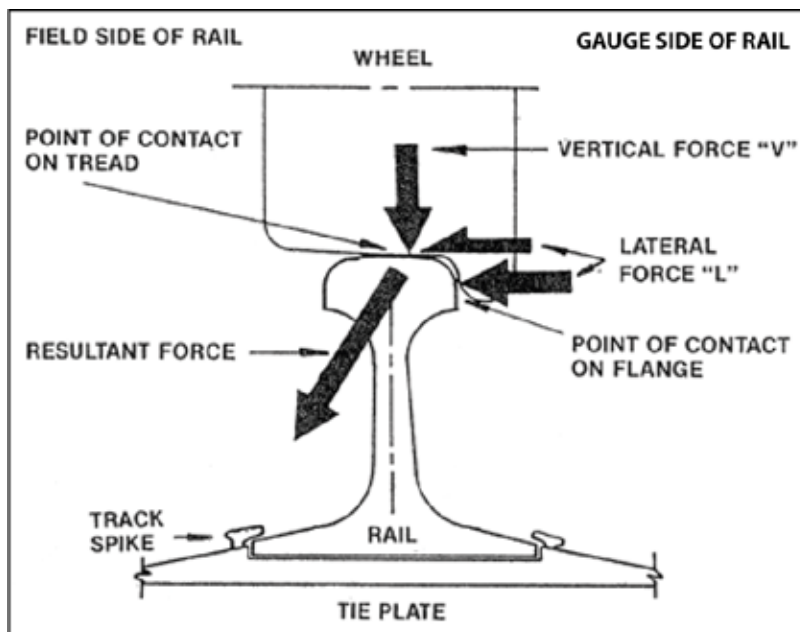
Figure 4. Lateral-to-vertical forces between wheel and rail

A combination of lateral (L) and vertical (V) forces exist at the wheel/rail contact (Figure 4). The ratio of lateral-to-vertical (L/V) forces provides an indication of the likelihood of a derailment. The probability of a derailment increases as the L/V ratio increases. A high lateral force, combined with a low vertical force (e.g., empty cars), will tend to push the wheel flange up and over the gauge face of the rail (i.e., wheel climb), or push the rail outward with sufficient force to cant the rail outward and roll over the rail.

- The wheel flanges, centrifugal forces and frictional curving forces of wheel truck assemblies will exert lateral force on the high rail. In-train forces (i.e., buff and draft forces) can also exert lateral force on the track.
- As lateral forces try to tip the rail over, the rail is restrained by its torsional stiffness and by the weight on adjacent wheels.
- Raising the high rail (i.e., superelevation) compensates for centrifugal force by shifting some car weight to the low rail, reducing the lateral force (centrifugal) and the vertical force on the high rail.
- Lubricating the gauge side of the low rail will reduce frictional curving forces that may cause high rail rollover or low rail wheel drop-in.
- For a wheel to drop in, there must be either a significant increase in lateral load on the track or a significant reduction in lateral strength of the track.
