RAIL TRANSPORTATION SAFETY INVESTIGATION REPORT R19W0050

MAIN-TRACK TRAIN DERAILMENT

Canadian National Railway Company
Freight train U73451-11
Mile 197.47, Rivers Subdivision
St. Lazare, Manitoba
16 February 2019

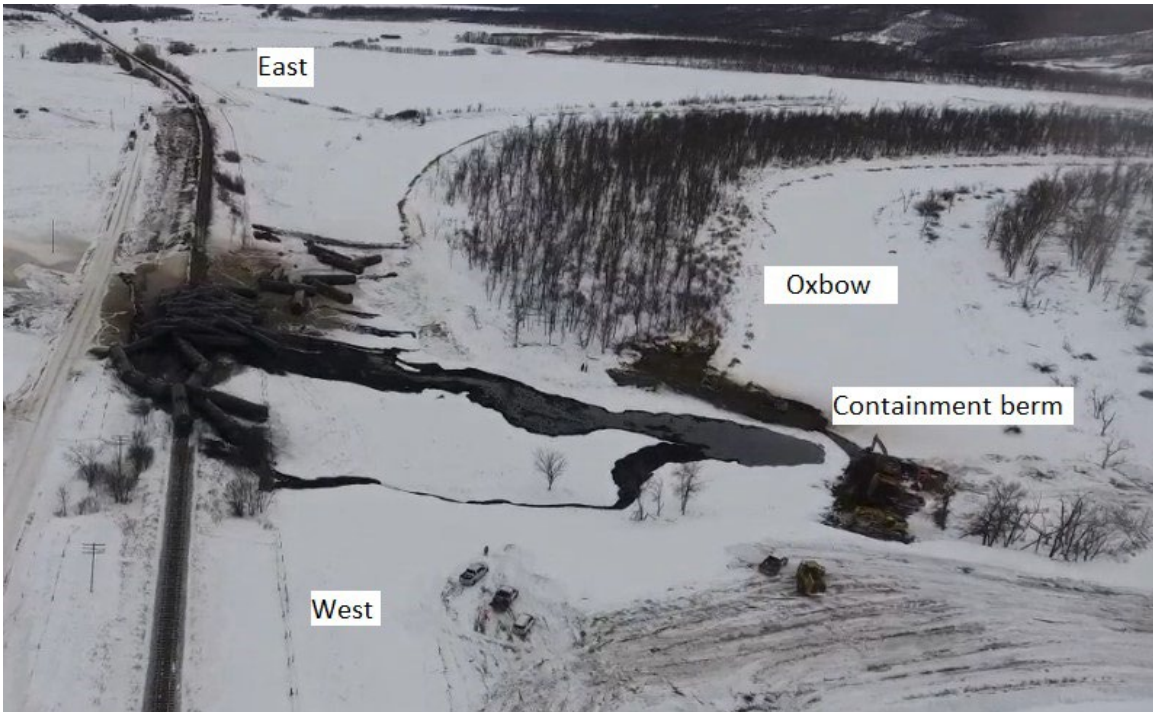
Figure 3. Aerial overview of the derailment site (Source: Curtis McLeod and Amon Rudolph, with TSB annotations)

All wheels on the 6th car derailed. The train had separated between the 6th and 7th cars and the remaining 35 derailed tank cars (7th to 41st) came to rest in various positions along the right-of-way between Mile 197.39 and Mile 197.49 (Figure 3).

At the east end of the derailment site, the 7th to the 15th cars had rolled down the south embankment toward the frozen oxbow. Further west, the 16th to 34th cars came to rest piled up side by side on, and perpendicular to, the track structure. At the west end of the site, the 35th to 38th cars came to rest just south of the track structure whereas the 39th to 41st cars came to rest either on or just north of the track structure (Figure 4).

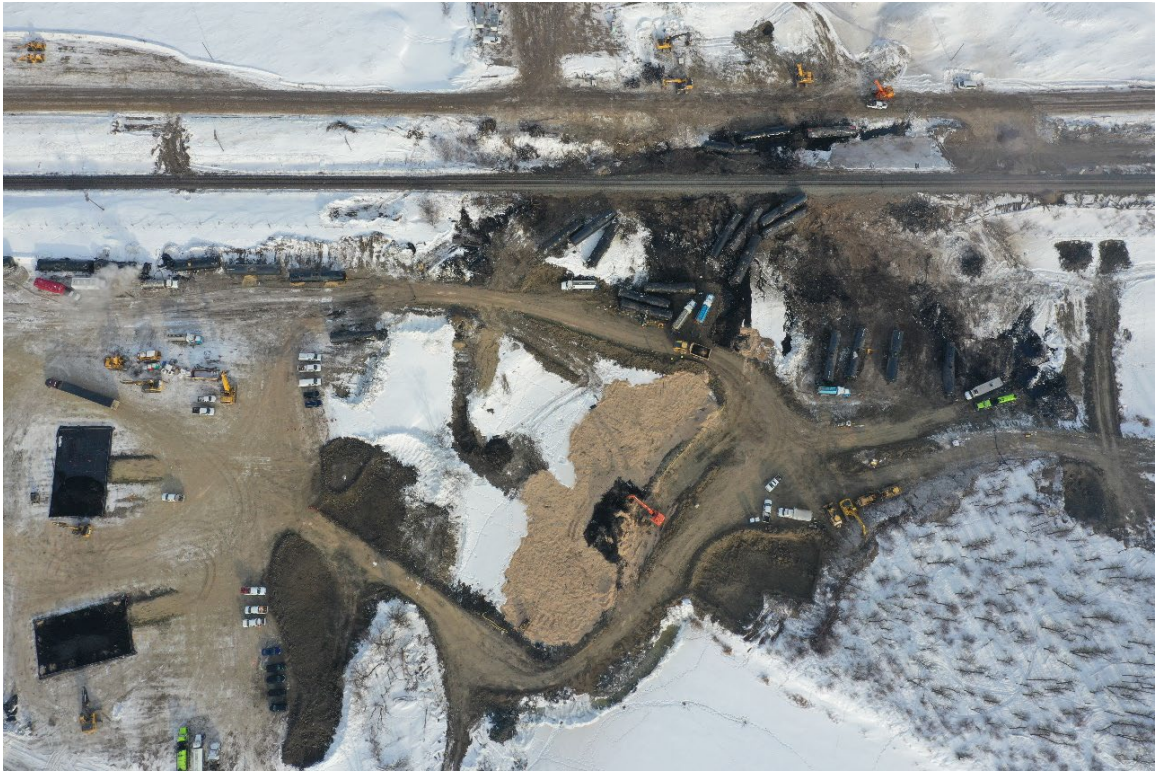
Figure 7. Aerial view of site remediation activities (Source: GHD)

On the south side of the rail line, where derailed cars were lying on their sides down an embankment, there were 4 or 5 paths of product extending from the cars down the embankment. A large pool of crude oil had formed south of the cars on the embankment. The initial product release was about 10 to 15 m wide and 70 m long extending down to the oxbow. There were areas where the product had melted the snow and the product became more viscous as it cooled. Additional adjacent areas were used for various initial response operations, including equipment staging, equipment decontamination, and access roadways (Figure 7).

Emergency response at the site included the following steps:

- A large containment berm was constructed across the oxbow.
- Soil samples were taken outside of the immediate area of the derailment to establish baseline concentrations for product constituents such as benzene, toluene, ethylbenzene and xylenes.
- A 3-level product recovery program was implemented that included
 - the transfer of remaining product from within the derailed cars;
 - the recovery of pooled product from the ground surface; and
 - the mixing of stabilizing products (wood chips, sand) with pooled product on the ground to facilitate recovery by excavation.

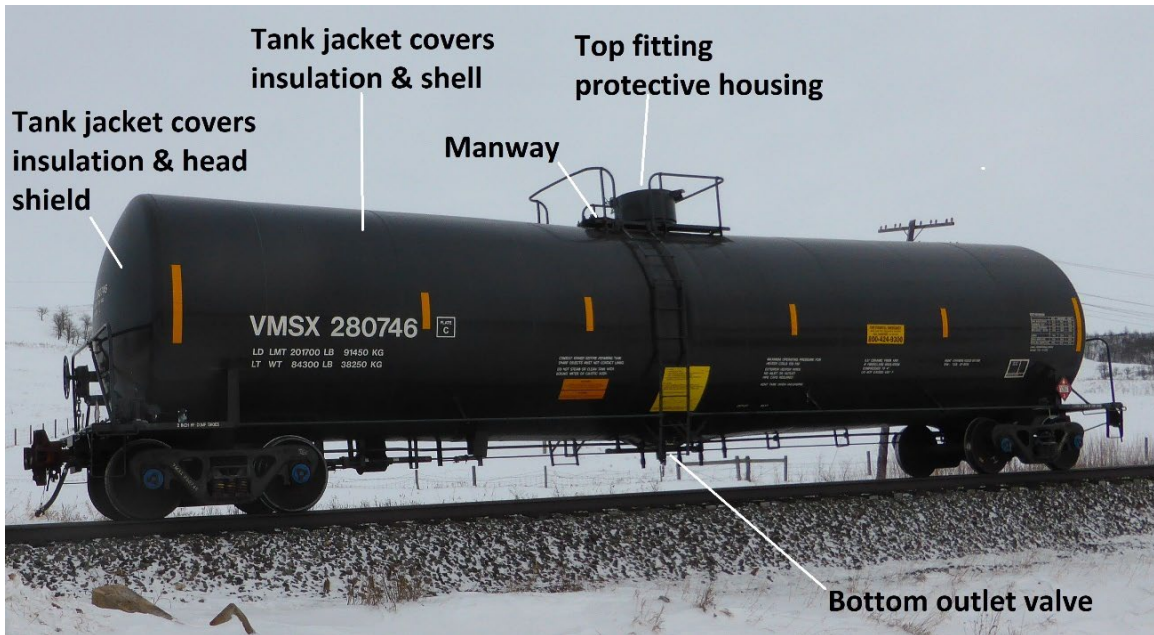
Figure 16. General arrangement of Class 117R tank car VMSX 280746 (5th car from head end) after being re-railed. A tank car jacket and insulation encase the tank shell and full head shields. The pressure relief devices are located inside the top fitting protective housing. (Source: TSB)

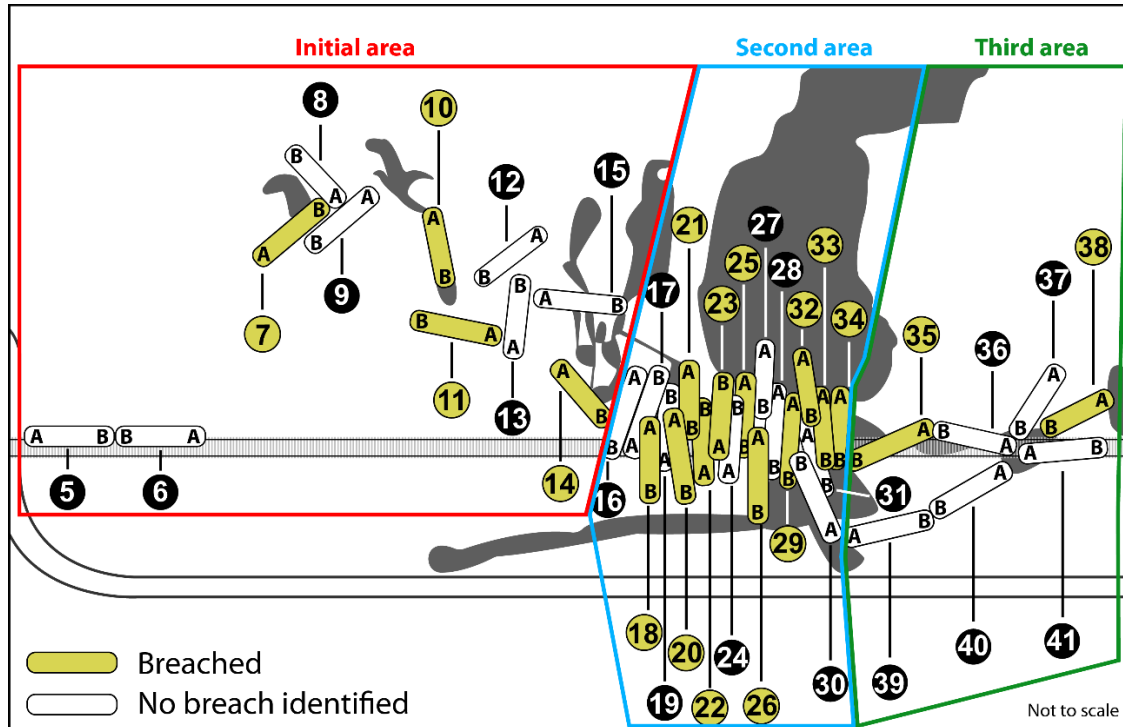
Figure 17. Diagram of the occurrence site showing the 3 major areas within a derailment zone (Source: TSB)

Different types of damage, that range both in severity and the amount of product released, have been observed in each of the 3 derailment zone areas (Figure 17). The reasons for the

amount of damage sustained by each of the derailed tank cars vary, but common elements include the speed of the train at the time of the derailment, the size of the derailment area, the topography of the derailment zone, and the weather at the time of the derailment. The following observations are considered typical for each area and are provided to explain the dynamic forces at work on the tank cars during a derailment.
