RAIL TRANSPORTATION SAFETY INVESTIGATION REPORT R21V0118

MAIN-TRACK TRAIN DERAILMENT

Canadian National Railway Company
Freight train A47251-02
Mile 547.7, Chetwynd Subdivision
Hodda Station, British Columbia
03 June 2021

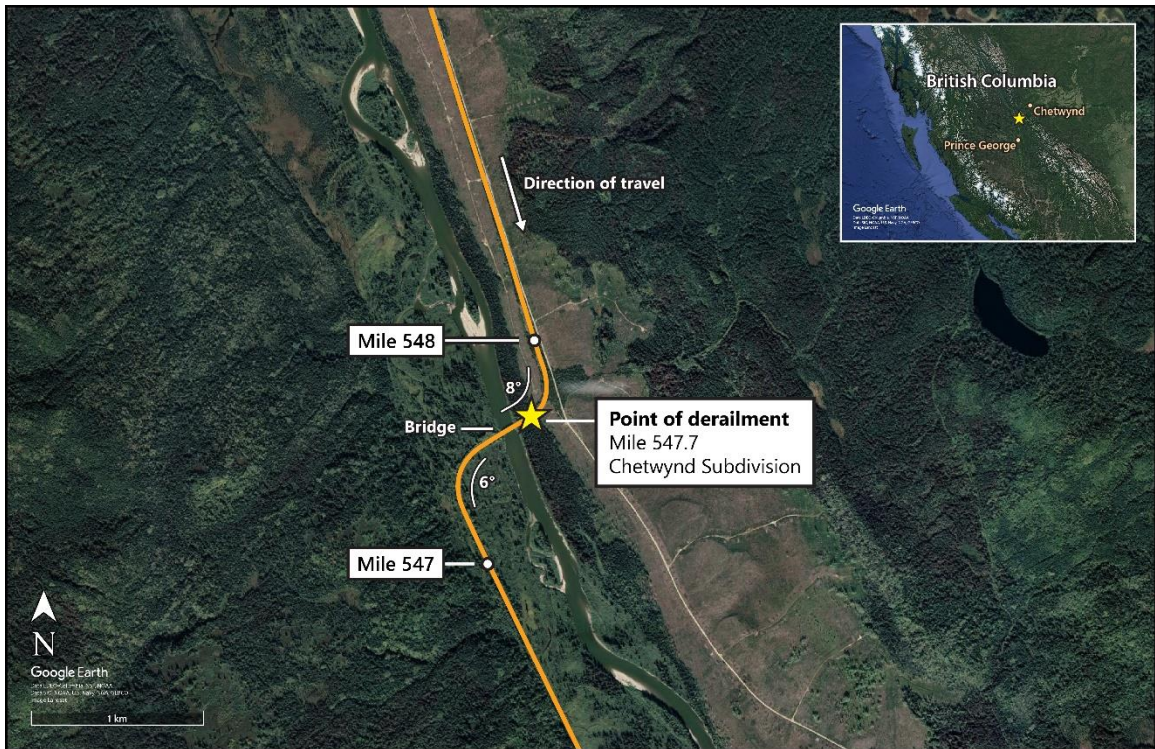
The derailment took place at Mile 547.7 in a remote area about 85 miles north of Prince George. Near the point of derailment in the direction of travel, there is an 8° right-hand curve. The track then crosses a bridge over Parsnip River, after which there is a 6° left-hand curve (Figure 1).

Figure 1. Map showing the occurrence location (Source: Google Earth, with TSB annotations)
