# RAIL TRANSPORTATION SAFETY INVESTIGATION REPORT R22V0238

## **COLLISION BETWEEN A TRAIN AND A TRACK UNIT**

Canadian Pacific Railway Company  
Freight train 302-25 and hi-rail vehicle L15034  
Mile 116.7, Shuswap Subdivision  
Near Campbell Creek, British Columbia  
29 December 2022

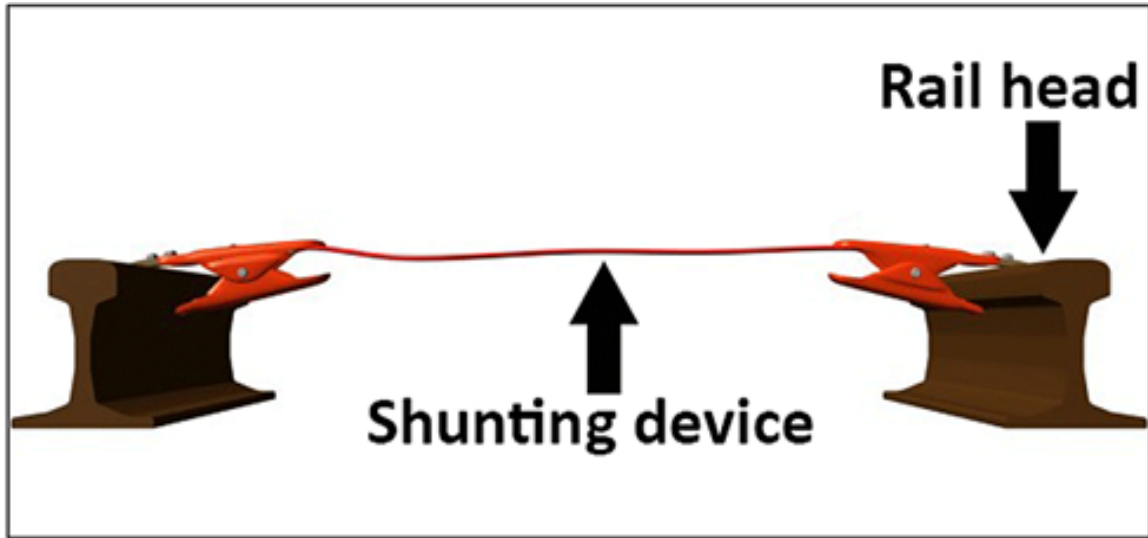
Shunting devices (Figure 8) offer an alternative to the shunting by track units. These devices, which are installed by hand, shunt the track circuit and, therefore, ensure that Stop signals will be displayed to trains when approaching blocks occupied by workers.

Figure 8. Shunting device (Source: TSB)

In the U.S., some railways require that shunting devices be used while work crews are working on the track. CP does not provide guidance on permitting or not permitting the use of shunting devices.
