MARINE TRANSPORTATION SAFETY INVESTIGATION REPORT M23C0104

ENGINE ROOM FIRE

Bulk carrier *Cuyahoga*
Lake Erie
Kingsville, Ontario
23 May 2023

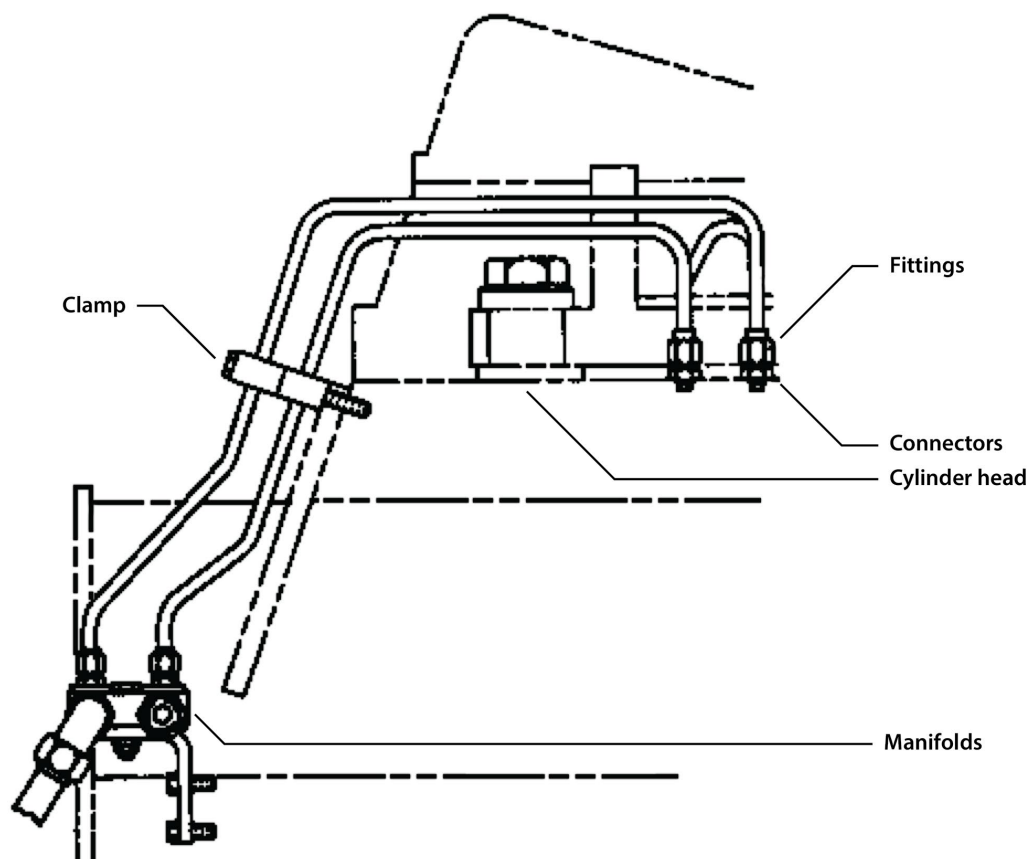
Figure 5. Fuel injection supply and return lines showing positions of clamps, connectors, and fittings (Source: Manufacturer's specifications with TSB annotations)

Fuel injection supply and return lines between manifolds and injectors were connected at the cylinder heads (Figure 5). The lines were ½-inch diameter steel tubes. The fuel injection

lines were comprised of –08 steel tube with a brazed steel flat end, a 13/16-16 UNC (unified national coarse) threaded connector, and an O-ring face seal (ORFS) fitting.^{10,11,12}

ORFS fittings typically provide reliable leak-free connections. However, the tightening sequence and clamping force between the sealing faces of the fittings on the fuel injection lines are critical to ensuring adequate sealing against leaks, and the majority of leaks that do occur are due to loose fittings.¹³ Typical causes for loose fittings are¹⁴

- excessive strain caused by an incorrect tightening sequence;
- improper use of tools;
- failure to apply the specified torque;¹⁵ and
- vibration.

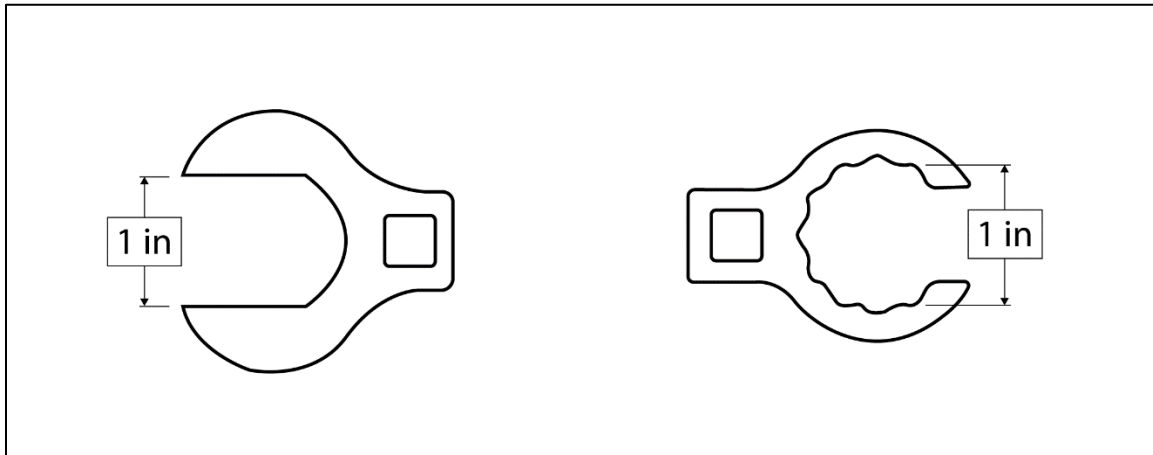
Figure 8. Crow's foot attachments. A double hex flare nut attachment (right) gives a better fit than an open-ended attachment (left) for applying the correct torque (Source: TSB)

The fittings required the use of a crow's foot attachment at the end of a ratchet extension that was approximately 30 cm long and connected to a torque wrench. The manufacturer's installation and maintenance instructions state that a double hex flare nut crow's foot attachment should be used (Figure 8, right) and that the full specified torque should be applied to each fitting in a single step. In this occurrence, the crew used the open-ended crow's foot (Figure 8, left) attachment that they had on board the vessel, and torqued the fittings in multiple steps. Torquing bolts in a flange connection in multiple steps maintains relative positions during the process and ensures the gasket is sealed. For fittings such as the fuel injection line connections, torquing in multiple steps is unnecessary.

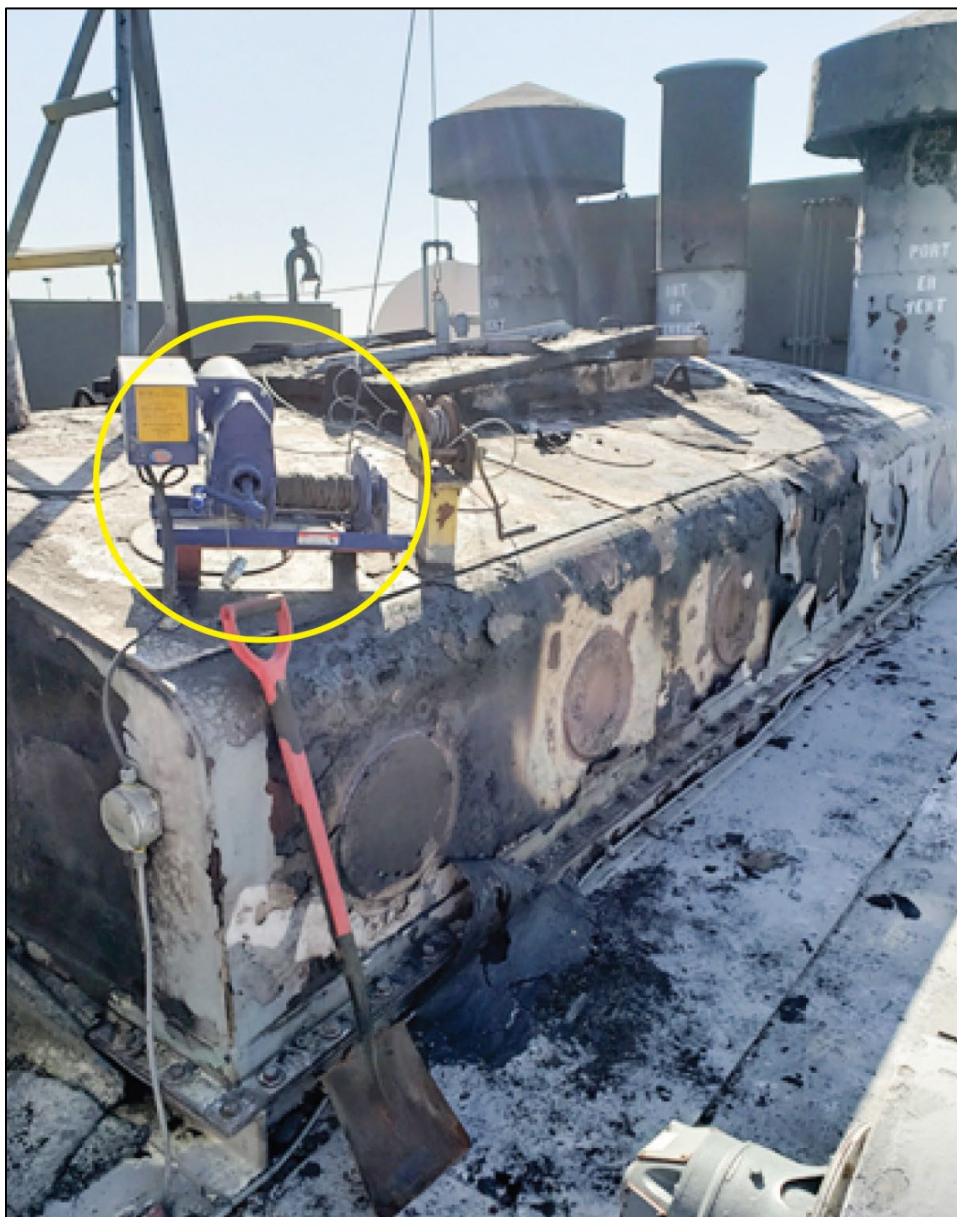
Figure 15. Skylight hatch and winch (circled) (Source: TSB)

The chief engineer, who was unable to reach his muster station in the engine control room because of the fire, went to the boat deck and attempted to reach the skylight hatch to close it. He observed that the winch's electric motor was running, and the skylight hatch was opening wider. When he heard the master's attempt to contact the second engineer by radio, he became aware that the second engineer was absent. The chief engineer then re-entered the aft deckhouse accommodations on the port side to search for the second engineer, but he encountered heavy smoke and abandoned the attempt.

The skylight hatch was used to move equipment and material in and out of the main engine room (Figure 15). The hatch was often left open to improve the circulation of air in the main engine room.

The skylight hatch was opened and closed using a power-operated winch. Normally, this winch was controlled remotely from the engine room, but it could also be opened and closed locally by using a manual crank.

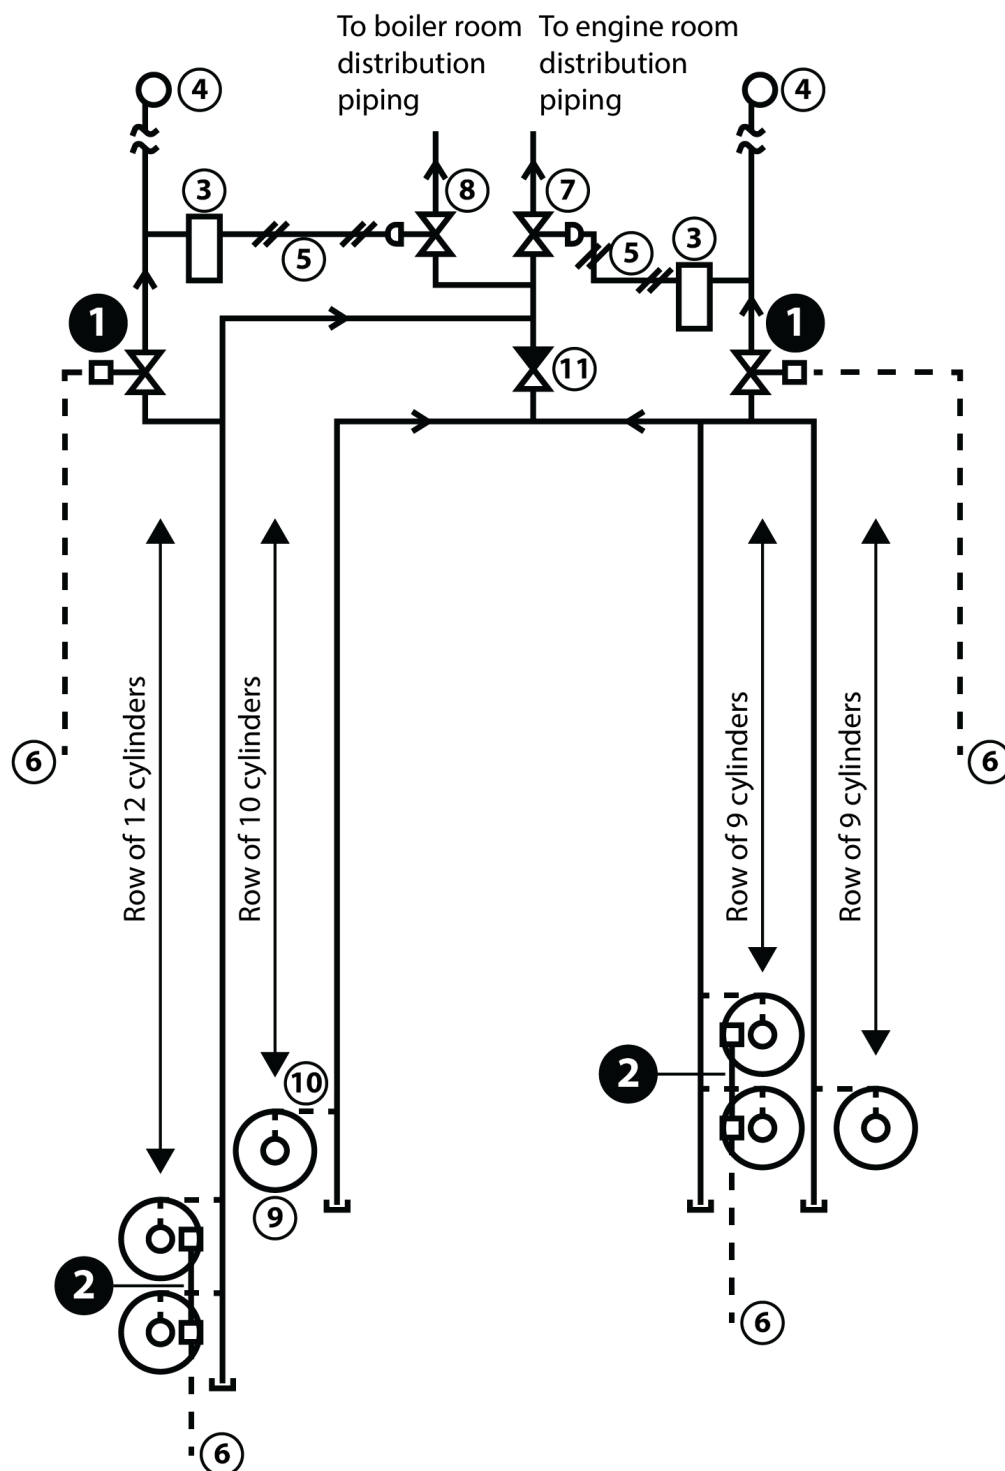
Figure 16. Layout of the CO₂ fixed fire suppression system as installed on the *Cuyahoga* (Source: TSB)

The *Cuyahoga* was fitted with a CO₂ fixed fire suppression system to protect the engine and boiler rooms. The system was installed in 2002 as part of an upgrade to the vessel. The system comprised 40 CO₂ cylinders of a nominal 45 kg capacity for a total of 1800 kg (Figure 16). The CO₂ could be released into either the engine or boiler rooms in stages or all at once.

The *Cuyahoga's* system used 4 stainless steel cables to trigger the CO₂ release remotely. Two were connected to the control heads on the directional stop valves and 2 were connected to the tandem control heads for the discharge valves on the cylinders. The order of operation depended on which space the CO₂ was to be released in but, in any case, the directional stop valve was to be operated before the tandem control valve (Figure 16).

A post-occurrence examination of the *Cuyahoga's* manifold layout showed that the directional stop valves (Figure 16, annotation 1) were in the closed position and had not been activated by the remote pull cable or manually. In addition, 7 out of 40 hose connections on the valve heads were found to be only finger-tight. A representative from a third-party service provider who attended the vessel after the occurrence found many other leaks: approximately a third of the cylinder valves had loose swivel nuts at the connection to their discharge heads and, in some instances, the sealing O-rings between the cylinder valves and discharge heads were missing (Figure 18). When the cylinders were weighed

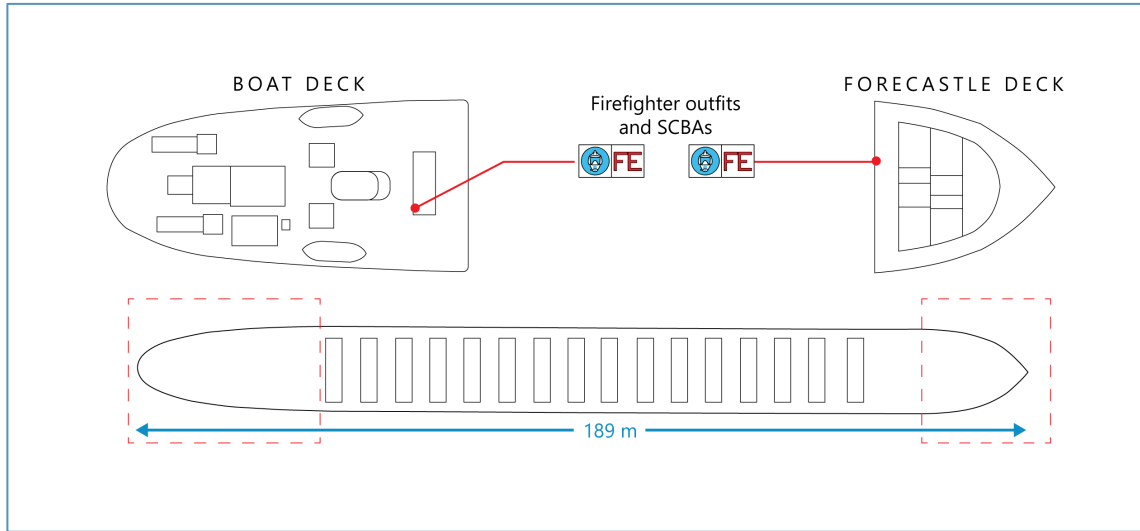
Figure 22. One firefighter outfit and SCBA was stored on the boat deck and 1 set was stored on the forecastle deck (Source: TSB).

At the time of the occurrence, the *Cuyahoga* was equipped with the required minimum of 2 firefighter outfits and 2 SCBAs with 4 charged air cylinders. On the *Cuyahoga*, 1 firefighting equipment locker was located on the forward deckhouse and the other was located on the boat deck of the aft deckhouse (Figure 22).

In previous occurrences, a lack of firefighting equipment and a lack of familiarity have led to crew member injuries and placed people in danger when responding to vessel fires.⁵² In this occurrence, the decision to use the CO₂ system even though the engine room was not properly sealed was influenced by the fact the *Cuyahoga* carried only enough equipment for 1 team of 2 firefighters, which was insufficient for an engine room fire.
