## AVIATION INVESTIGATION REPORT

A04Q0199

### RUNWAY EXCURSION

**BE-A100 KING AIR C-GAIK**

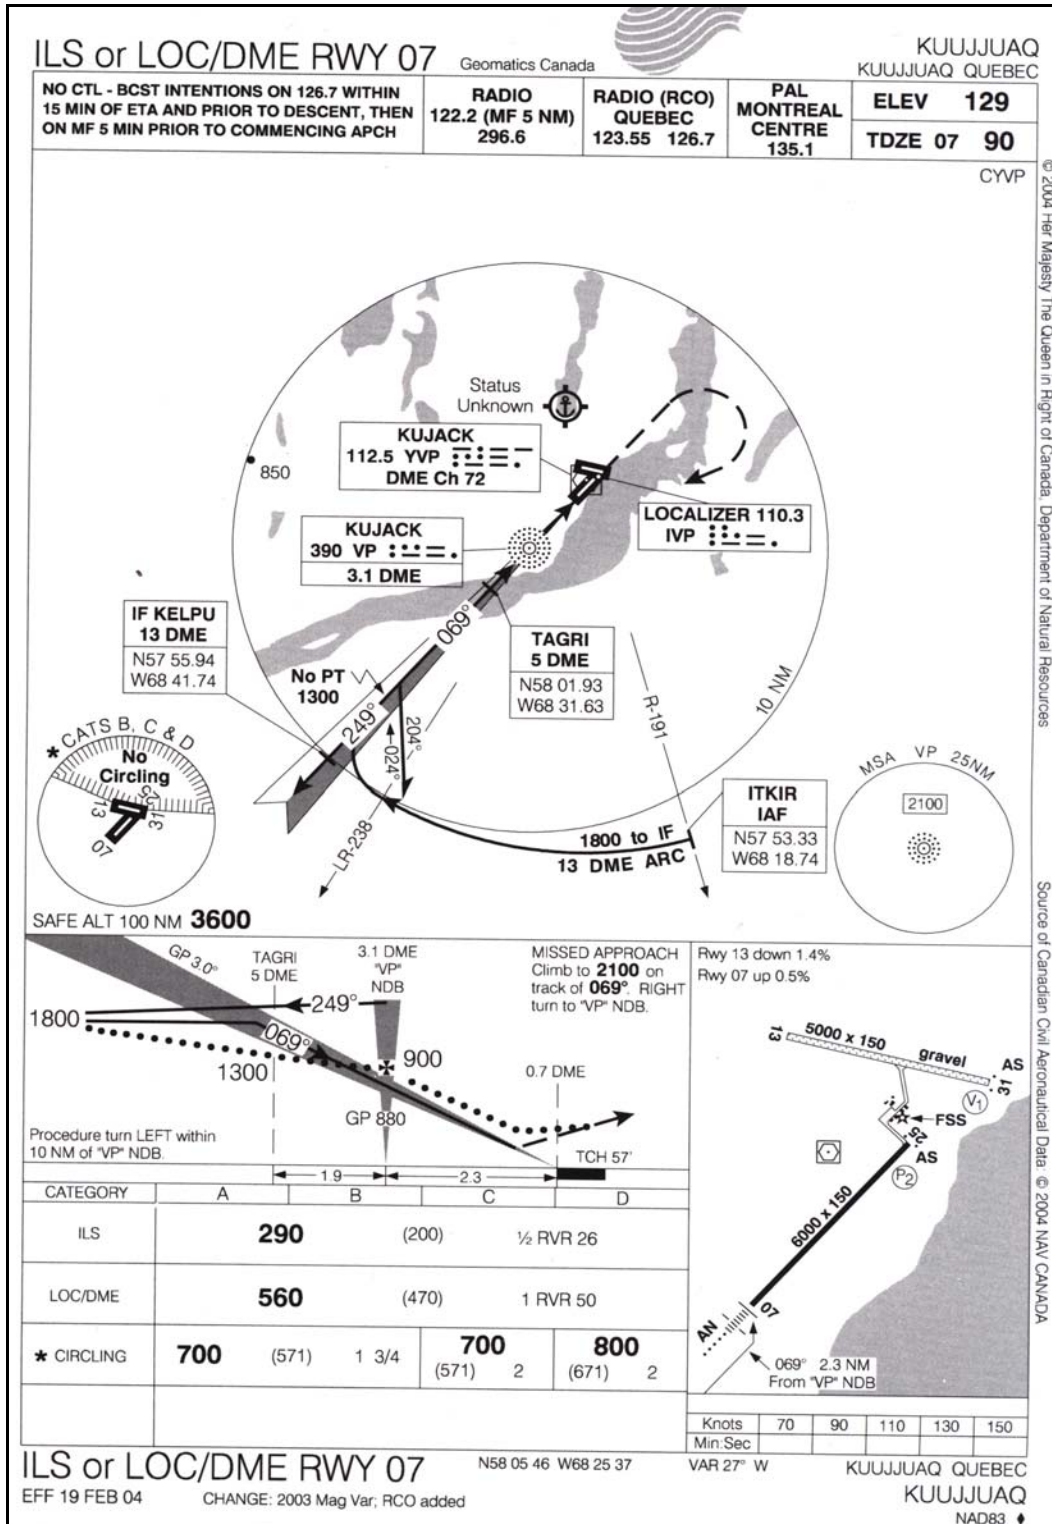
# Appendix B – Approach Chart ILS or LOC/DME RWY 07

The ceiling and visibility dictated a precision approach to Runway 07, but it was about 110° out of wind and very slippery. The winds favoured a landing on Runway 31, but the reported ceiling was lower than required for a circling approach. Regardless, the surface of Runway 31 was 40 per cent covered with six-inch snow drifts. The decision to fly an approach into Kuujuaq instead of proceeding to the alternate airport indicates that the crew was not processing the significance of the information regarding wind and runway conditions. They continued an

Fully expecting that it was unlikely they would be able to land in Kuujjuaq, the crew indicated to the company and the FSS their intention to attempt one ILS approach to Runway 07 and then divert to Schefferville. The crew never discussed strategies for landing in the reported conditions and did not discuss which runway would be preferable for a landing. The fact that the first officer did not know that the captain was intending to land on Runway 07 did not allow the crew to properly assess the risk of landing on a slippery runway in strong, crosswind conditions.
