AVIATION INVESTIGATION REPORT
A09P0249

LOSS OF CONTROL – COLLISION WITH WATER

ELBOW RIVER HELICOPTERS LIMITED
BELL 212 (HELICOPTER), C-GTKE
LILLOOET, BRITISH COLUMBIA, 20 nm S
14 AUGUST 2009

Report Number A09P0249

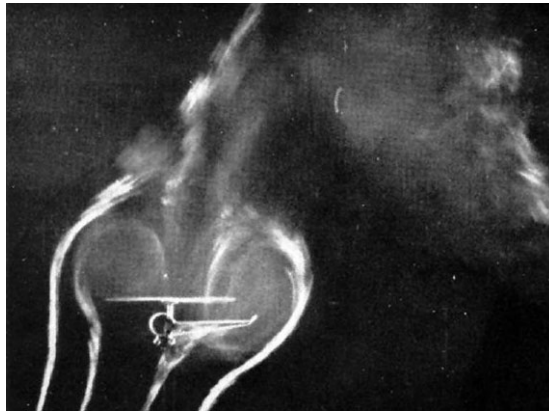
Helicopters are susceptible to an aerodynamic phenomenon known as the vortex ring state (VRS). VRS occurs when a helicopter's flight path, airspeed, and rate of descent coincide with the helicopter's downwash.⁴ The risk of VRS increases when a helicopter slows in a downwind condition. In normal flight, airflow from the main rotors is directed downward. In VRS, the tip vortices generated by the main rotors re-circulate through the rotor, adversely affecting lift (see Photo 1). A helicopter in VRS quickly begins losing altitude, despite having power available to sustain flight. A helicopter in VRS may also experience vibrations, excessive flapping, and a reduction in cyclic authority. Applying more power (increasing collective pitch) serves to further accelerate the downwash through the main-rotor, exacerbating the condition.

Photo 1. Air circulation during VRS⁵
