**AVIATION INVESTIGATION REPORT
A10Q0098**

ENGINE PROBLEM - COLLISION WITH TERRAIN

**AÉROPRO (2550-4330 QUÉBEC INC.)
BEEHCRAFT A100 KING AIR C-FGIN
QUÉBEC, QUEBEC
23 JUNE 2010**

Report Number A10Q0098

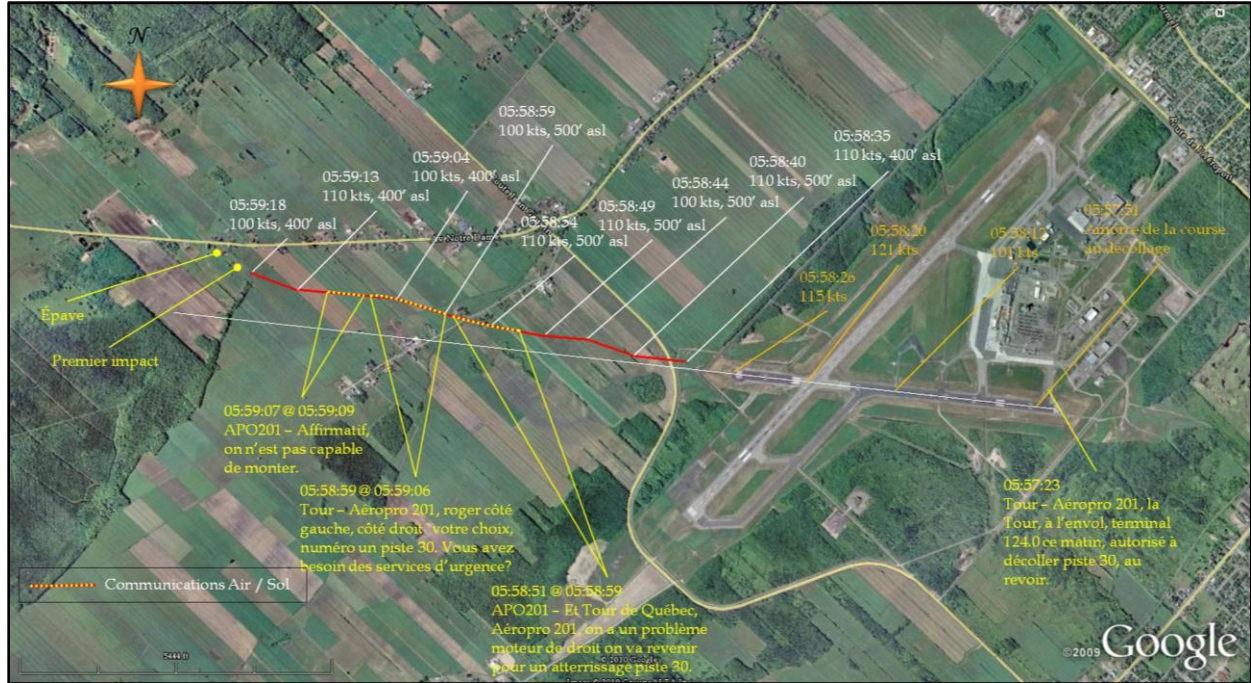
Figure 1. Trajectory of the aircraft

APO201 appeared on the Québec radar approximately 800 feet past the end of the runway, 160 feet above ground level (agl) ³ at 110 knots (Figure 1). Five seconds later, the aircraft turned 10° to the right; it was at 260 feet agl, the maximum altitude reached during the flight; its speed was unchanged. A few seconds later, the co-pilot informed the airport controller that there was a problem with the right engine and they would return and land on Runway 30. The controller immediately informed APO201 that it had priority to land and asked whether emergency services would be needed. ⁴ The co-pilot stated that the aircraft was unable to climb. This was the last transmission from APO201.

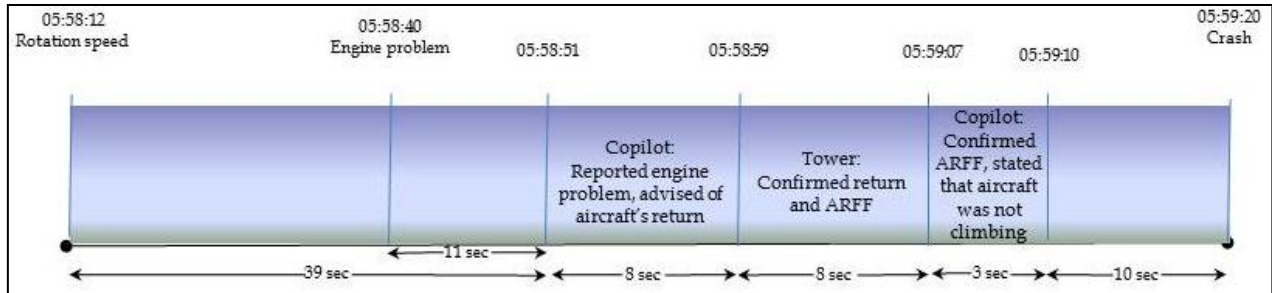
Figure 2. Timeline of communications after take-off

There were 3 radio communications between APO201 and the Québec tower after take-off (see Figure 2). They occurred after the engine problem, one after the other. All communications from APO201 were made by the co-pilot. They contained the distress call, navigation information, the dispatch of aircraft rescue and firefighting (ARFF) services, and the aircraft performance problems. The communications began 39 seconds after the aircraft reached rotation speed and occurred over a total period of 19 seconds. The aircraft crashed 21 seconds after the first call from APO201 and 10 seconds after the last communication.

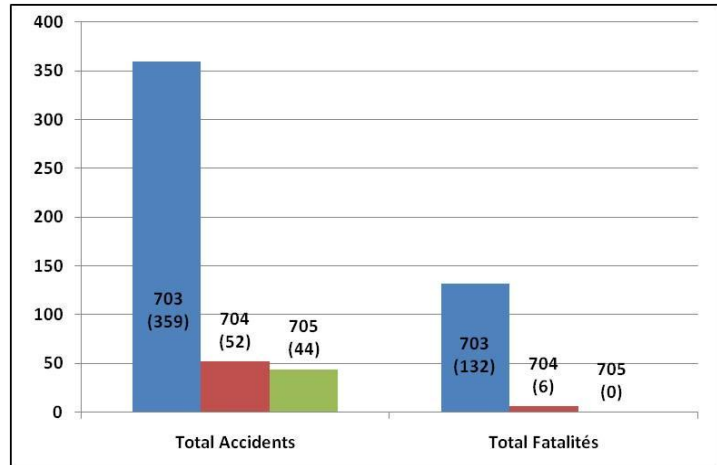
Figure 4. Total number of accidents and fatalities, 2001 to 2010, by type of operation

Regulation of air taxi operations is less stringent. For example, the recurrent training requirements are lower, SOPs are not approved by TC, the criteria for incident reporting are less restrictive, and air taxi operations are one of the last to be required to implement SMS.

The operating environment for air taxi operations is more demanding: companies are smaller; flights are shorter and so there is a higher average number of take-offs and landings per hour of flight time; and the aircraft are exposed to more severe weather for most of the flight time because of the altitude of the flights. They also serve smaller airports and aerodromes in remote areas with minimal services such as navigation aids, emergency services, ground services, and flight planning.
