**AVIATION INVESTIGATION REPORT
A12Q0029**

SMOKE IN THE CABIN

**PASCAN AVIATION INC.
BEECHCRAFT B100, C-FLKS
MONTRÉAL/SAINT-HUBERT AIRPORT, QUEBEC
21 FEBRUARY 2012**

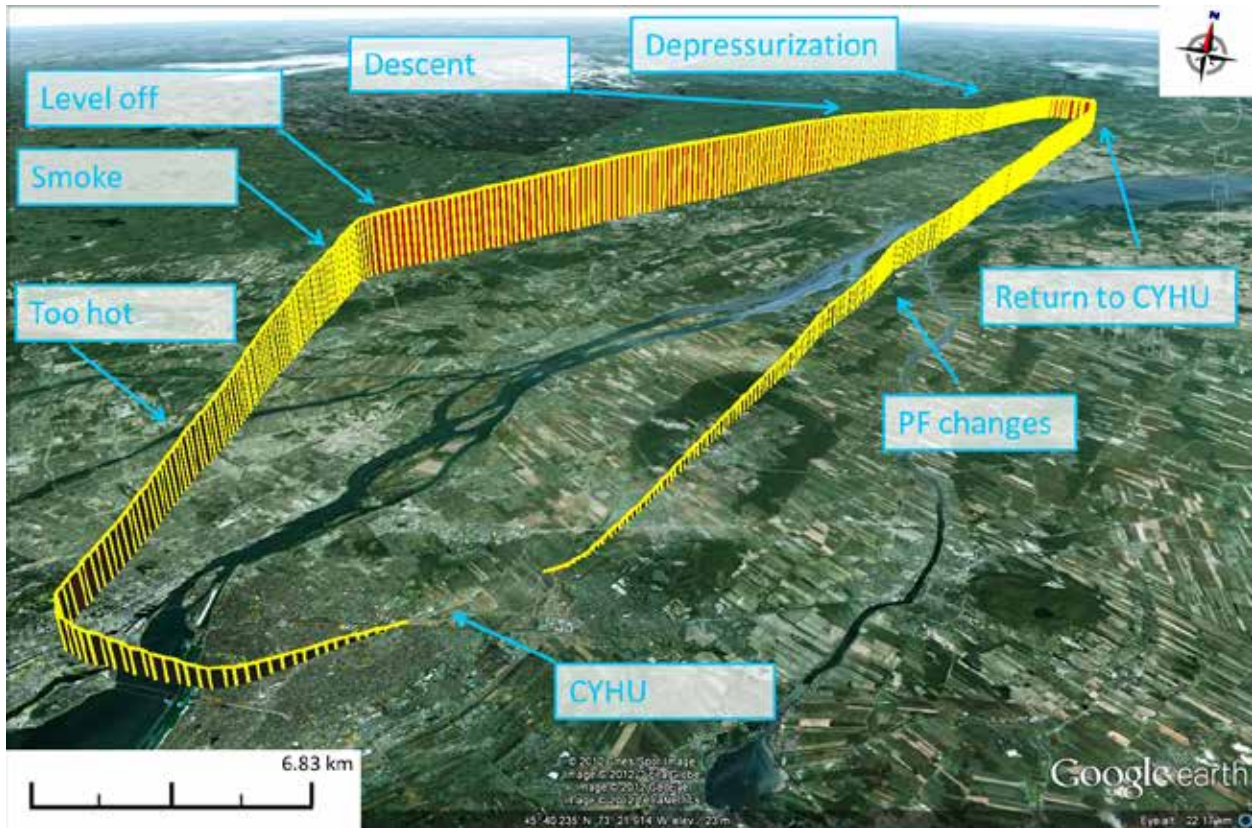
Figure 1. Flight trajectory based on radar data

A visual approach was carried out, and the aircraft landed uneventfully at 0951, with CYHU aircraft rescue and fire-fighting (ARFF) services following the aircraft during the landing roll-out. Since there was no visible smoke, the flight crew taxied and parked the aircraft away from the company facility, escorted by ARFF. Figure 1 shows the aircraft's flight path.
