**AVIATION INVESTIGATION REPORT
A12W0121**

LOSS OF CONTROL AND COLLISION WITH TERRAIN

**ALTA FLIGHTS LIMITED
CESSNA 172M C-GRGW
CLARESHOLM, ALBERTA, 22 NM WNW
26 AUGUST 2012**

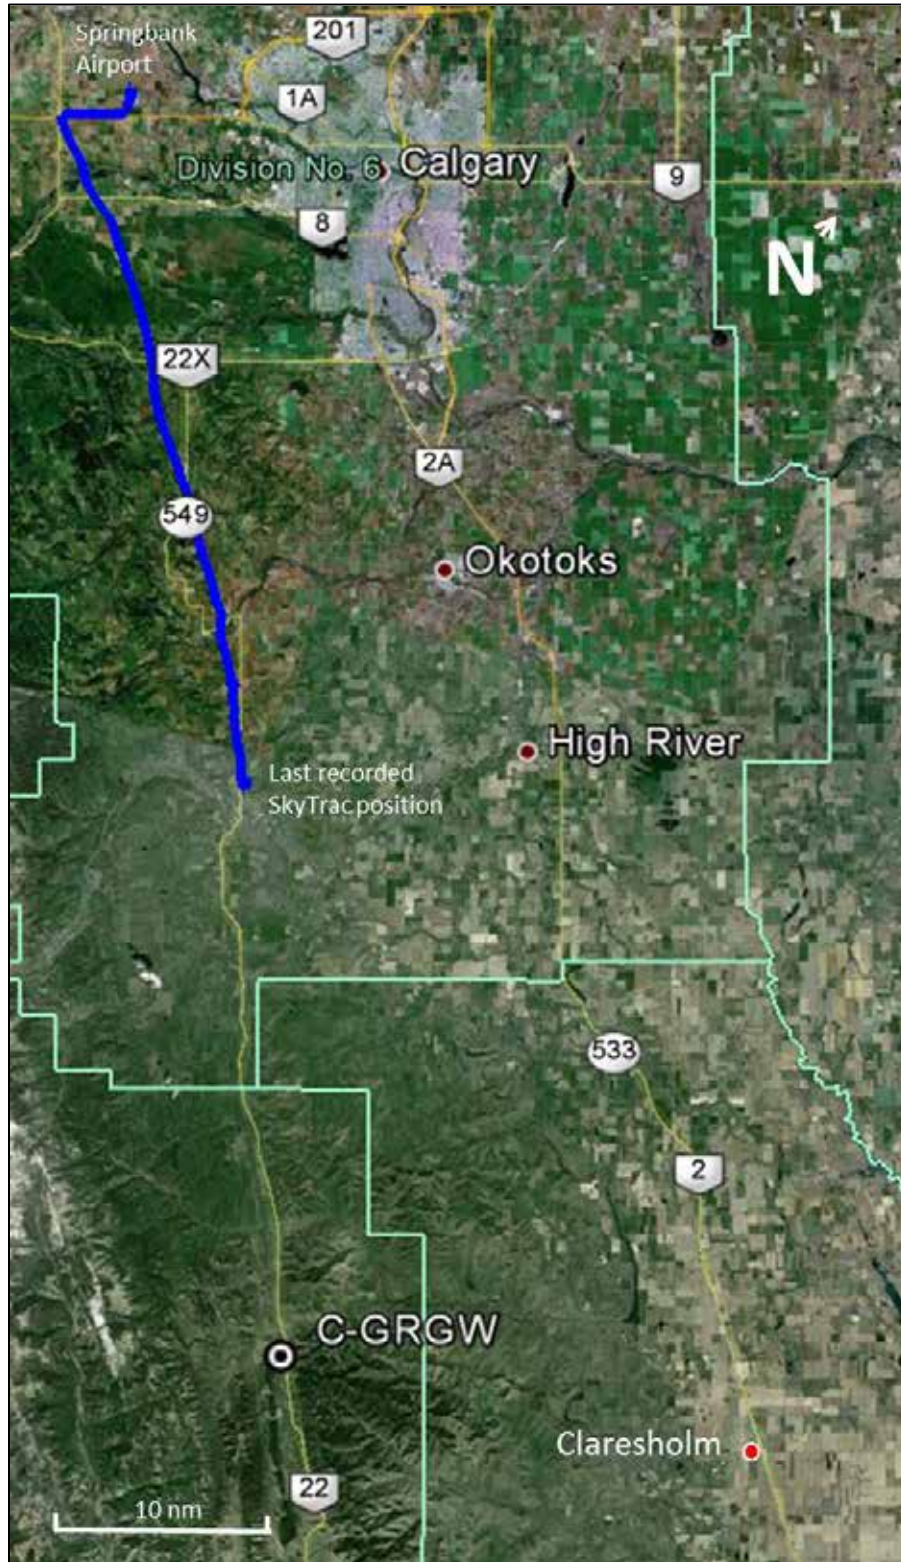
Appendix A – Route of Flight

The aircraft, C-GRGW, had departed Edmonton International Airport (CYEG) in late morning on the day of the accident, on a routine pipeline patrol to the south. The first segment of the patrol terminated at Springbank Airport (CYBW), where C-GRGW landed at 1554¹ to report problems with a pipeline between Springbank Airport and Pincher Creek, Alberta. The client contacted Alta Flights Limited headquarters and requested a patrol of the line. The company informed the pilot of this request, and the day's flying was revised. The aircraft departed Springbank Airport at 1642 (Appendix A).
