# AVIATION INVESTIGATION REPORT A14F0065

## **Unstable approach and hard landing**

Airbus A319, C-FZUG

Sangster International Airport

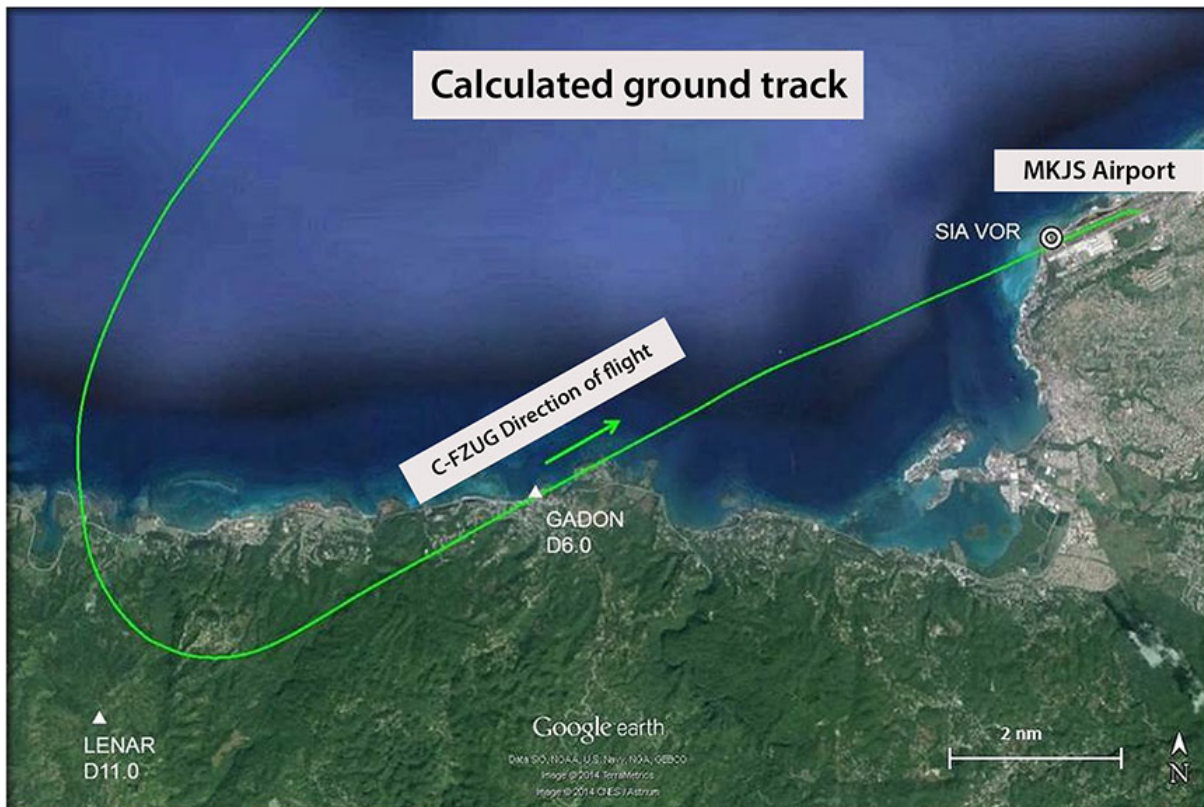
At 1425:44, the final approach track was intercepted from the left (north), at a distance of approximately 9.6 nautical miles (nm) from the threshold (inside of LENAR) (Figure 1). The aircraft was at an altitude of 3000 feet, with flaps 1 selected. According to Air Canada Rouge standard operating procedures (SOP), at this point (4 nm before the FAF), the aircraft should be configured with flaps 2. The autopilot was engaged and the autothrust was on. The airspeed was approximately 200 knots, and the aircraft was slightly above the 2.95-degree precision approach path indicator (PAPI), but below the 3.2° FPA. The aircraft began its final approach descent. Shortly afterward, the flight mode annunciator (FMA) lateral and vertical modes changed to NAV and FINAL DES<sup>10</sup> respectively, indicating that the aircraft was being managed by the flight management and guidance system (FMGS). The selected airspeed was still 190 knots. In these modes, the aircraft will fly the required lateral and vertical flight path, while the autothrust will vary the thrust to maintain the selected speed.

Figure 1. Aircraft ground track with approach fixes (Source: Google Earth, with TSB annotations)

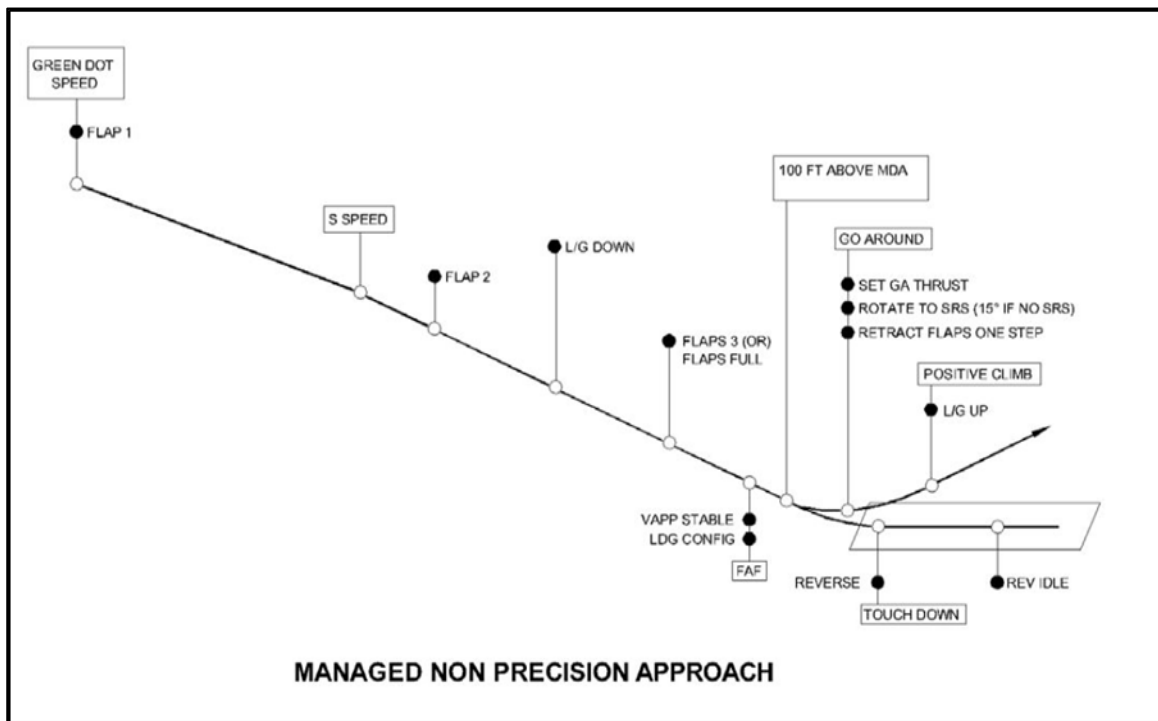
At 1427:02, the aircraft crossed the FAF at the appropriate height (2000 feet) with an airspeed of 188 knots ( $V_{APP}$  plus 54 knots). At that time, the landing gear was down, with flaps 1 selected. According to Air Canada Rouge SOPs for a non-precision managed approach, at this point the aircraft should have been stable at  $V_{APP}$ , with landing gear down and flaps 3 selected (Figure 2).

Figure 2. Air Canada Rouge standard operating procedures for a managed non-precision approach (Source: Air Canada Rouge)

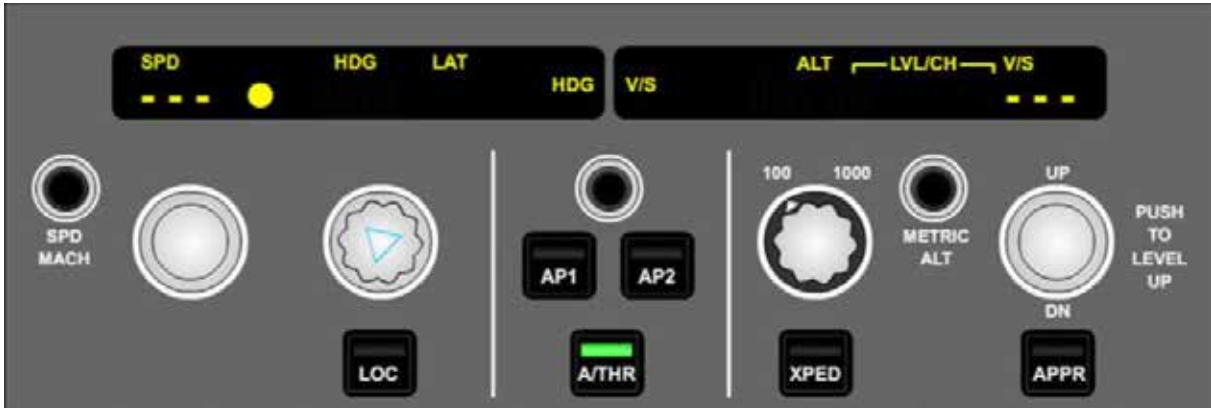
The operation of the aircraft’s FCU is detailed in the Airbus A319 *Flight Crew Operating Manual*. The FCU is the primary interface between the flight crew and the auto-flight system. It is located in the centre area of the glareshield. Flight crew operation of the FCU can modify any current flight parameters on a temporary basis and can also be used to select operational modes for the autopilot, flight director, and autothrust systems. Autopilot guidance modes can be selected on the FCU (Figure 3). The specific mode is displayed on the FMA portion of the PFD.

Figure 3. Flight control unit, showing the altitude selector knob (second from right), and the vertical speed/flight path angle selector knob (far right) (Source: Federal Aviation Administration, Accident Overview, Indian Airlines Flight 605, Airbus A320-231, VT-EPN)
