**AVIATION INVESTIGATION REPORT
A15C0005**

**COLLISION WITH TERRAIN
AIRSPAN HELICOPTERS LTD.
EUROCOPTER AS350 B2 (HELICOPTER)
C-GJPW
KEY LAKE, SASKATCHEWAN, 11 NM SE
21 JANUARY 2015**

Aviation Investigation Report A15C0005

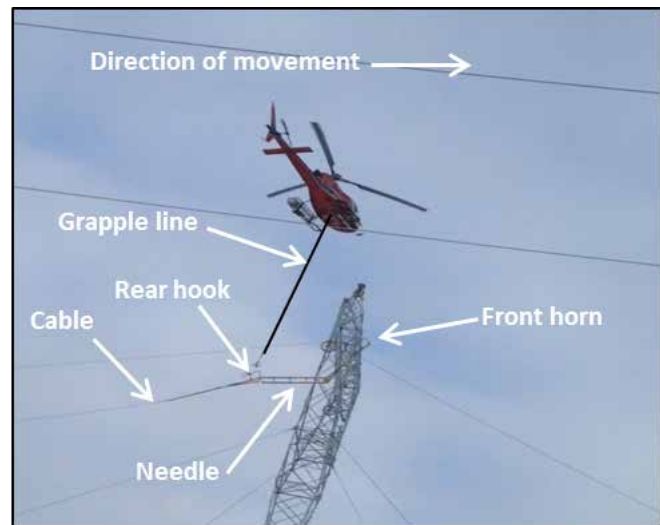
Figure 2. Approaching the tower

For centre-phase stringing operations, the feeder cable is attached to the rear of the needle. The helicopter is manoeuvred first to attach the grapple to the needle's rear hook and then to slowly guide the needle under the insulator string until the needle's front horn is caught on the tower steel (Figure 2).¹⁰ Once the front horn is caught on the tower steel, the pilot manoeuvres the helicopter to remove the grapple from the needle's rear hook and repositions the helicopter to the opposite side of the tower. There, the helicopter is manoeuvred to attach the grapple to the needle's front hook. The pilot then lifts the front horn off the tower steel and pulls the needle partially under the insulator string until the rear horn is caught on the tower steel (Figure 3). Finally, the pilot hooks the grapple back onto the needle's rear hook to pull the feeder cable through the centre, drops the cable into the stringing dolly (Figure 1) and continues to the next tower (Figure 4).

¹⁰ Figures 2, 3 and 4 are photos of the occurrence aircraft conducting stringing operations on a different day with a different pilot.
