AVIATION INVESTIGATION REPORT

A15F0165

Severe turbulence encounter

Boeing 777-333ER, C-FRAM

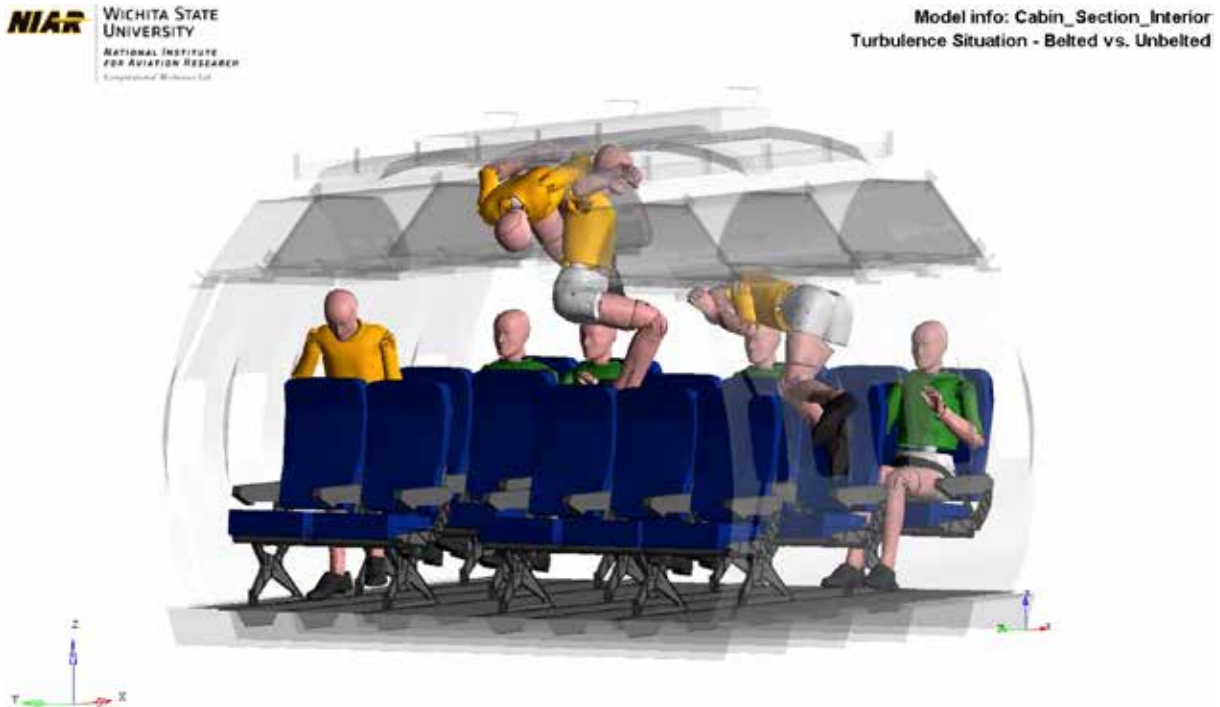
Figure 3. Screen capture of animation demonstrating the effects of severe turbulence on restrained passengers (green) and unrestrained passengers (yellow) in an aircraft, based on acceleration data collected from ACA088's digital flight data recorder

The acceleration forces encountered resulted in passengers who were not wearing seat belts contacting various furnishings and surfaces in the cabin causing a variety of injuries, including 1 serious injury.
