# AVIATION INVESTIGATION REPORT

## A15P0217

### **Loss of control during night approach and near collision with terrain**

Sikorsky S-76C+ (helicopter), C-GHHJ

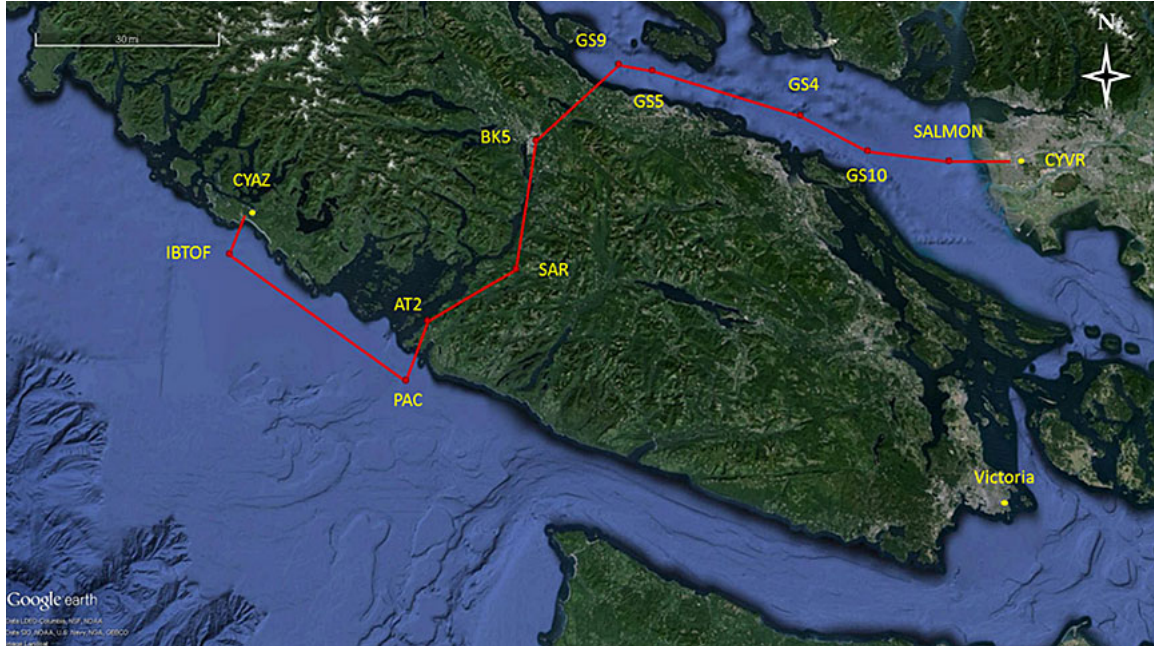
During the initial climb to 2500 feet above sea level (ASL) on the company-approved NVFR route (Figure 1), the flight crew discussed the limited visibility due to darkness. However, the clouds and reported visibility at the time met regulations for NVFR flight.<sup>5</sup>

Figure 1. Helijet night visual flight rules route (Source: Google Earth, with TSB annotations)

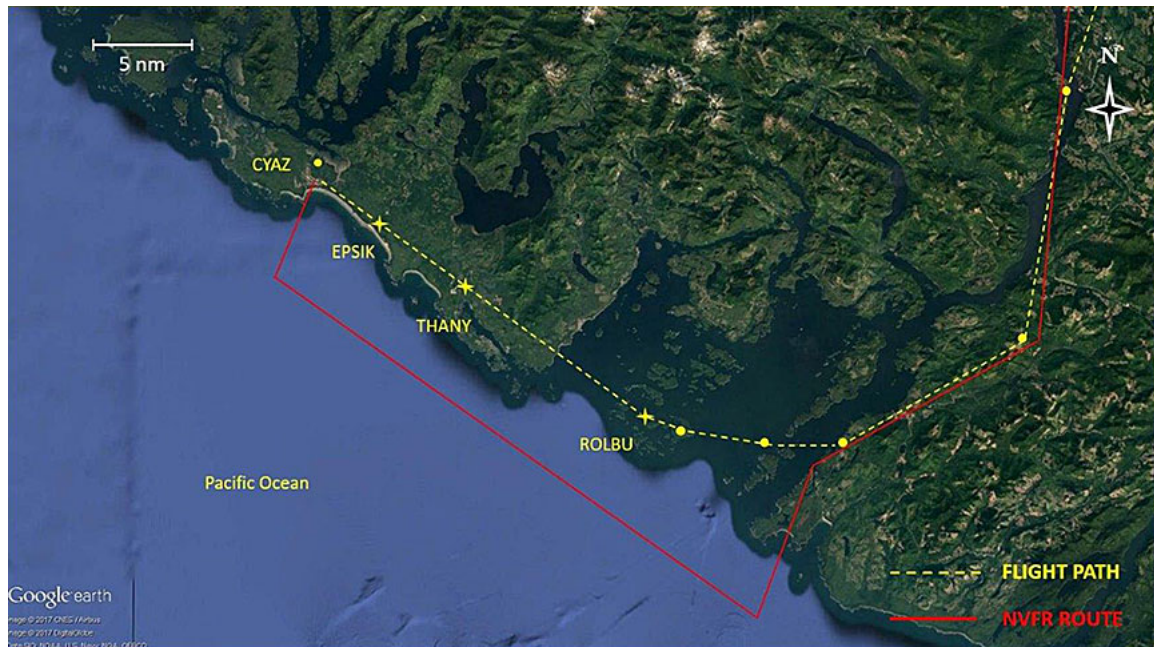
At 0232, the PF started to slow the helicopter and began a descent to 900 feet ASL. One minute later, the PM completed the final approach checklist. After crossing waypoint EPSIK (Figure 2) at 0237:06, the helicopter continued to slow and descend, levelling at 620 feet ASL as the PF maintained speed at 85 knots indicated airspeed (KIAS).

Figure 2. Night visual flight rules route and the helicopter's flight path (Source: Google Earth, with TSB annotations)
