AIR TRANSPORTATION SAFETY INVESTIGATION REPORT A17O0264

COLLISION WITH TERRAIN

Hydro One Networks Inc.
Airbus Helicopters AS 350 B2 (helicopter), C-GOHS
Tweed, Ontario, 8 NM NNE
14 December 2017

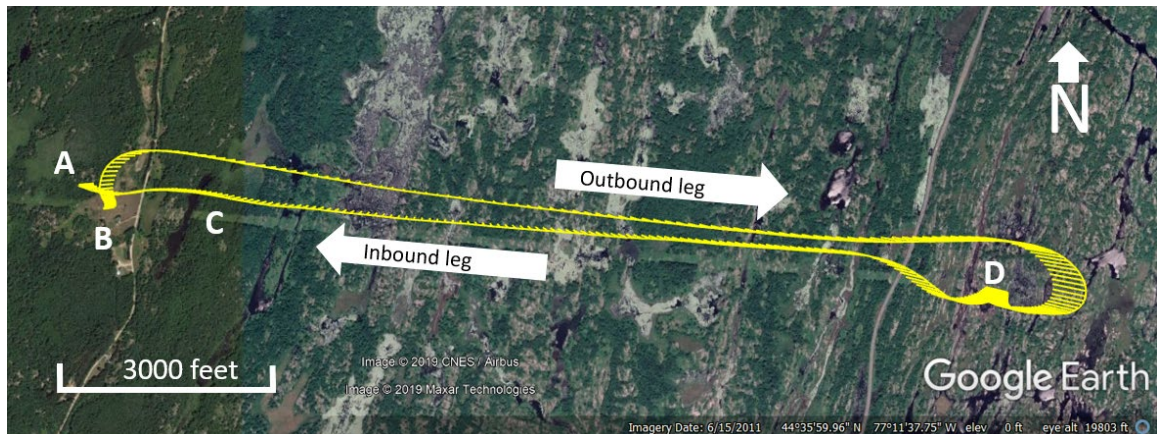
Figure 1. Occurrence helicopter's path (Source: Google Earth, with TSB annotations)

When the helicopter was at a height of about 75 feet AGL, the tail rotor, tail rotor gearbox, and vertical fin separated from the tail boom. The helicopter departed from controlled flight, climbed, began to rotate rapidly to the left, and then rapidly descended. At 1146:42, the helicopter struck the surrounding trees and then the ground about 400 feet northwest of its intended landing site (Figure 1). All 3 passengers became separated from the helicopter before impact and were fatally injured. The pilot was also fatally injured.

- A Accident site
- B Staging area
- C Preform bag
- D Transmission tower

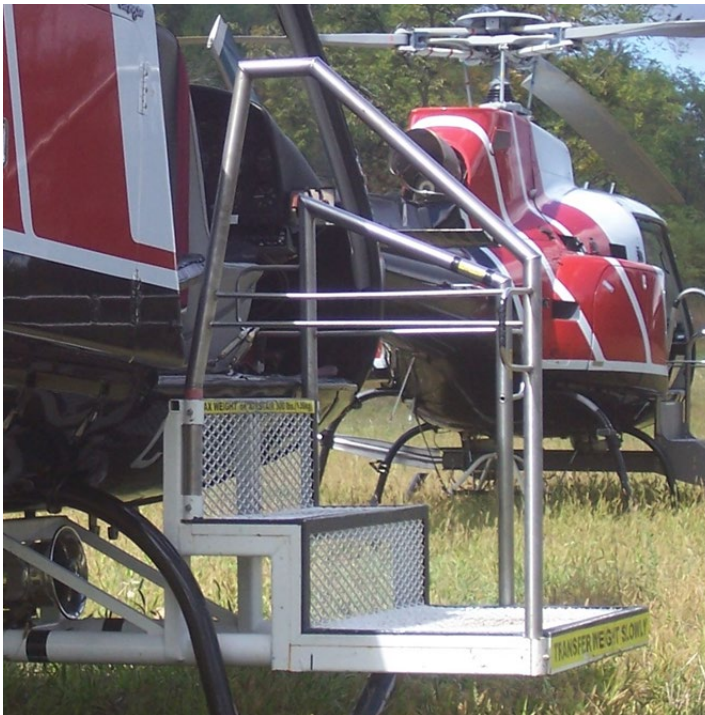
Figure 3. Helicopter with Air Stair attached (Source: Hydro One Networks Inc.)

The Air Stair mounts to the underside of the fuselage but does not extend below the skid gear (Figure 3). When the Air Stair is installed, the helicopter's front left seat is replaced with a box that the PLTs use to stow equipment, and the floor of the helicopter is fitted with anchor points where the PLTs can attach their fall restrict tethers when they are ready to transfer.

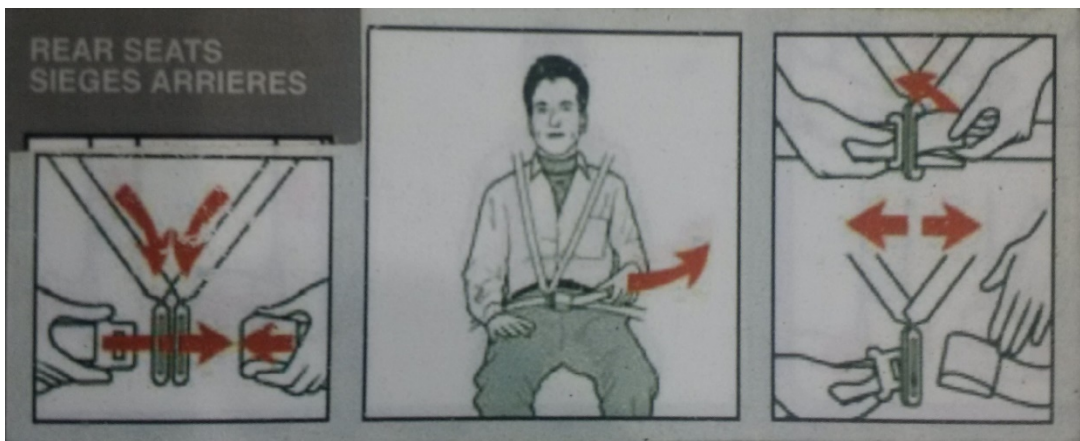
Figure 9. Hydro One's safety briefing card showing how to use the safety belts for the rear seats of the helicopter (Source: Hydro One Networks Inc.)

The helicopter had a 4-seat fixed-position rear bench, which was normally equipped with a 4-point safety belt for each seat. These safety belts were designed so that one half of the lap strap buckle had to be inserted through metal tongues on the shoulder harness before connecting the second half of the lap strap buckle (Figure 9). Lifting the buckle latch simultaneously released the lap strap and both shoulder harness straps. It was possible to wear the lap strap portion only, without the automatic locking shoulder harness attached.
