## **AIR TRANSPORTATION SAFETY INVESTIGATION REPORT A20P0013**

### **RUNWAY EXCURSION**

De Havilland Aircraft of Canada Ltd. DHC-8-402, C-FKWE

Terrace Airport, British Columbia

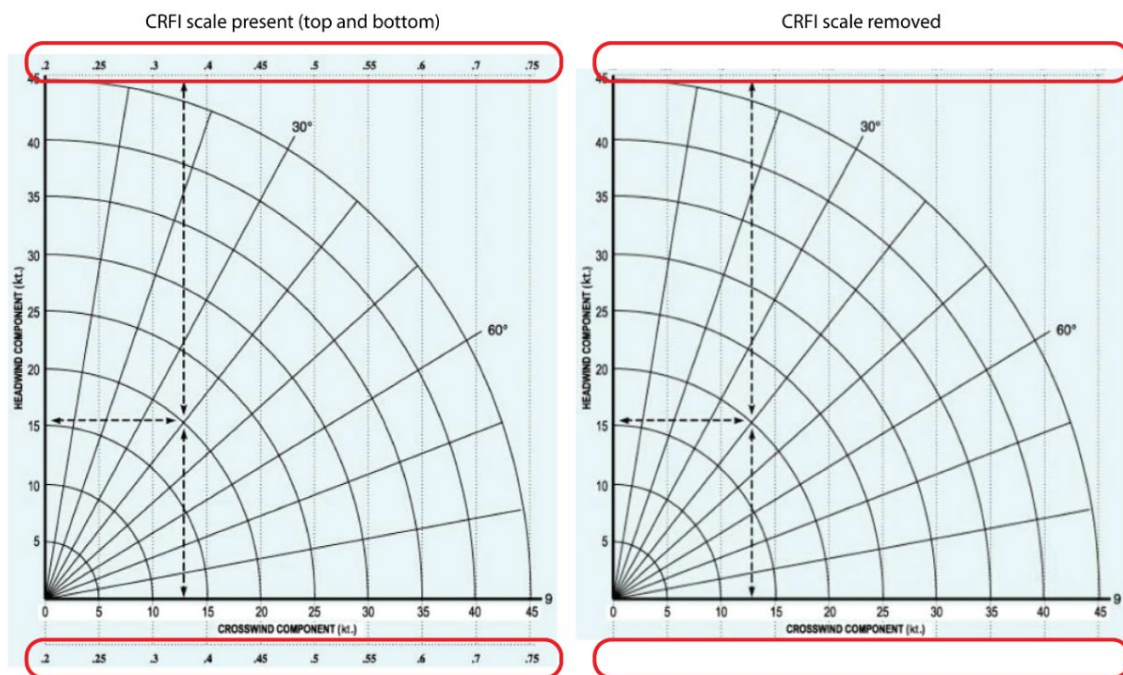
Following this decision, WestJet Encore published several revisions to its AOM,<sup>34</sup> QRH,<sup>35</sup> and Winter Operations Guide.<sup>36</sup> These revisions included a number of changes, both editorial and procedural in nature. As part of these revisions, in August and September 2019, references to the CRFI were removed, the procedure for using the CRFI when calculating landing distance on a contaminated runway was changed, and the crosswind component chart was added to the Winter Operations Guide, but it did not include the CRFI scale (Figure 4).

Figure 4. Comparison of crosswind component charts. The version on the left was included in Revision 006 of the Quick Reference Handbook (effective 30 November 2017) and included the Canadian Runway Friction Index scale above and below the graph. The version on the right is included in Revision 23 of the Winter Operations Guide (effective 10 December 2019). (Source: WestJet Encore Ltd., with TSB annotations)

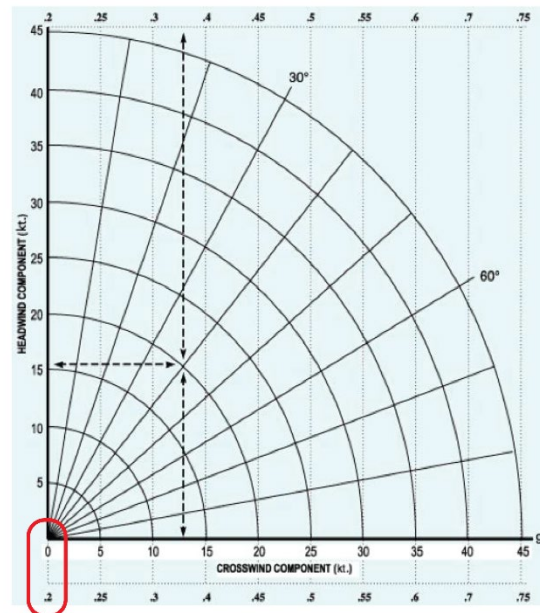
For example, with a CRFI value of 0.20 (which was reported shortly before the occurrence), the crosswind limit would be 0 (Figure 5), meaning that any crosswind component would exceed the limitation.

Figure 5. Crosswind component chart with Canadian Runway Friction Index scale. A Canadian Runway Friction Index value of 0.20 indicates a 0-knot crosswind component (circled). (Source: WestJet Encore Ltd., DHC-8-400 Quick Reference Handbook, Revision 006 [effective 30 November 2017], p. 2-5, with TSB annotations.)

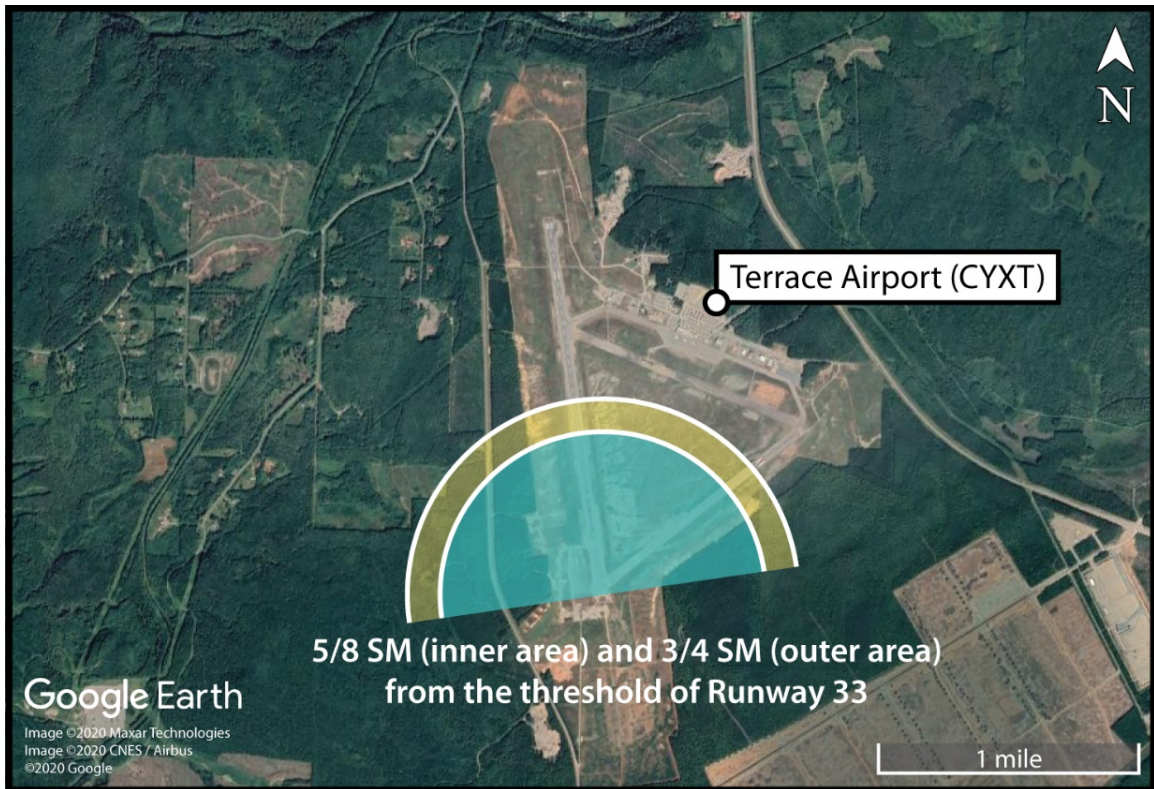
In this occurrence, while the actual visibility for the flight crew at any point along the approach path and landing cannot be known, the FSS specialist at CYXT estimated the visibility at the time of the occurrence to be  $\frac{5}{8}$  SM, or 3300 feet. Figure 6 shows the flight crew's estimated field of view with a visibility of  $\frac{5}{8}$  SM compared to a visibility of  $\frac{3}{4}$  SM.

Figure 6. The estimated flight crew's field of view with a visibility of  $\frac{5}{8}$  statute mile (inner area) compared to a visibility of  $\frac{3}{4}$  statute mile (outer area) from the threshold (Source: Google Earth, with TSB annotations)
