MARINE INVESTIGATION REPORT

M00C0019

GROUNDING

CHEMICAL TANKER *SUNNY BLOSSOM*

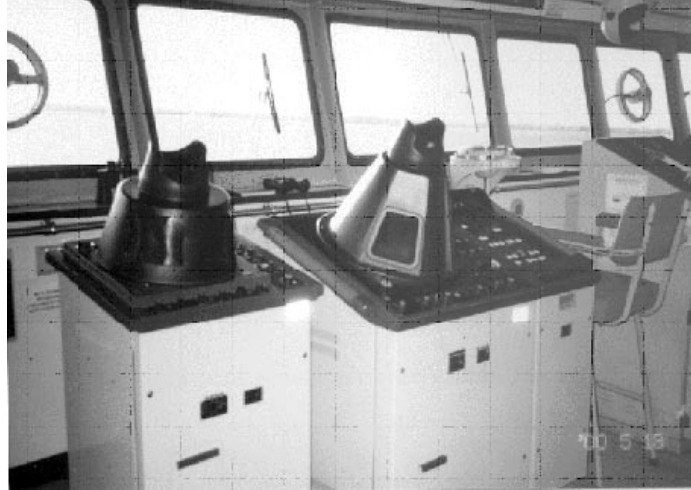
The apprentice pilot observed that the heading markers of both radars were approaching 280° G and advised the pilot accordingly. The pilot went to the radar, commented on the poor radar performance and immediately ordered the OOW to reduce speed from about 7 kn to the dead slow ahead speed of 5 kn. The vessel continued to swing to starboard across the channel. There is conflicting information as to what helm orders were given. One account maintains that there was no time to give helm orders, whereas another account maintains that a series of port helm orders was given. At 0730, the chemical tanker grounded upstream of buoy D36, on the north side of the channel, on a heading of 274° G. The vessel was aground starboard side to the shoal with a list to port of 2.5° (see Appendix A, Photo 1).

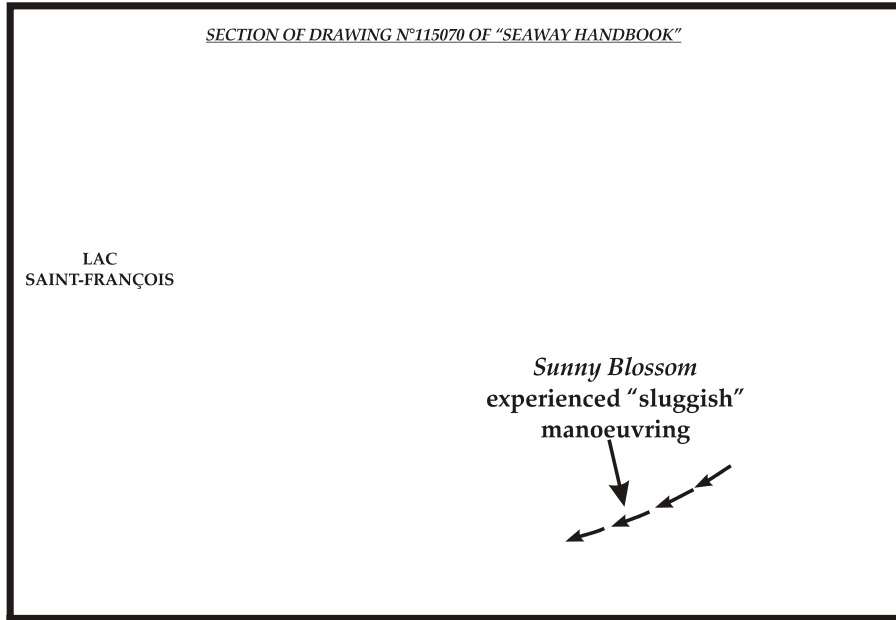
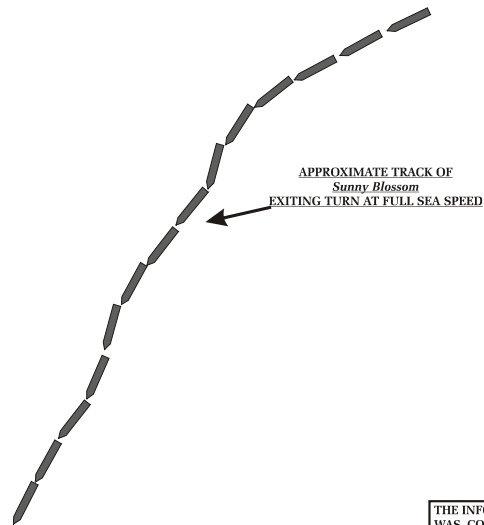
Appendix B – Sketches

At 0726, the course steered was altered from 236° G to 234° G, and the vessel crossed over to the south side of the channel. When the apprentice pilot advised the pilot that the vessel was 0.81 nm from Saint-Anicet lower range beacon and 0.36 nm from Île Lanouette, the pilot ordered the helmsman to apply 10° starboard helm. Buoys D34 and D35 were then observed as the vessel rounded between them. As the radar heading marker neared the south side channel target of D37 at 0727, the pilot gave helm orders to reduce the vessel's swing and then told the helmsman to steer 247° G. Buoy D37 could now be seen on the starboard bow. The pilot confirmed this visual cue by going to the radar and observing the buoy at a distance of 0.31 nm.

At about 0729, the vessel began to yaw to port and the pilot ordered "hard-a-starboard." The heading stopped falling off at 246° G and the helm was eased to starboard twenty. When observing buoy D37 ahead, the vessel's response was found to be sluggish and the helm was once again put hard over to starboard. The vessel started to respond and, when the heading reached 250° G, the pilot ordered "steer two six seven." The third officer informed the apprentice pilot that the next course was 266.5° G and that he agreed with the pilot's order. As the vessel cleared buoy D37 on the south side of the channel, the third officer remarked that the vessel was very close to the buoy. The pilot repeated the order "course two six seven." By now, the rain had intensified to the extent that visibility was almost nil.
