MARINE INVESTIGATION REPORT

M00M0083

UNCONTROLLED DESCENT OF FREIGHT ELEVATOR

FREEZER TRAWLER *MERSEY VENTURE*

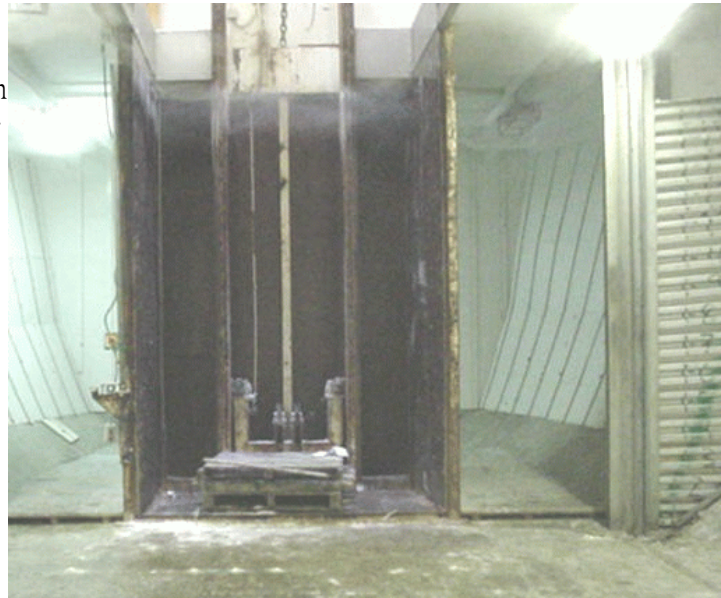
The elevator was supplied and installed as original equipment at new building by MacGregor-Navire (N) A/S, the marine division of Kone Incorporated. As installed, the elevator consisted of a platform which moved vertically in guides located on a steel structure within a hoistway enclosed on three sides. The device links the factory deck and the refrigerated hold below, with a height of lift of approximately 3.65 metres.

The lift main drive machine (a winding drum type Model No. UN2B - 1 electric hoist) is located on top of the steel structure on the forward side. It had two suspension cables of 14 mm diameter steel wire rope rove to advantage through two sheaves configured as single whip purchases. The system had two limit systems to control the vertical travel. The primary stage limit system was located on the rope hoist itself. A secondary stage limit system, using magnetic proximity limit switches, was mounted on the frame of the elevator. The switches provided redundancy in the event of a failure of the primary system. A load cell was installed on the rope hoist to prevent operation of the elevator in an overstressed condition. The safe working load of the elevator was rated at 3.5 tonnes.
