MARINE INVESTIGATION REPORT

M00W0265

ACCIDENTAL RELEASE OF LIFEBOAT

BULK CARRIER *PACMONARCH*

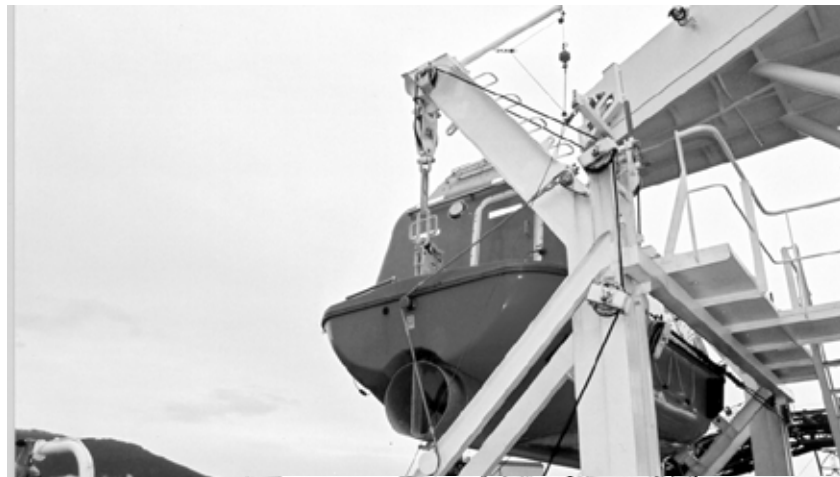
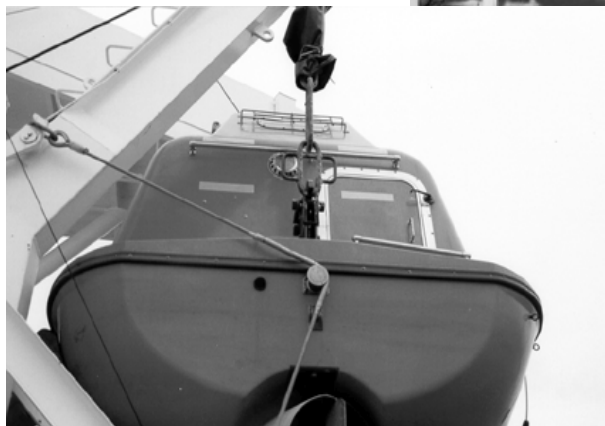
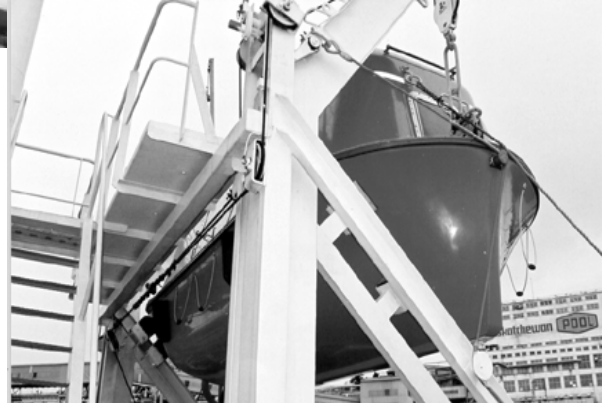
One end of each gripe is secured to a pad eye that is welded to the ship's deck; the other end passes over a freely rotating hooked lever that is attached to the side of the davit.

In the lifeboat's stowed position, the free end of this rotating lever bears against the rigid support frame of the

davit, preventing it from turning.

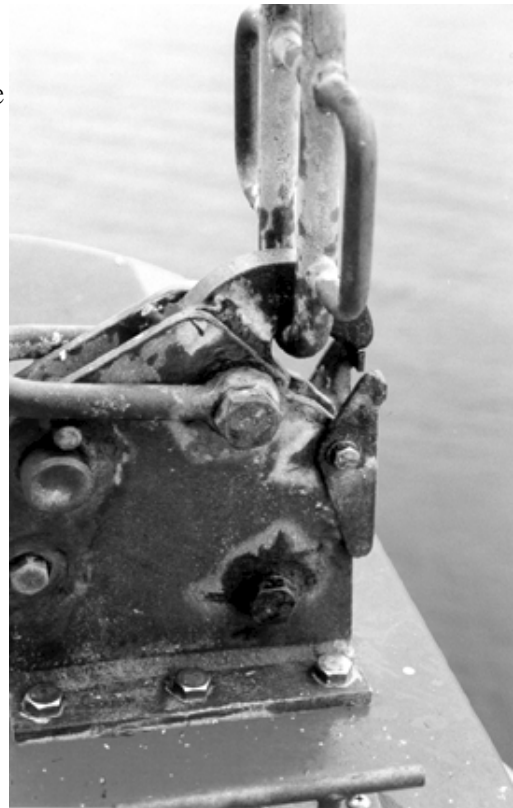
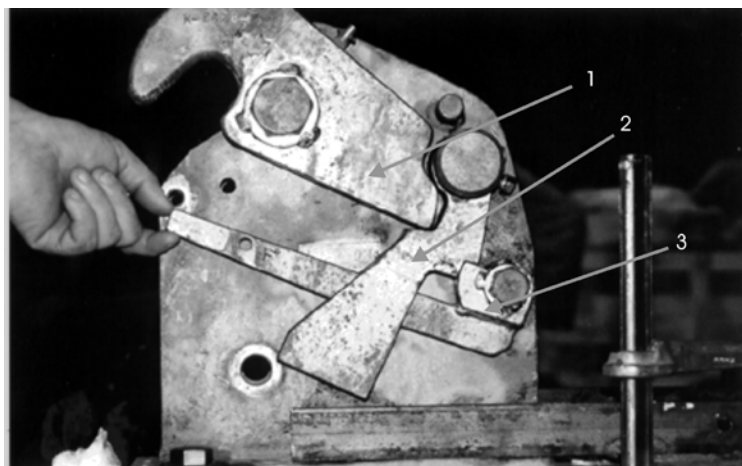
On each hook assembly, the hook, the blocking lever, and the reset lever carry reference marks. The cheek plates have corresponding reference marks. The hook has been correctly reset when these marks are properly aligned.

The TSB's post-occurrence inspection of the hook assemblies indicated that, in the reset position, the reference marks on the reset levers were not aligned with the reference marks on the cheek plates. The top surface of the mark on the reset lever was just below the bottom surface of the marks on the cheek plates (see Photograph 20).

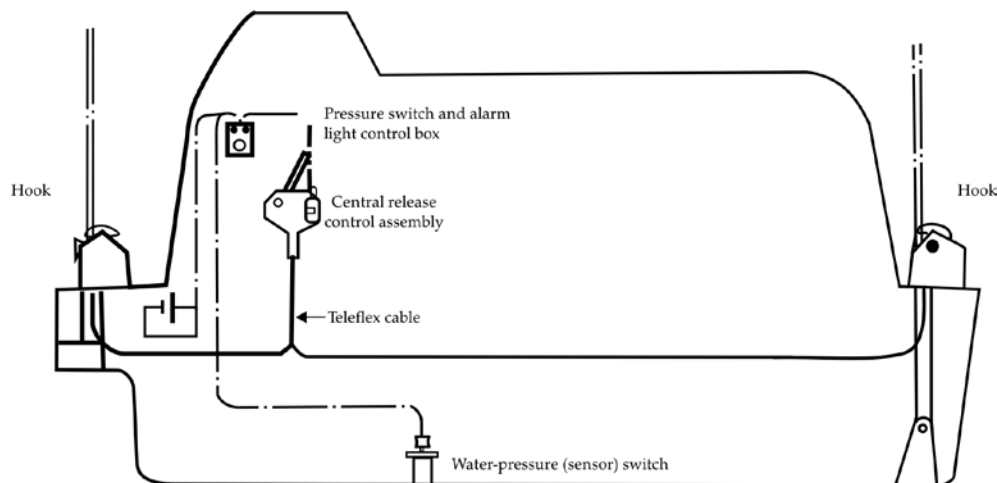
The central release control assembly is just behind and to port of the coxswain's seat (see Photograph 12). It is made of two galvanized steel side plates to which are connected the release lever, the cable connection arms, and the interlock lever. A solenoid coil is mounted on top of the framework formed by the side plates.

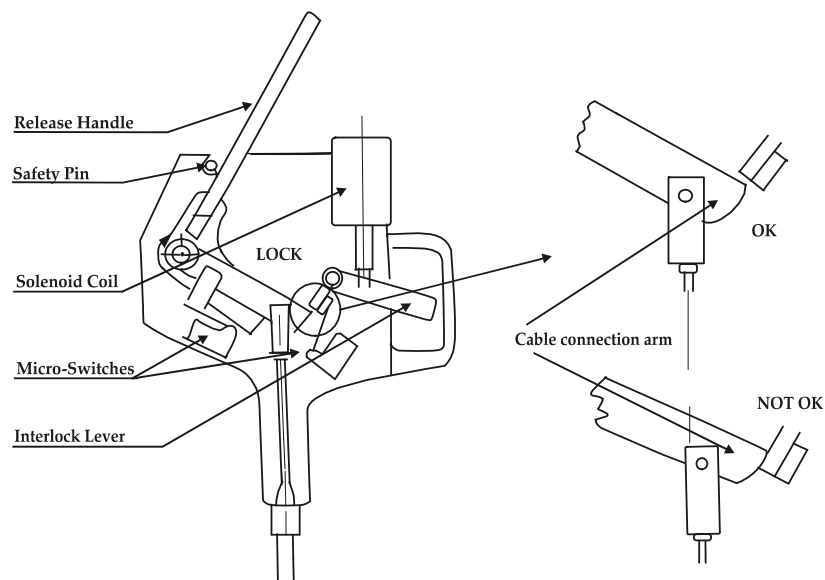
The interlock lever can swing into, or out of, a position where it blocks the upward travel of the cable connection arms and, thereby, the release handle. The free end of the interlock lever is enclosed in a housing, one side of which is covered by a clear Perspex removable window that faces the operator. In an emergency, the operator can remove the window and manually lift the interlock lever away from its blocking position. According to the instruction manual, the frame around the perspex window is painted in two colours: the top half is red and the bottom part green. When inspected by the TSB, the entire frame was found to be painted red.

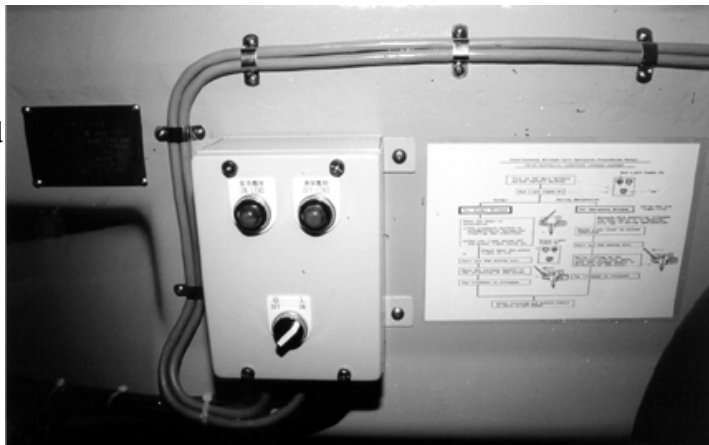
Inside the lifeboat is an alarm light control box (see Photograph 13). The front panel of this control box has an on/off power supply switch and two indicating lamps: one red and one green. These lamps are connected to the three microswitches in the central release control assembly and to the water-pressure switch. The red lamp indicates two operating conditions: one when the lifeboat is out of the water and it is not safe to pull the release handle; the other when the hooks have been opened and the suspension rings released.

The green lamp also indicates two operating conditions: one when the lifeboat is in the water and it is safe to pull the release handle; the other when the hooks have been correctly reset to the load-bearing position.
