MARINE INVESTIGATION REPORT

M01L0129

STEERING GEAR FAILURE AND SUBSEQUENT GROUNDING

THE BULK CARRIER *CEDAR*

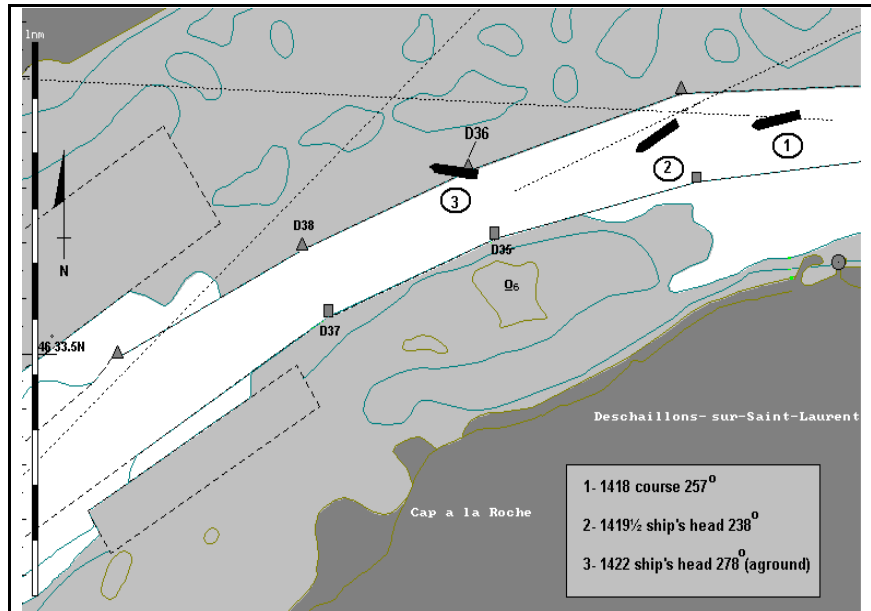
The *Cedar* was still making close to 9 knots and, as the bow came into contact with the channel bottom, the vessel's head shifted to port about 7° before coming quickly to a stop at 1422. The vessel was now aground at position 46°33'48" N; 072°07'33" W on a heading of 278°(position 3, Figure 2), the helm hard to port, but the rudder still to starboard about 4°.
