MARINE INVESTIGATION REPORT

M01M0100

SWAMPING

SMALL FISHING VESSEL *ALAIN-JOSÉE*

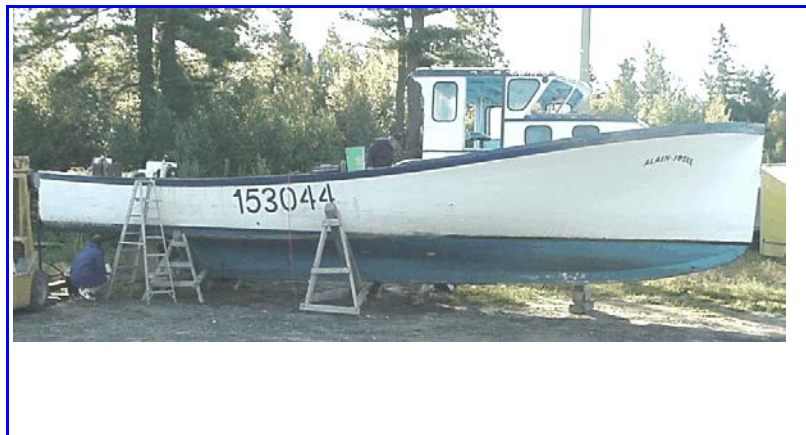
The *Alain-Josée* is a small wooden fishing vessel of open-deck construction. The wheelhouse and accommodation are located forward of the open working deck (well deck).
