MARINE INVESTIGATION REPORT

M01N0020

FLOODING AND SINKING

SHRIMP FACTORY FREEZER TRAWLER *FAME*
120 NAUTICAL MILES NORTHEAST OF
BELLE ISLE, NEWFOUNDLAND AND LABRADOR
19 APRIL 2001

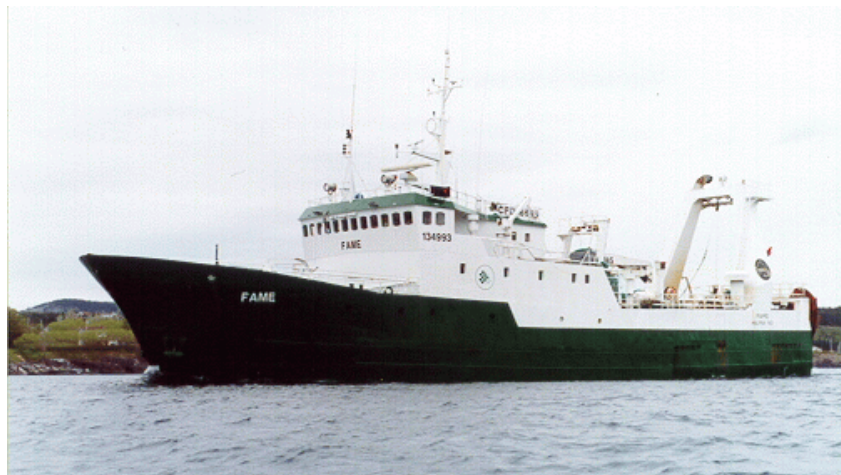
OUTLINE GENERAL ARRANGEMENT

The location of the engine room, decks, watertight hatches, oil fuel, water ballast, and freshwater tanks, refrigerated upper and lower holds, shrimp-processing areas, and crew accommodation, etc. were as shown in the Outline General Arrangement (see Figure 1).
