**MARINE INVESTIGATION REPORT  
M02C0030**

**SINKING AND LOSS OF LIFE**

**AMPHIBIOUS PASSENGER VEHICLE *LADY DUCK*  
OTTAWA RIVER  
NEAR THE HULL MARINA  
GATINEAU, QUEBEC  
23 JUNE 2002**

Report Number M02C0030

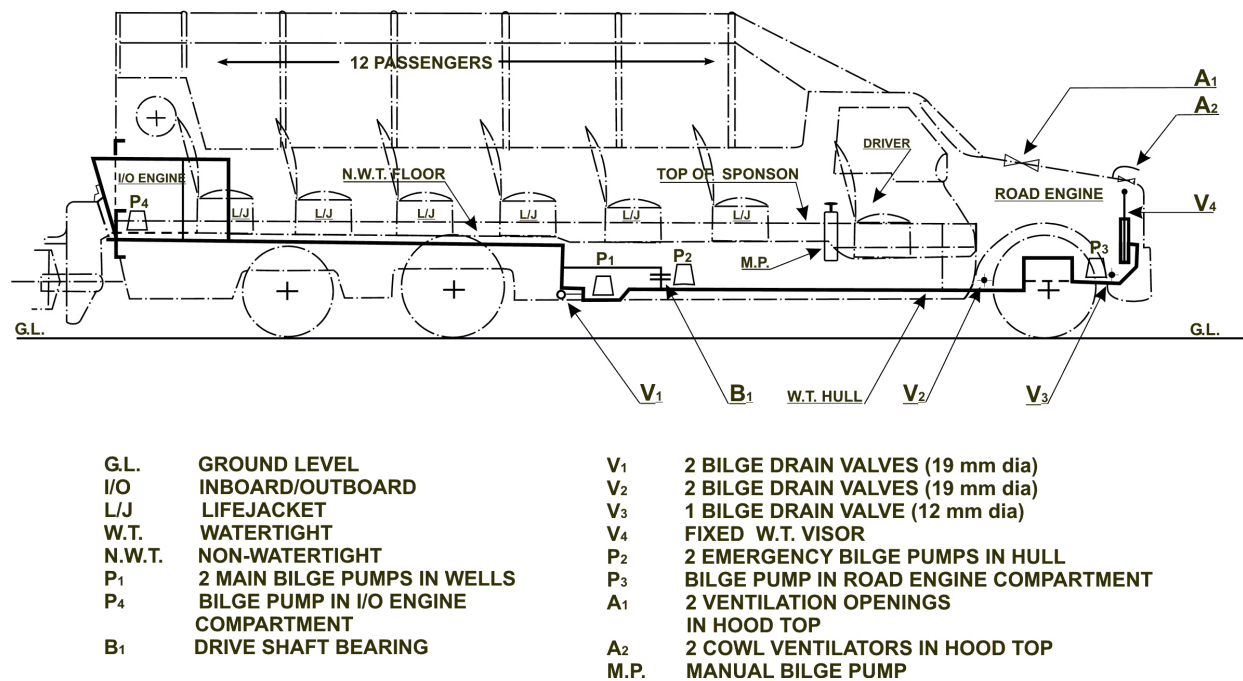
Figure 1. Construction profile outline

The bottom of the chassis was enclosed with welded and bolted steel plating and the sides were extended upward to enclose a buoyant structure. The original truck wheels and suspension were fitted outside the watertight hull. The effective breadth of the chassis was increased by the

The vehicle was fitted with five drainage points, each comprised of a hand-operated, ball check valve (seacock) with a swing-check, non-return valve immediately inboard, both of which were mounted on a common pipe spigot and closed with a screwed steel plug. Four of the drainage points were 19 mm ( $\frac{3}{4}$  inch) in diameter; the fifth was 12 mm ( $\frac{1}{2}$  inch) in diameter. Once on shore, the drainage points could be used to release accumulated water from the bilges (see Figure 1).

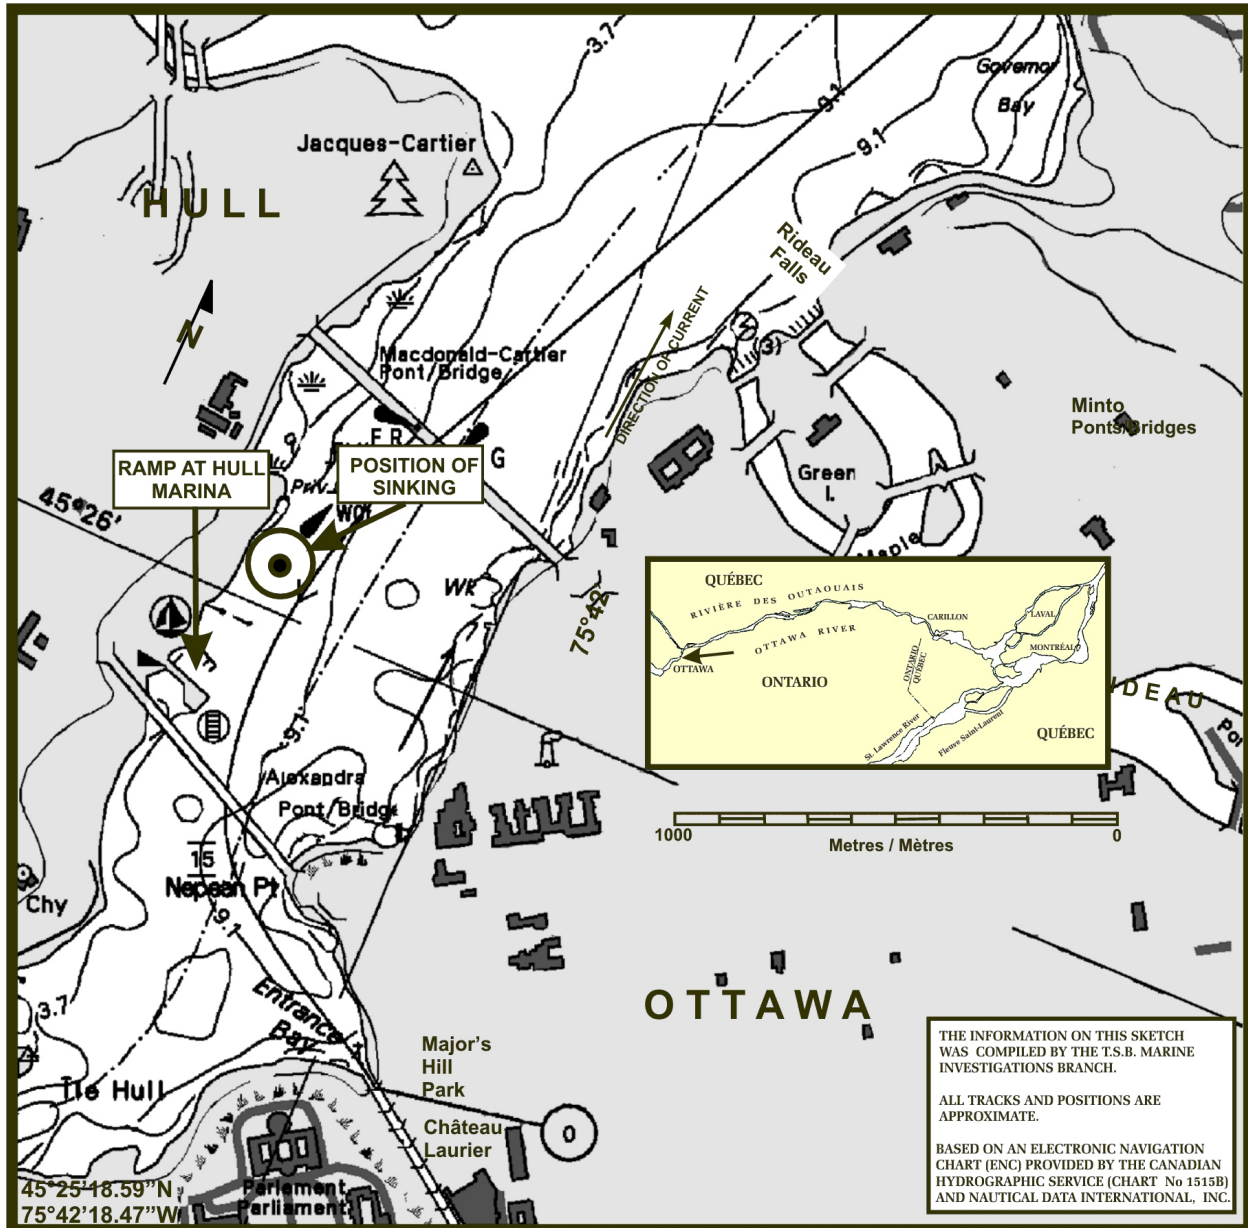
Figure 2. Chart of the occurrence area

Toward the end of the tour, at about 1608, while returning to the Hull Marina at approximately 8 km/h, the driver noted that the front end of the vehicle was floating lower than normal and that water was being continuously discharged from both sides of the vehicle near midships. The driver then ordered the four foremost passengers and the tour guide to move to the back of the vehicle to try to decrease the forward trim.

The forward trim continued to increase and, realizing that the safety of the passengers was at risk, the driver instructed the tour guide to tell the passengers to don PFDs. At this time, he diverted the vehicle toward the nearest point on the Quebec shore. The driver then broadcast a MAYDAY on emergency VHF channel 16, identifying the *Lady Duck*, giving its position and the number of passengers on board. At about 1610, the situation deteriorated rapidly as more floodwater accumulated in the forward end of the vehicle. The driver then called on the passengers to abandon the sinking vehicle. The driver left the steering position, made his way aft and, with seven other persons, managed to get free of the sinking vehicle. The remaining four passengers became trapped under the fabric awning and sank with the vehicle in 8 m of water.
