MARINE INVESTIGATION REPORT

M02C0064

COLLISION

Between the Great Lakes Bulk Carrier
Canadian Prospector
and the Heavy Lift Ship *Stellanova*
St. Lawrence Seaway, Quebec
12 October 2002

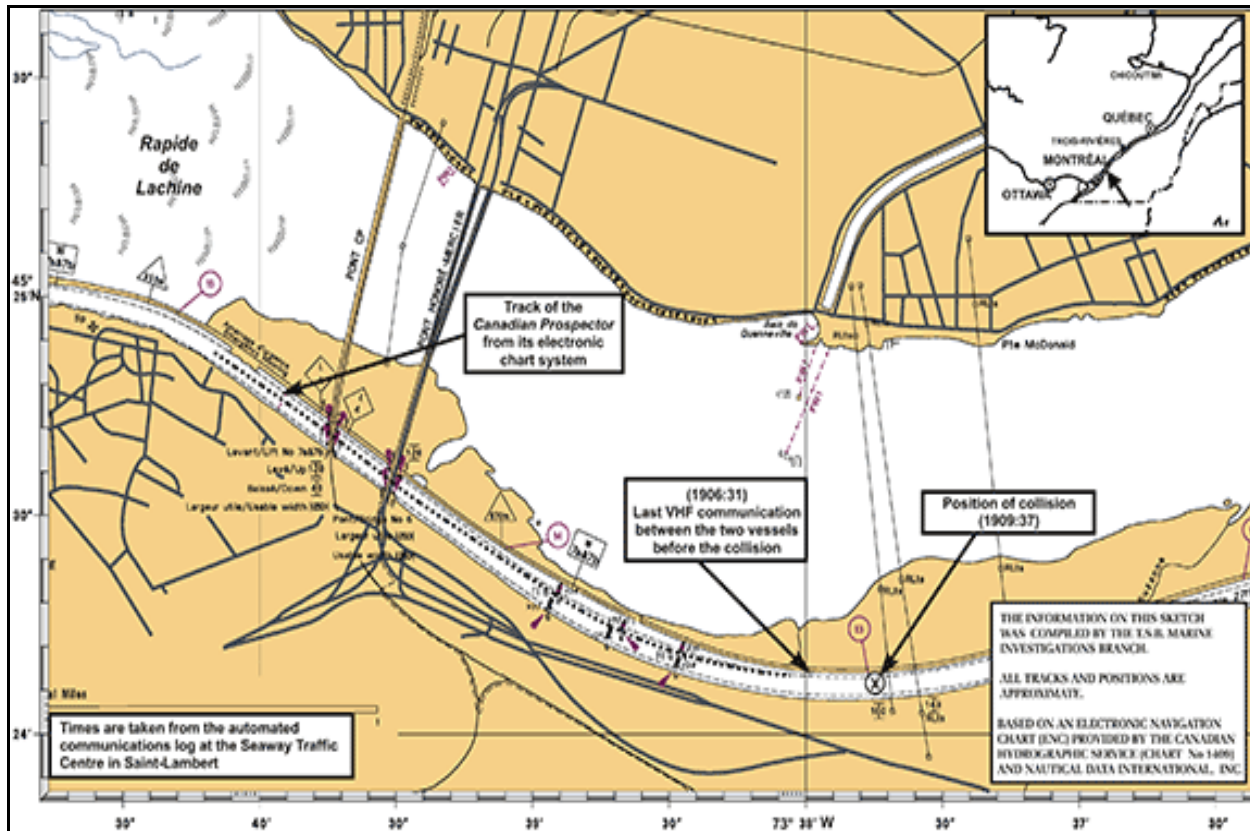
Figure 1. Chart of the occurrence area

A short time later, the *Stellanova* sheered towards the centre of the channel. The pilot ordered the helmsman to steer hard-to-port, but the *Stellanova* continued the sheer to starboard. At 1906:31, the *Stellanova* advised the *Canadian Prosperator* that it was coming back to the north side of the channel and that the two ships should effect passage port to port. The *Canadian Prosperator* firmly rejected the proposal and immediately requested confirmation of their earlier starboard-to-starboard arrangement. The *Stellanova* responded that its main engine was operating full astern.

The *Canadian Prosperator* was steered closer to the north side of the channel edge to give the *Stellanova* maximum sea room to prevent a collision. However, at 1909:37, the two vessels collided. The angle of impact was estimated to be 120°. On impact, the *Canadian Prosperator* swung to port and its over-the-ground speed decreased from 4.1 knots to 2.3 knots. At the time of impact, the *Stellanova* was pushed towards the south side of the channel, where it struck the edge. The rudder and rudder stock were warped, causing hydraulic oil to leak into the Seaway. At 1912, the Seaway station at Beauharnois received a brief damage report.
