Transportation Safety Board  
of Canada

**MARINE INVESTIGATION REPORT**  
**M03M0040**

**GROUNDING**

**LARGE FISHING VESSEL *SHINEI MARU* No. 85**  
**APPROACHES TO HALIFAX HARBOUR**  
**03 MAY 2003**

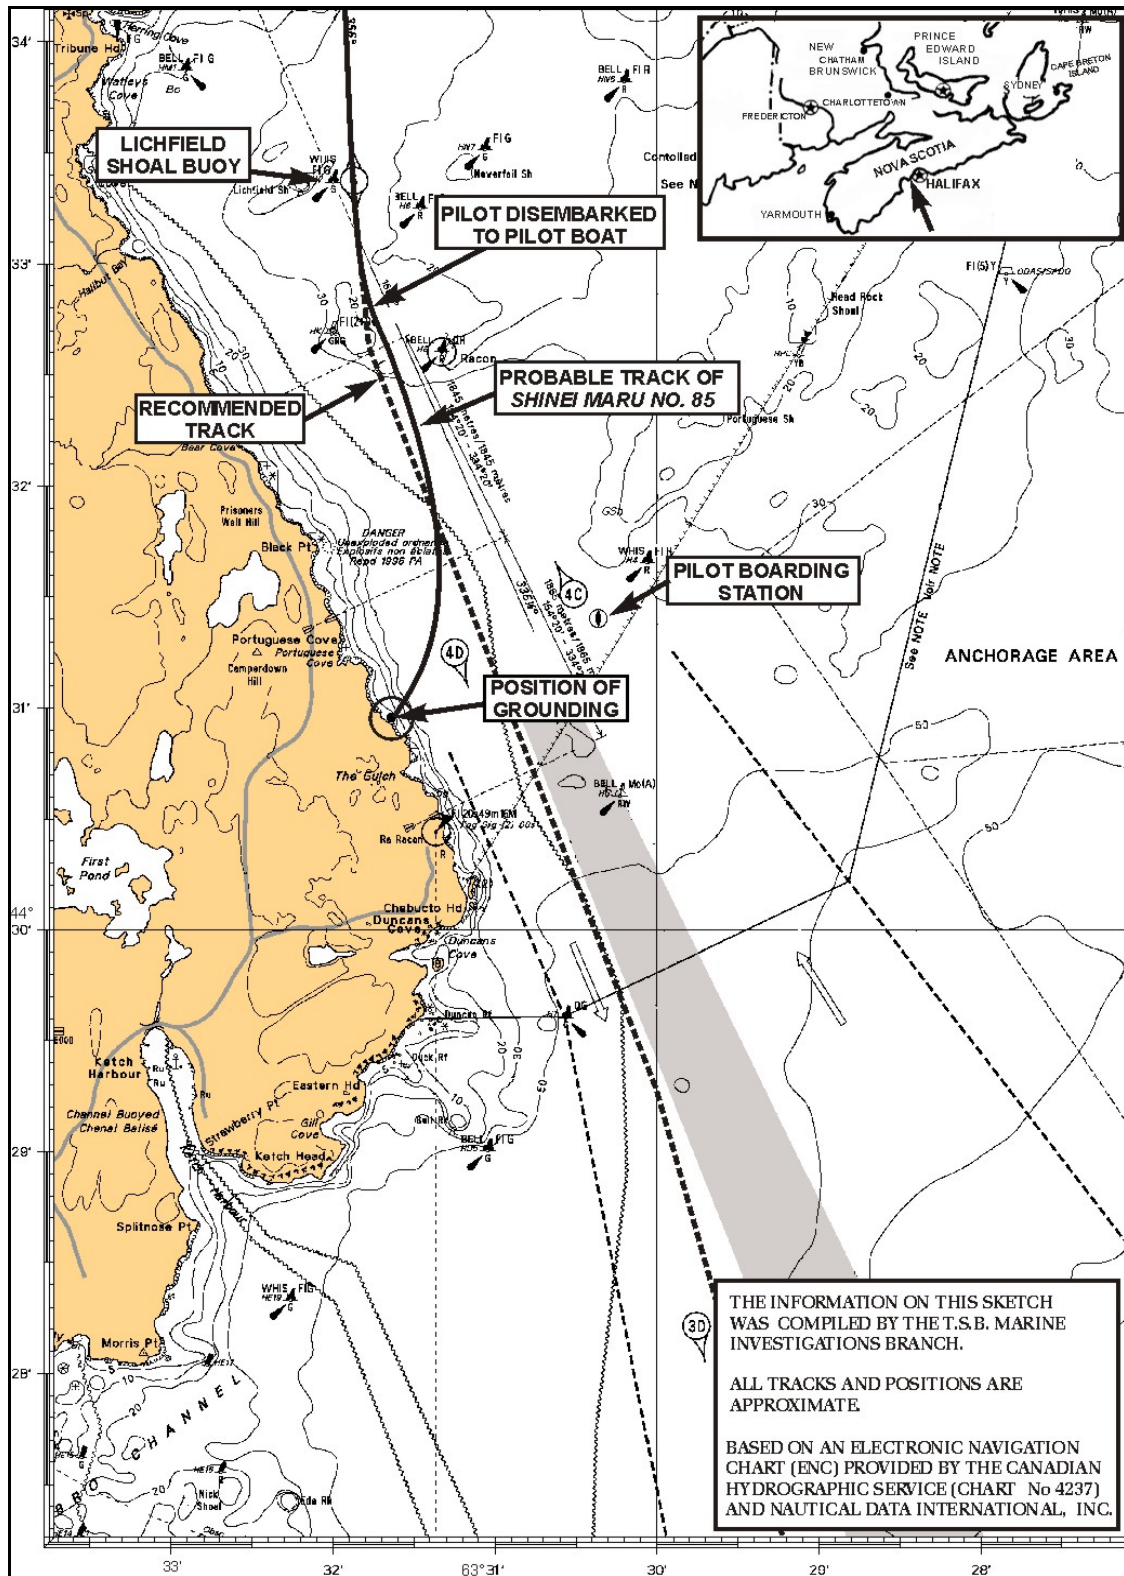
# Appendix A: Sketch of Occurrence Area

The type of video plotter on board was used as a fishing aid rather than as a navigational aid. Nevertheless, the vessel's track inbound to Halifax was displayed on the video plotter, and the outbound course to grounding was also visible. The outbound plot line followed the recommended route up until a point just after Lichfield Shoal (when the pilot disembarked). The straight-line plot of the vessel's track then changes direction from Lichfield Shoal to the point of grounding (see Photo 3). However, the probable track<sup>5</sup> of the vessel is as shown in Appendix A.
